HISTORIC PRESERVATION COMMISSION CERTIFICATE OF APPROPRIATENESS APPLICATION

Address: 65 W. Front Street Red Bank ^{NJ.} Block: 30 Lot: 9

June 18, 2020

RE: Inspection for Stucco Repair
65 West Front Street
Red Bank, New Jersey
Our Reference No. 20-178.00

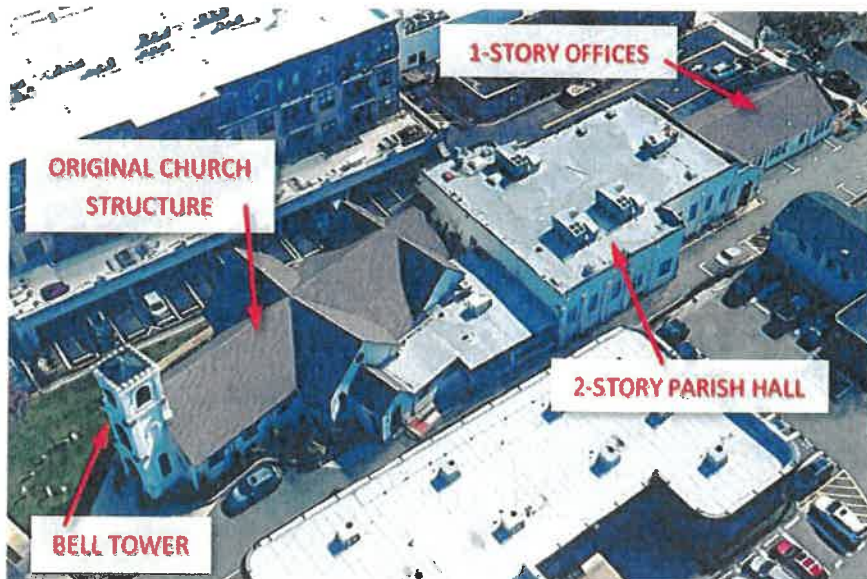
Photo 1 - Aerial Imagery of Property Facing South-East

The subject building is the Trinity Church. The property extends from West Front Street at the front to White Street at the rear. The original church structure has been modified over time to include a 2-story Parish Hall addition and a 1-story office space addition at the rear, as shown in Photo 1. All exterior walls are masonry construction with a light-colored cementitious "parge" or "stucco" surface coating. This surface coating is visibly cracked and damaged at several locations around the building.

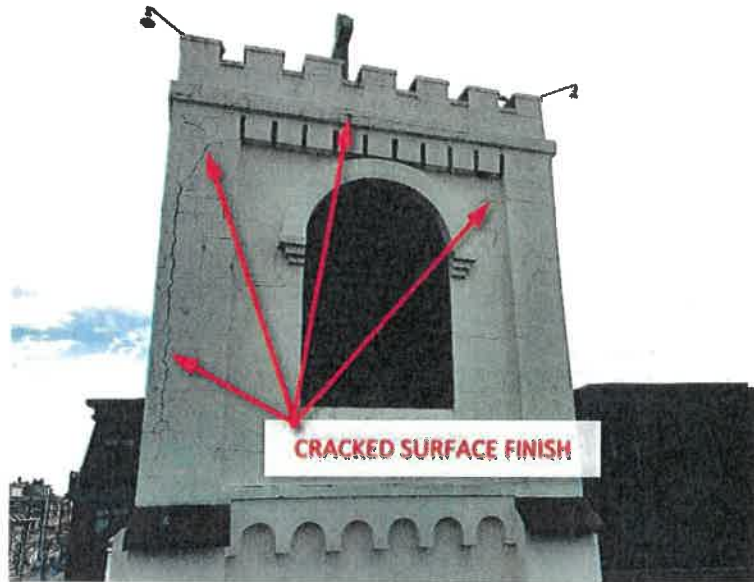
Photo 2 - Bell Tower Right Side Third Story

The 3-story Bell Tower structure over the front entry for the church is constructed of 2-3 wythe thick brick masonry walls and is covered on the outer surface with a cementitious stucco material, adhered directly to the surface of the brick. The third story portion of the bell tower exhibited multiple significant cracks in the finish material, shown in Photo 2. A contractor was provided to make invasive inspection openings in the wall at damaged areas, which were accessed via high-reach.

The Bell Tower brick masonry walls are deteriorating, with loss of mortar from the brick joints, and will require restoration of the interior surfaces for the full height of the tower, and of the exterior surface finish for the third story, to prevent more significant damage. The minor cracks at the lower levels of the tower, entrances and worship space should be patched or sealed.

Restoration to the Bell Tower walls should include stripping all damaged and loose finish material from exterior and interior surfaces, re-pointing all exposed brick mortar joints, and applying a new surface parge-coat finish to all surfaces. The rotting wood material on the inner wythe of the brick wall should be removed and replaced with new brick masonry. All exterior surface cracks should be ground down and patched with a compatible material to match the existing finish.

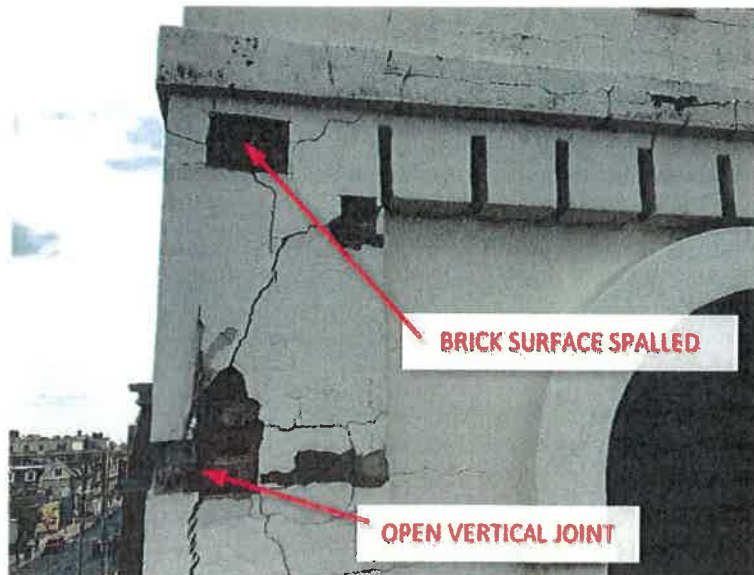
Photo 3 - Invasive Inspection Areas

At some areas, the surface of the brick masonry spalled off the wall with the damaged stucco finish. There is an open vertical joint at the corner where the outer wythe of brick on the side wall meets the front wall, shown in Photo 3.

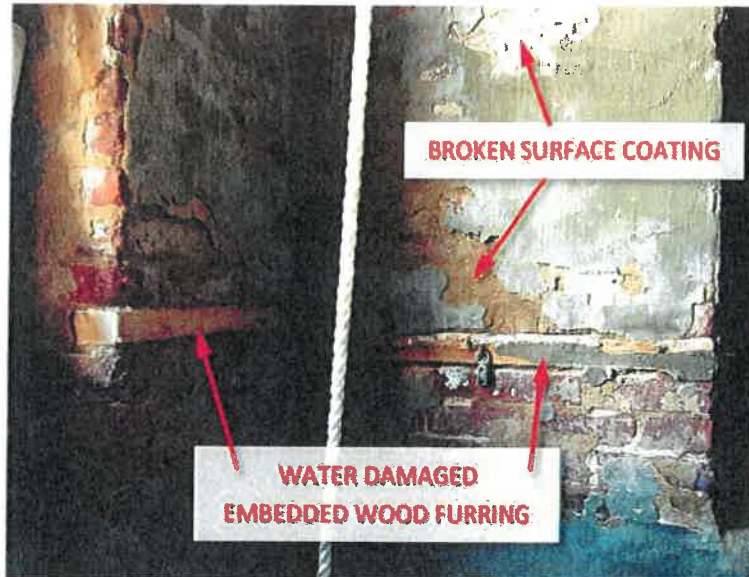
The interior of the Bell Tower was accessed via internal ladders. Horizontal wood boards are embedded in the inner wythe of brick masonry at regular intervals, most of which are significantly water damaged, shown in Photo 4.

Photo 4 - Water Damaged Wood Boards Embedded in Brick Wall

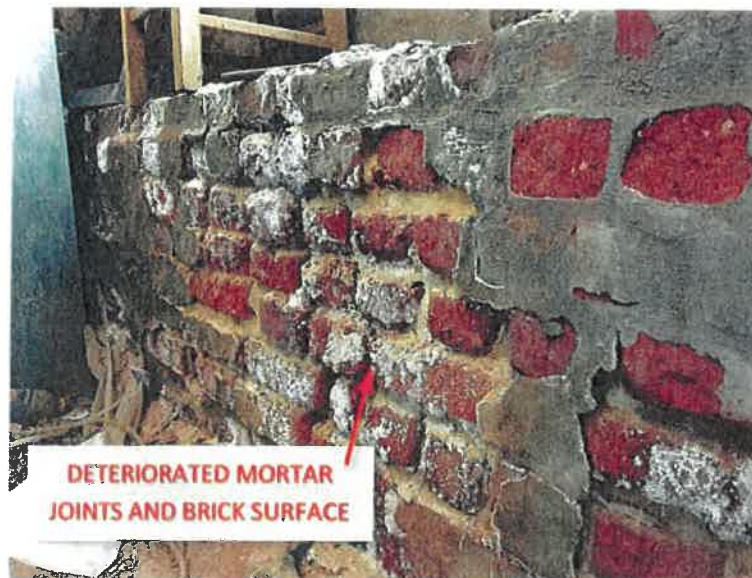
A thin cementitious parge coating is cracked, broken and de-bonded throughout the interior wall surfaces. The mortar in the brick masonry joints is dried out and falling away from the wall at many locations, as shown in Photo 5.

Photo 5 - Deteriorated Mortar at Brick Masonry Inner Surface

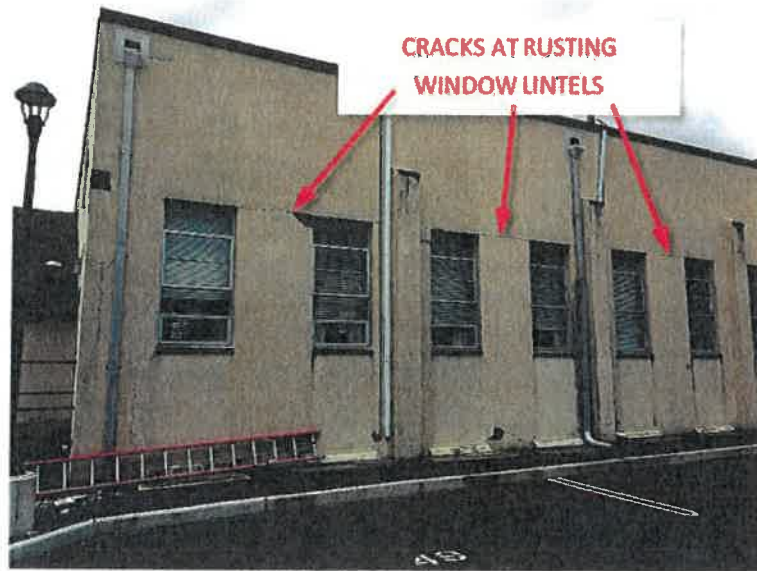
Photo 6 - Parish Hall Wall at Left Side, Facing North-West

The side walls of the Parish Hall structure are constructed of 8" thick unit masonry, with an inner wood furring and drywall finish. There are several windows and doors with steel lintels across the openings. The steel lintels are rusting, causing cracks in the wall at the top corners of the openings, shown in Photo 6.

The walls of the 2-story Parish Hall have significant damage to the cementitious surface finish and the underlying masonry wall structure. Large areas of the walls exhibited de-bonded finish and cracks. The steel window lintels are rusting, both at the upper floor and at the basement levels, causing cracks in the mortar joints and wall finish at the window corners. These walls will require restoration to the structure and exterior surface finish throughout the building.

The walls of the 2-story Parish Hall should be stripped of all damaged, de-bonded and loose finish material throughout. Any damaged masonry within the wall structure will need to be removed and replaced. All significantly rusting steel lintels over windows and doors should be removed and replaced with new hot-dipped galvanized steel lintels. Minor surface rusting can be cleaned and coated with a rust-inhibitive paint system.

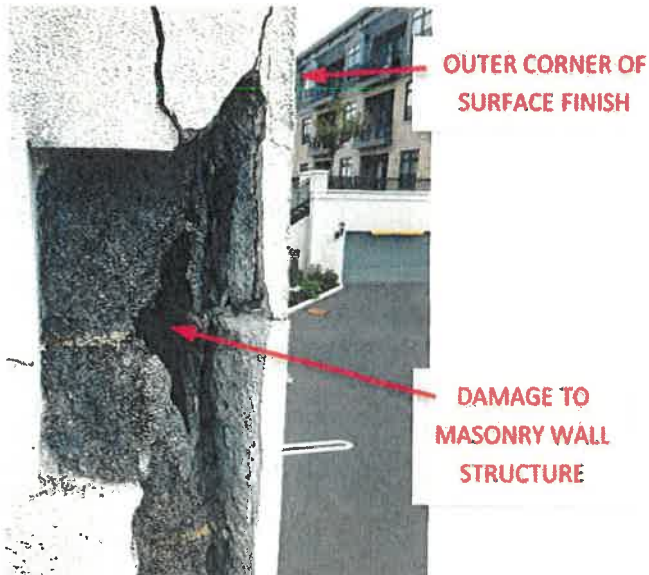
A section of damaged stucco finish material had already broken away from the corner of the wall. The contractor removed some additional finish material that was loose, which revealed deterioration of the 8" masonry block wall structure, shown in Photo 7. The face shell of the masonry broke off with the stucco finish.

Photo 7 - Invasive Inspection of Masonry Wall Structure at Corner

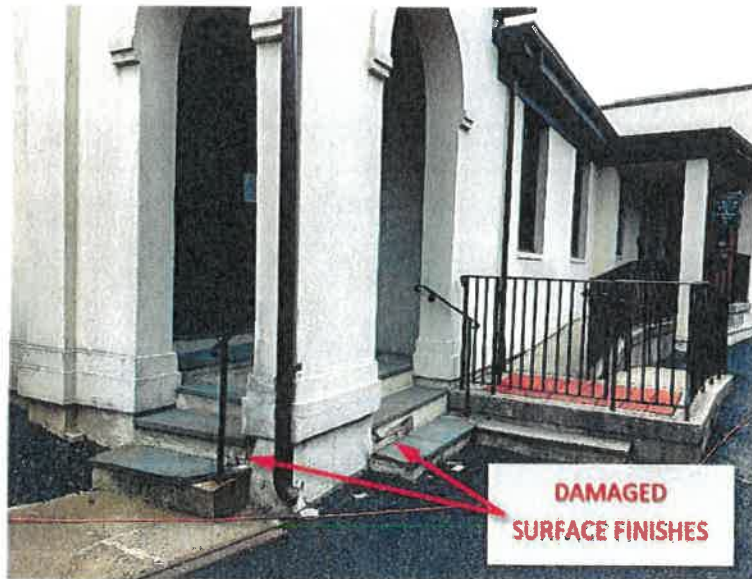
The walls of the worship space had some minor cracking of the exterior surface finish, but no significant damage or de-bonded areas were apparent. At the right side entrance to the worship space, there was some damaged finish material around a column base, and some cracking of the surface finish, shown in Photo 8.

Photo 8 - Damaged Finishes Near Column Base
