# Irving Place Historic District Designation Report

**Prepared by:** Red Bank Historic Preservation Commission

### Historic Architectural Survey, Proposed Irving Place Historic District

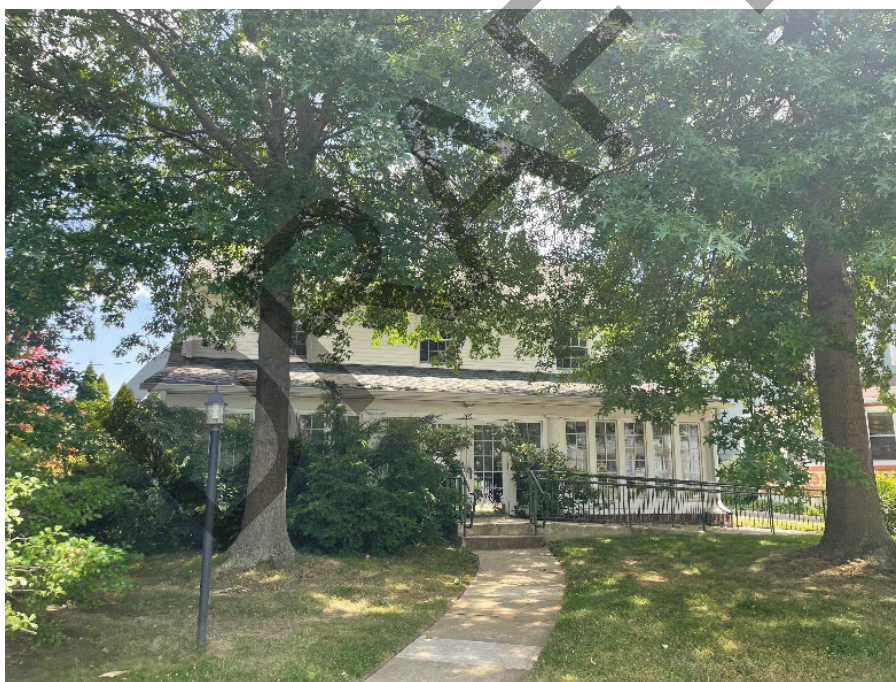
| Street Address: | 205 Maple Avenue | Zip Code: | 07701 |

| Architectural Style: | Dutch Colonial | Physical Condition: | Good |

Single-family dwelling with cross-gable roof with vinyl siding. The roof is asphalt shingles. There is an extended, enclosed, full-width porch with columns. The porch extends to the side of the building. Windows throughout the houses are double hung 8/8 in the front and 6/6 and 4/4 on the sides and rear.

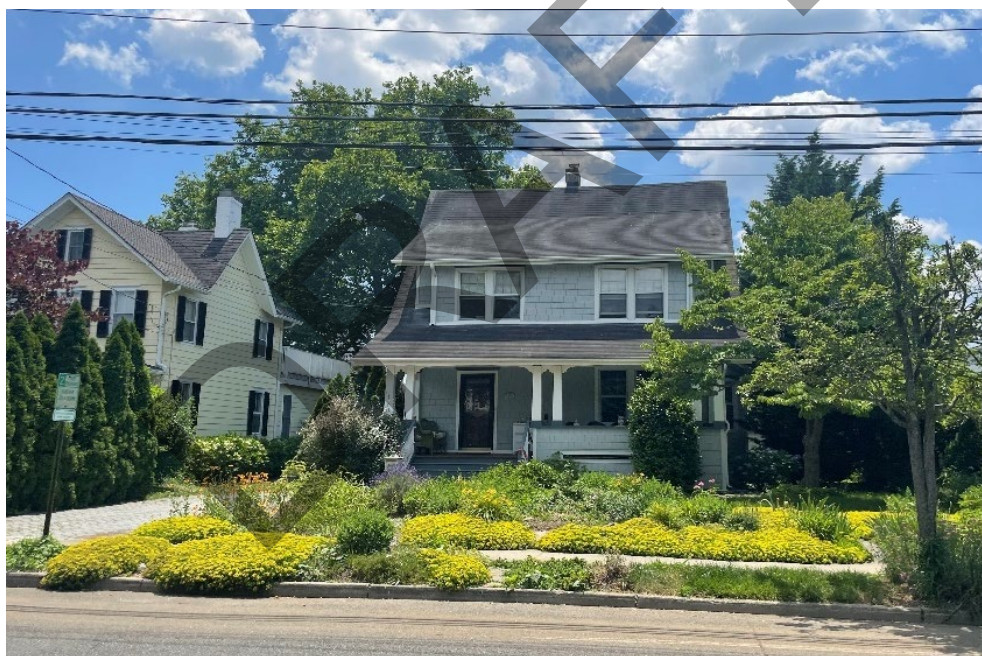
| Street Address: | 55 Irving Place | Zip Code: | 07701 |

| Architectural Style: | Dutch Colonial | Physical Condition: | Good |

Single-family dwelling with a gable roof. Stagger wood shingle shake siding. The roof is asphalt shingles—a full-extended open porch with solid railing and slender bracket posts. Center chimney. Windows throughout the houses are double-hung 6/1 in the front.

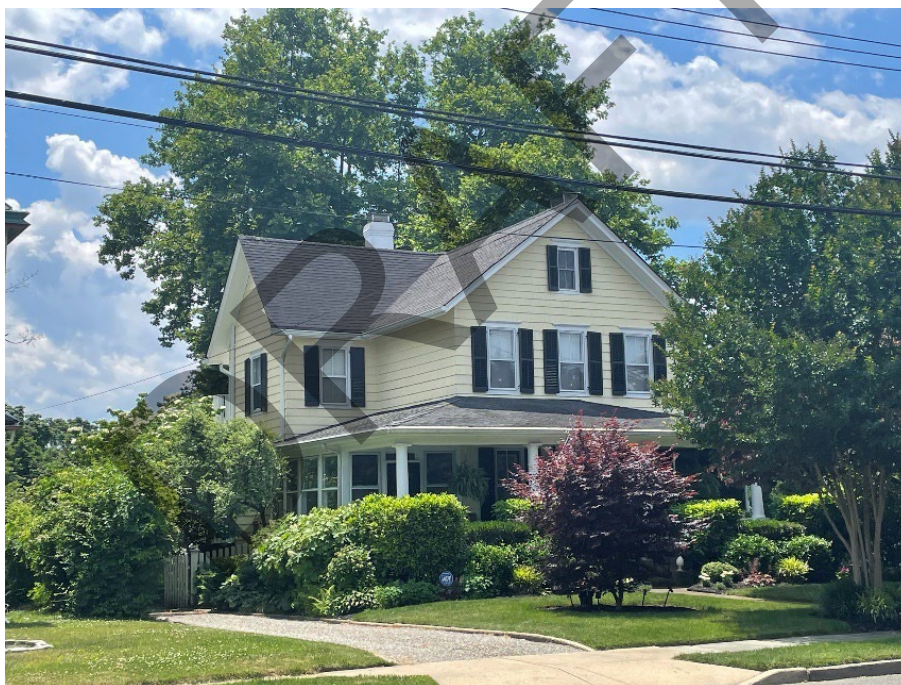
| Architectural Style: | Colonial | Physical Condition: | Good |

Single-family dwelling with a cross-gabled roof. The roof material is asphalt shingles. Wood panel siding. Full extended open porch with columns and solid railing. The porch extends to the side of the building. Windows throughout the houses are double hung 2/2. Wood shutters are on the windows.

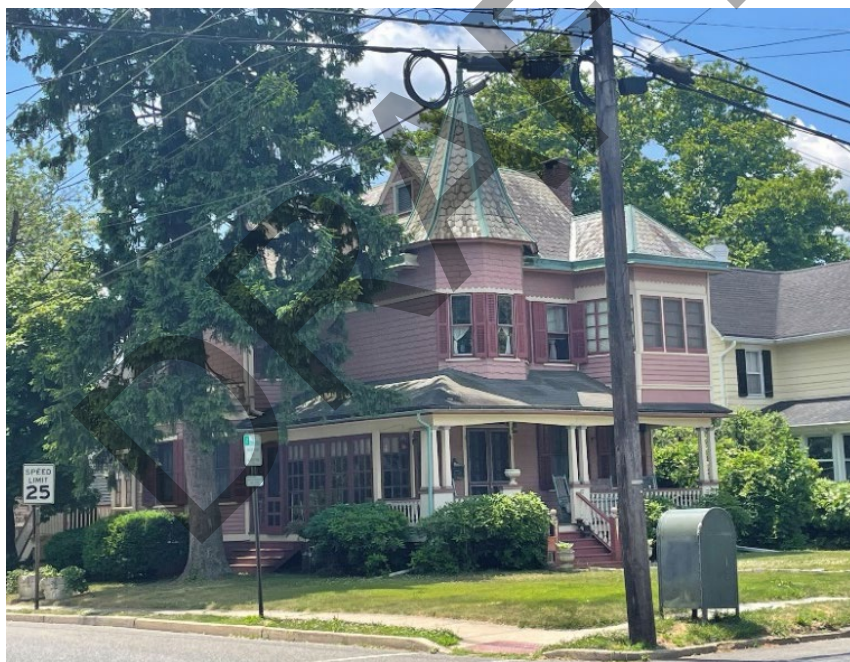
| Architectural Style: | Queen Anne-Shingle | Physical Condition: | Good |

Single-family dwelling with a pitched roof. Mixed pattern-shaped wood shingles and panel siding. Hexagon-shaped asphalt shingles. The second floor has a projecting bay in the front. On the side of the house is a projecting bay with a balcony. Wrap the porch with square columns and slender-turned spindles railing. Variety of window styles. Some windows feature shutters that appear to be operational. A brick chimney is located at the rear of the house. A barn-style two-car garage is at the rear of the property.

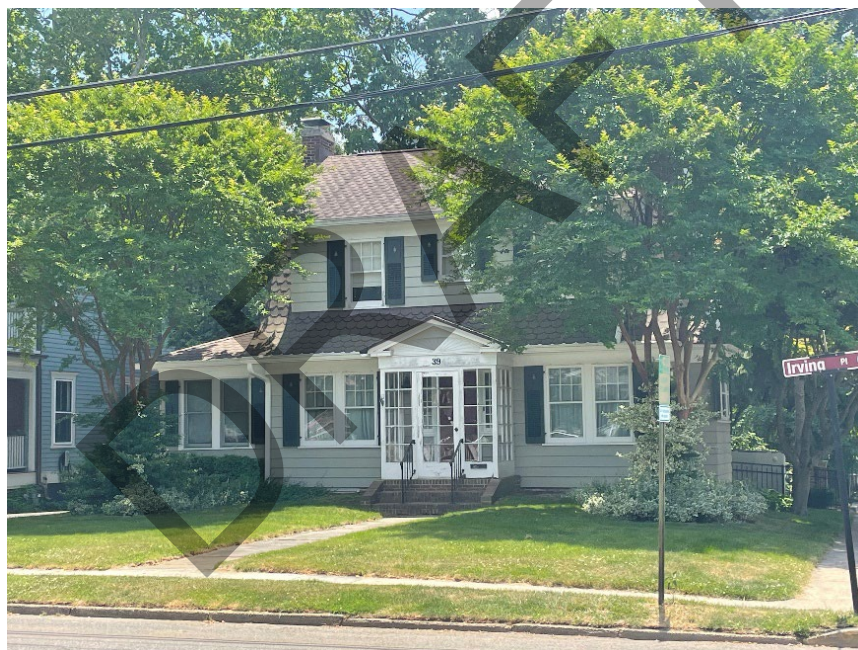
| Architectural Style: | Dutch Colonial | Physical Condition: | Good |

Single-family dwelling with a gambrel roof and hexagon-shaped asphalt shingles. The entrance has an enclosed portico. Windows 6/1 double-hung with wood shutters. There is a small semi-round window on the ½ story side of the house. A brick chimney is located at the side of the house. A barn-style single-car garage is at the rear of the property.

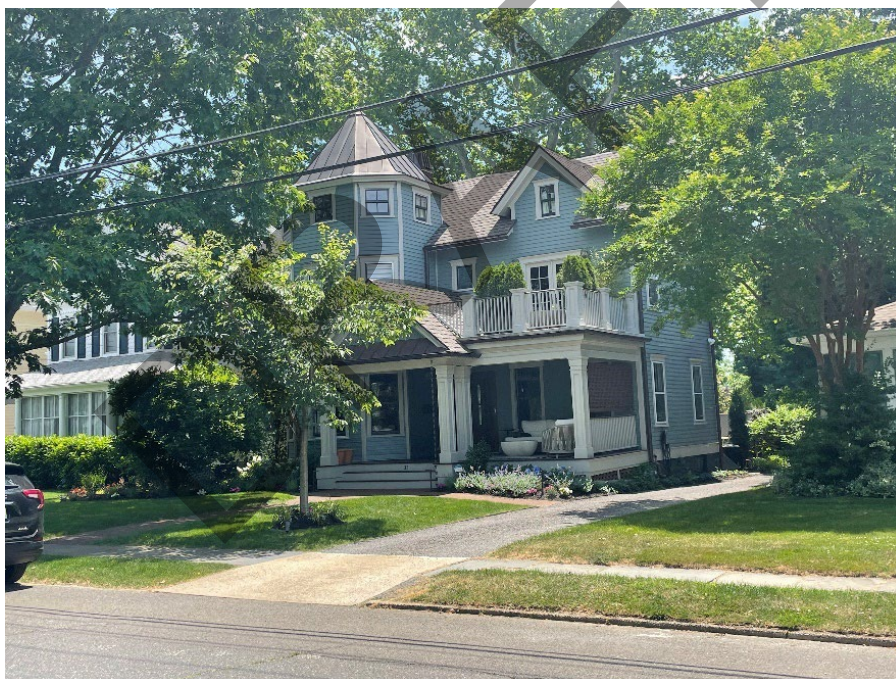
| Architectural Style: | Queen Anne-Shingle | Physical Condition: | Good |

Status: ☐ Contributing ☒ Non-Contributing

Single-family dwelling with a cross-gabled roof. On the side of the house are cascading hip roofs—an extended wrap open porch with round columns and a railing with slender turned spindles. The siding is clad with wood scales on the second, patterned wood on the half stories, and panels on the first floor—double-hung windows: 1/1 on the first and second floors and small 2/1 on the half story. A brick chimney is located at the side of the house.

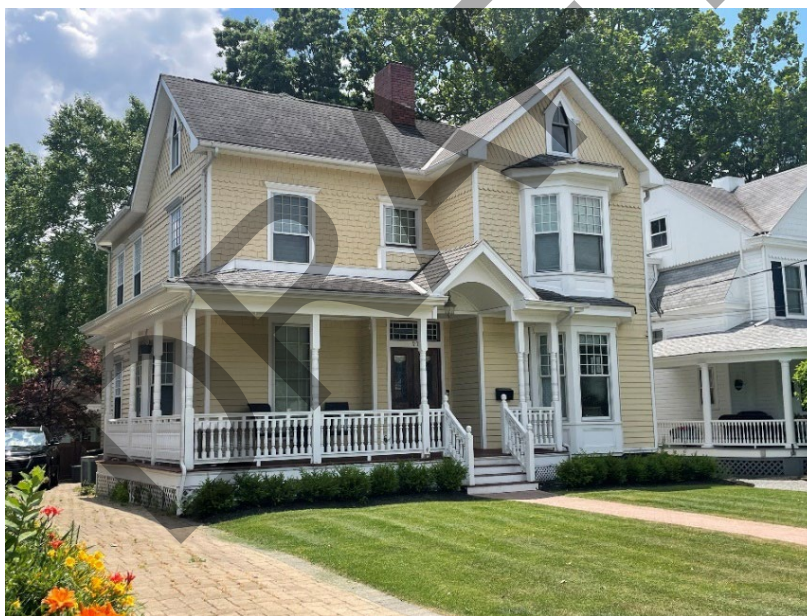
| Architectural Style: | Queen Anne-Shingle | Physical Condition: | Good |

Single-family dwelling with a crossed gable roof with staggered and diamond-shaped wood shakes on the second and half stories and panels on the first floor. Extended warped open porch with decorative bracket posts and matching railing. Projecting bay windows on the first and second floors of the front. Double-hang windows: 12/1 on the first and second floors and a small 2/1 on the half story. Stain glass transom above the front door. A brick chimney is in the center of the house.

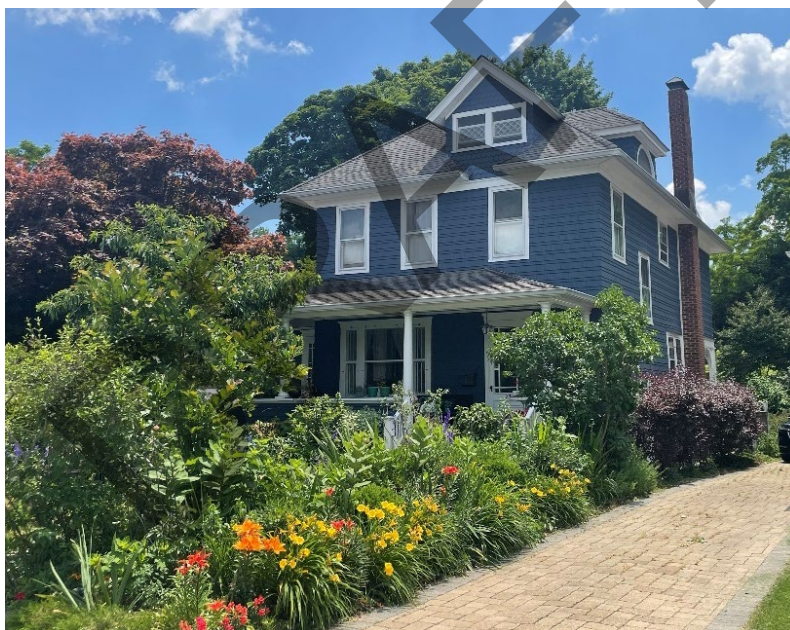
| Architectural Style: | American<br>Foursquare | Physical Condition: | Good |

Single-family dwelling with a hipped roof. Wood panel siding. Open porch with circular columns. Full-extended open porch with a solid railing and round columns. Picture window recessed within the porch—double-hung windows 1/1. A brick chimney is located at the side of the house. Three gable dormers on the front and side of the house.

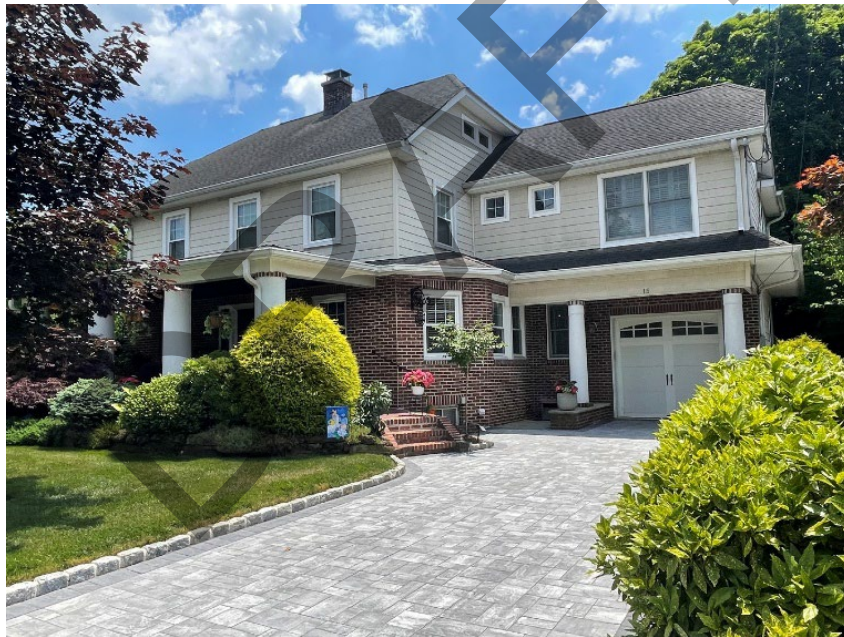
| Architectural Style: | Colonial Revival | Physical Condition: | Good |

| Status: | <input type="checkbox"/> Contributing | <input checked="" type="checkbox"/> Non-Contributing |

Single-family dwelling with a gabled roof. Partial open porch with large round columns. Attached front-facing garage—double-hung windows 6/1. The brick chimney is in the center.

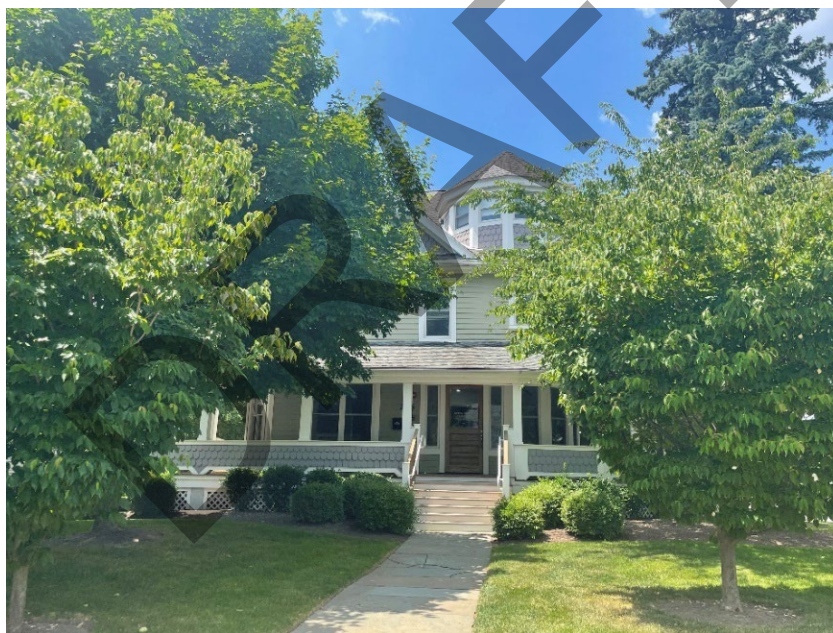
| Architectural Style: | Queen Anne-Shingle | Physical Condition: | Good |

Professional office with cross-gable roof with wood-scaled pediments. Extended open, warped porch with square posts and solid railing with scaled-shaped wood siding. The primary roof has hexagon-shaped asphalt shingles. Double-hung windows 1/1. Crisscross lattice under the porch. Partial round tower above the second floor.

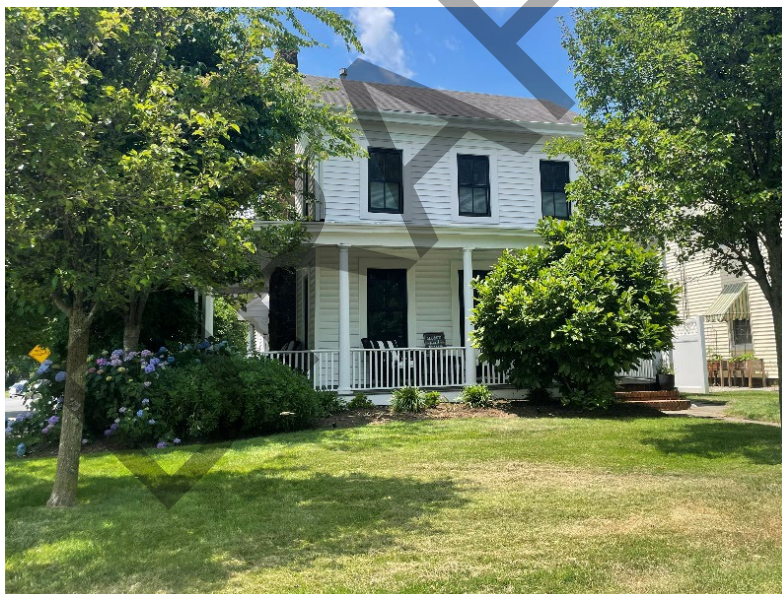
| Architectural Style: | Colonial | Physical Condition: | Good |

| Status: | <input type="checkbox"/> Contributing | <input checked="" type="checkbox"/> Non-Contributing |

Single-family dwelling with gable roof. An open, warped porch with round columns and railings with square balusters. A stone chimney is on the side of the structure—double-hung windows 2/2. A stained-glass window is on the side of the structure.

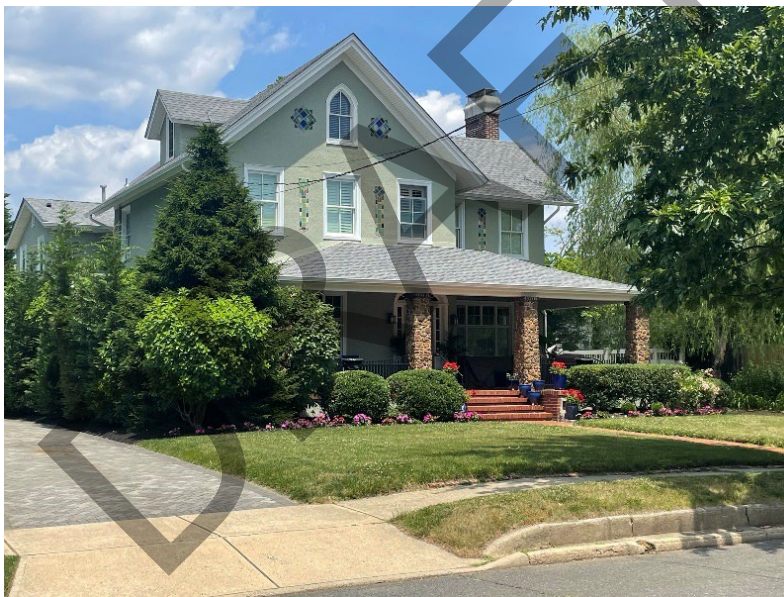
| Architectural Style: | Craftsman | Physical Condition: | Good |

Single-family dwelling with a cross-gable roof. Open extended porch with stone columns. There is a brick chimney on the side of the structure—double-hung windows 2/2. A stained glass window is on the side of the structure. Decorative glass tilework on the front façade. Two picture windows on the first floor. One gabled dormer on the side of the second floor. There is a brick chimney on the side of the structure.

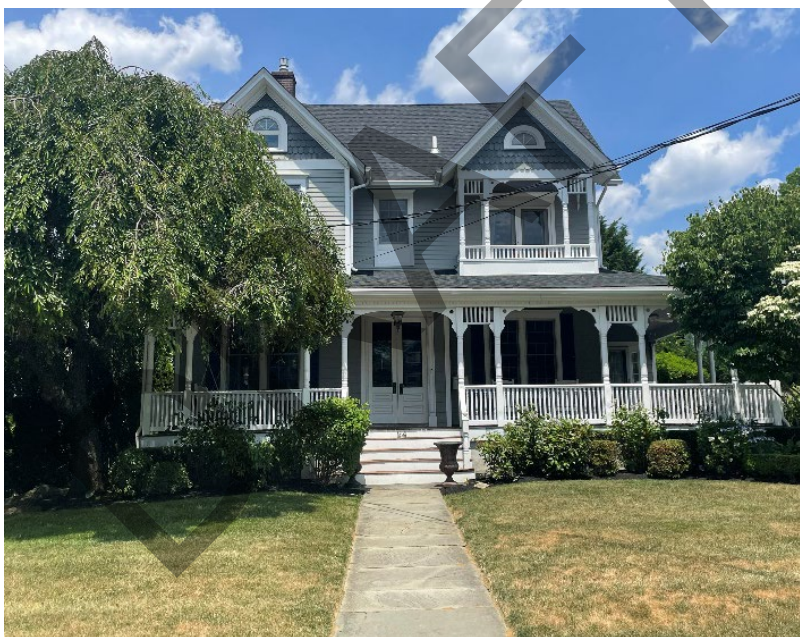
| Architectural Style: | Queen Anne-Stick | Physical Condition: | Good |

Single-family dwelling with gabled roof. There is an extended open wrap porch with decorative brackets and posts. There is a brick chimney on the side of the structure—double-hung windows 2/2. A stained-glass window is on the side of the structure. Crisscross lattice under the porch. Decorative glass tilework on the front façade. Dentils along the cornice of the porch and two balconies.

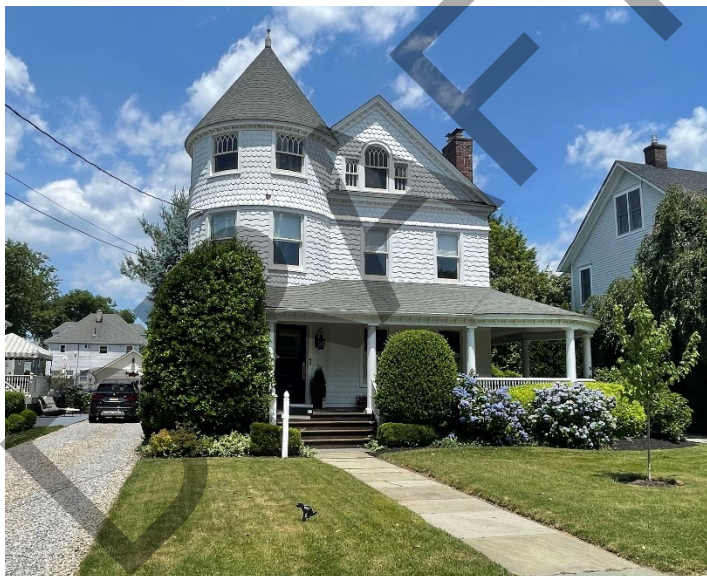
| Architectural Style: | Shingle | Physical Condition: | Good |

Single-family dwelling with a gable roof and circular tower. An open, extended wrap porch with circular columns. There is a brick chimney on the side of the structure. Modillion cornices. Variation of wood shingles around the structure. Double-hang cottage-style windows on the third story. Balcony on the side of the second story.

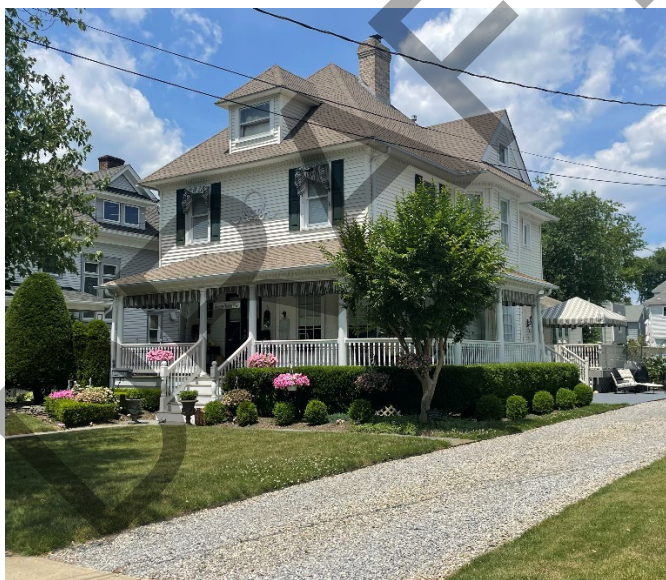
| Architectural Style: | American<br>Foursquare | Physical Condition: | Good |

Single-family dwelling with a hipped roof and three dormers, two gabled and one hipped. An open, extended wrap porch with circular columns and railing with slender turned spindles. There is a brick chimney in the center of the structure. Dentil cornices. Windows 1/1 double-hung with shutters on the second floor. Single-panel multiple-light windows on the first floor. Floral ornament on the second floor.

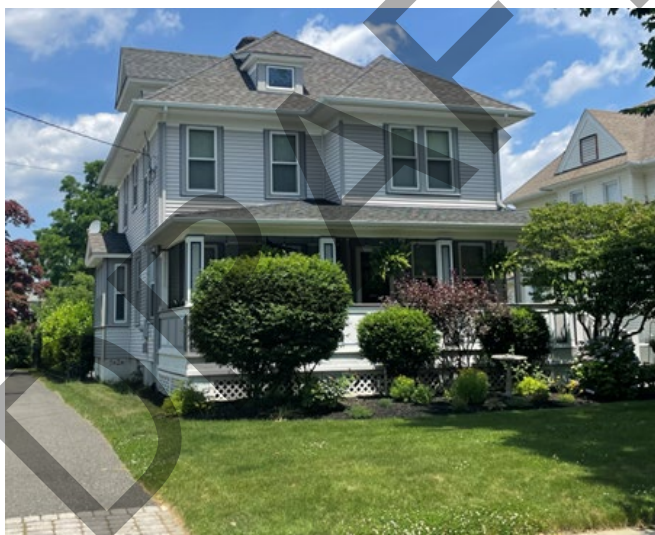
| Architectural Style: | American<br>Foursquare | Physical Condition: | Good |

Status: ☐ Contributing ☒ Non-Contributing

Single-family dwelling with a hipped roof and three dormers, two gabled and one hipped. An open, extended wrap porch with square columns and solid railing. There is a brick chimney in the center of the structure. There is a projecting bay window on the side of the building. Windows 1/1 double-hung. Crisscross lattice under the porch.

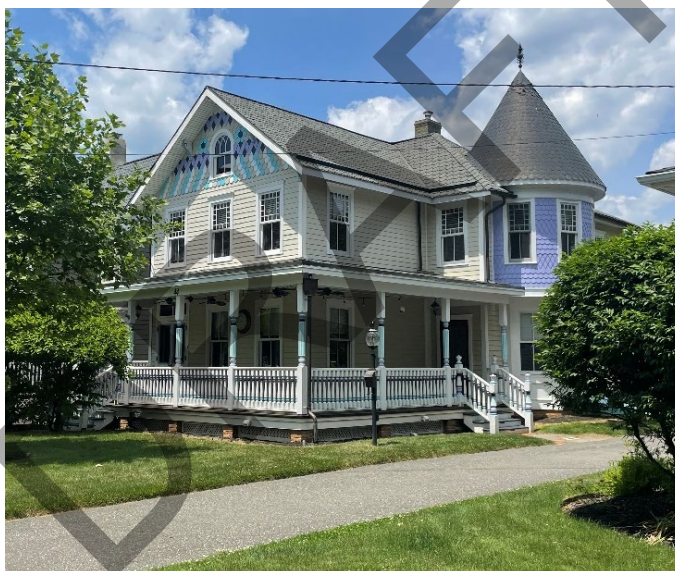
| Architectural Style: | Queen Anne | Physical Condition: | Good |

Single-family dwelling with a cross-gable roof and a tower on the side of the structure. A finial is on top of the building—double-hung windows with large panes of glass bounded by smaller panes. Open, extended wrap porch with decorative posts and railing with slender turned spindles. The front gable has decorative woodwork—a brick chimney in the center of the structure. The principal roof has hexagon-shaped asphalt shingles, and the tower roof has hexagon-shaped slate.

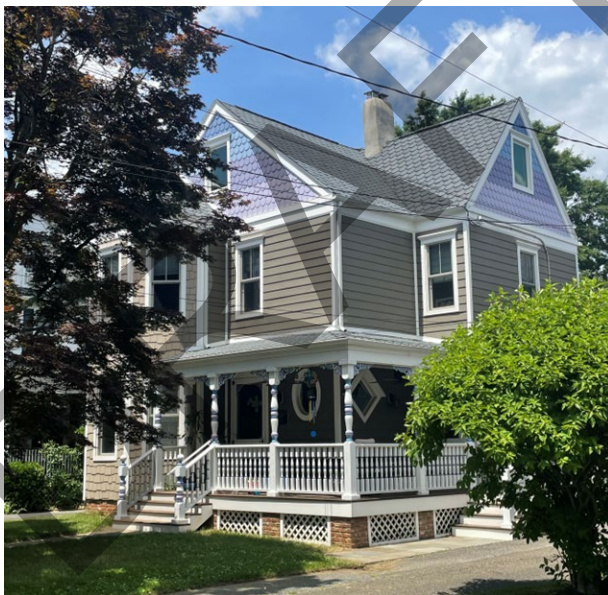
| Architectural Style: | Queen Anne | Physical Condition: | Good |

Single-family dwelling with a cross-gable roof. Double-hung windows 2/1. The front first-floor windows are of different shapes and sizes, including an extended open partial porch with decorative posts and railing with slender turned spindles. Front and side gables have detailed woodwork—a stucco chimney in the center of the structure. The principal roof has hexagon-shaped asphalt shingles.

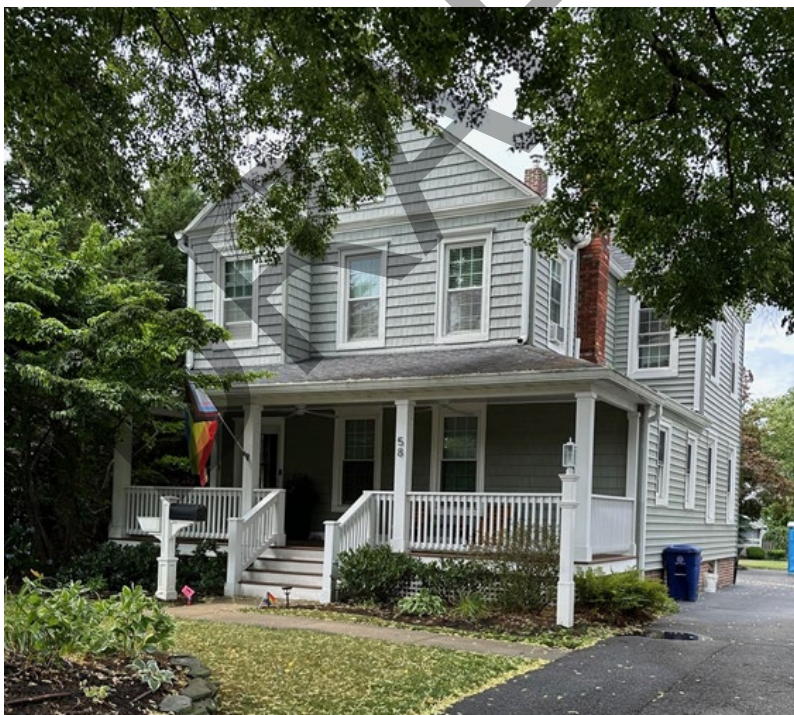
| Architectural Style: | American<br>Foursquare | Physical Condition: | Good |

Single-family dwelling with a cross-gable roof. Double-hung window 6/6. An open extended full porch with rectangular shaped columns and railing with rectangular spindles—a brick chimney on the side of the structure.

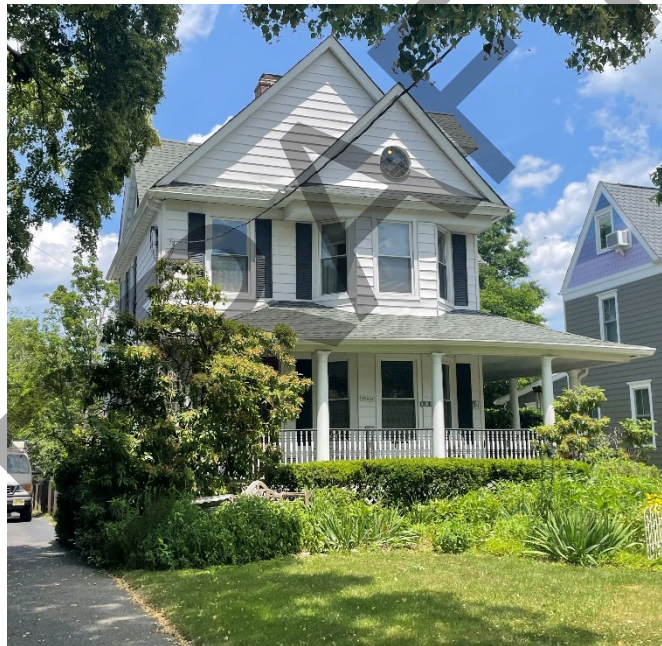
| Architectural Style: | Colonial Revival | Physical Condition: | Good |

Single-family dwelling with a cross-gable roof. Double-hung window 1/1. There is an extended open wrap porch with circular columns and railing with slender turned spindles. There is a brick chimney in the center of the structure. Shutters on the windows. Oval window on the front gable.

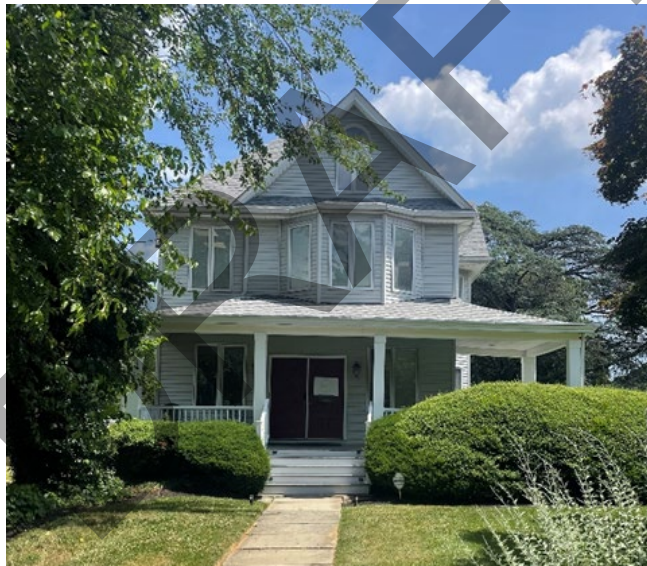
| Architectural Style: | American<br>Foursquare | Physical Condition: | Good |

Status: ☐ Contributing ☒ Non-Contributing

Professional office building with a cross-gable roof. Casement windows. An open, extended wrapped porch with rectangular-shaped columns and railing with rectangular spindles. Two brick chimneys are in the center of the structure.
