RED BANK TRAIN STATION REPORT

JUNE 2018

Red Bank Train Station Report Contents

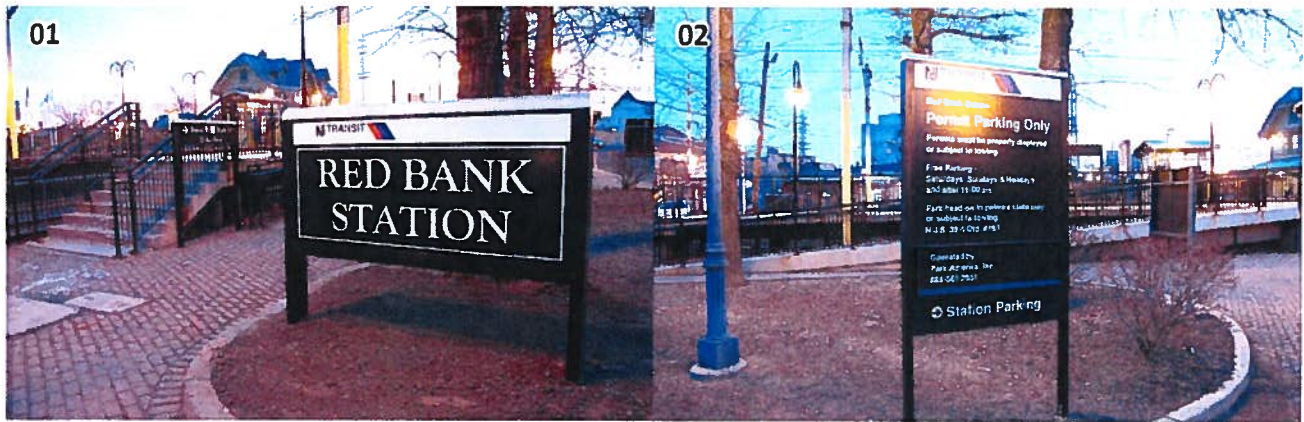
Red Bank Station has good quality signage that clearly identifies the station and how the parking lots are to be used. (RedBank_180201_070506.JPG, RedBank_180201_070443.JPG)

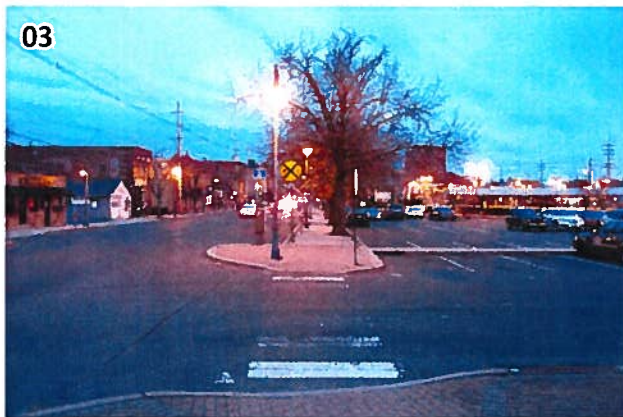
Lighting at the station and on adjacent sidewalks is bright and in good condition. (RedBank_180201_070313.JPG)

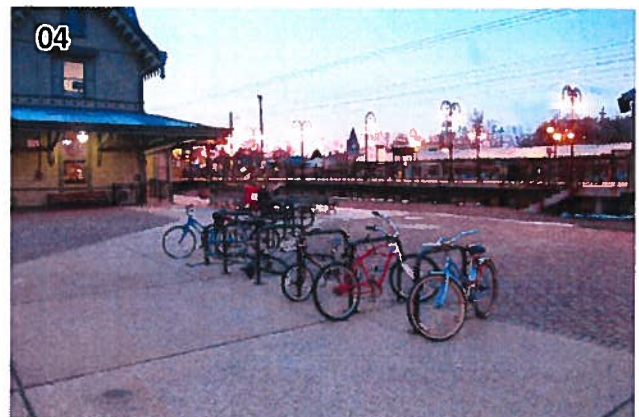
Parking for (20) bicycles is available on the north side of the station building with access to the New York-bound platform. (RedBank_180201_070609.JPG)

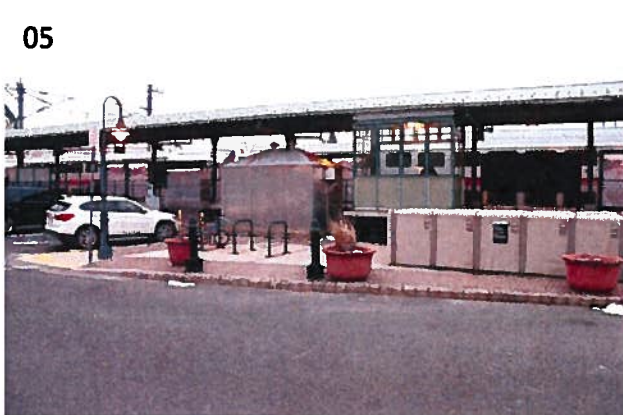
Additional parking for (16) bicycles is provided south of the station building on the NY-bound side (6 rack capacity + 10 bike box capacity) (RedBank_180201_074038.JPG)

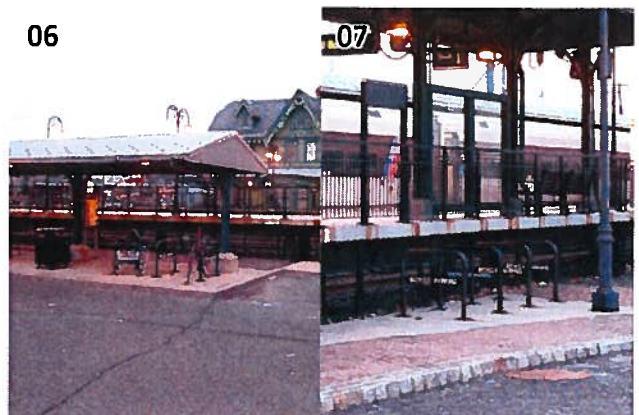
Parking for (22) bicycles is provided in (3) locations with access to the Bay Head-bound platform. (RedBank_180201_072437.JPG, RedBank_180201_072303.JPG)

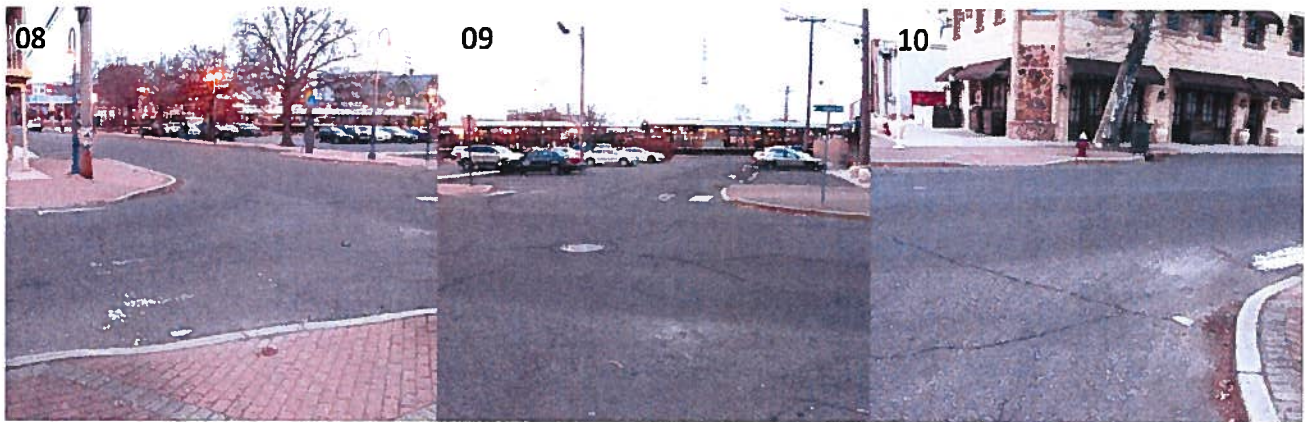
At the intersection of Bridge Ave and Oakland St, all crosswalks need to be re-striped. The northern leg of this intersection, crossing Bridge Ave, did not include a crosswalk and curb ramps. It may be worth adding a crosswalk and curb ramps to this leg, since it is a natural travel pattern to/from the station. (RedBank_180201_071950.JPG, RedBank_180201_072000.JPG, RedBank_180201_072005.JPG)

The intersection of Bridge Ave and Oakland St is a busy pedestrian crossing in need of rejuvenation. Provide ADA-compatible curb ramps at all crossing locations. Re-stripe crosswalks in high visibility thermoplastic. Northern leg of crosswalk is new; proposed to address pedestrian crossing habits that were observed in the field.

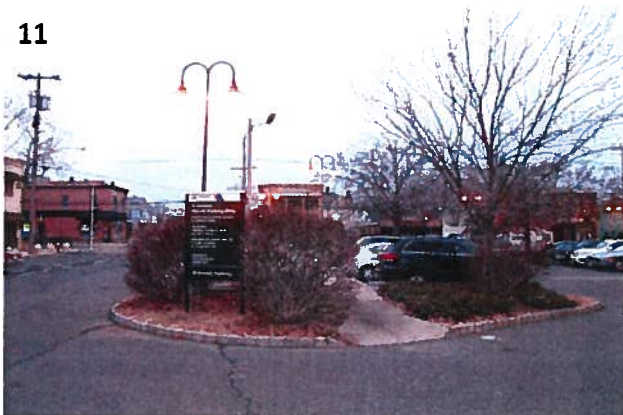
Lot 02 includes landscape islands with shrubbery in need of pruning. It may be possible to retrofit these islands to function as infiltration gardens by providing curb cuts and re-grading. (RedBank_180201_072330.JPG)

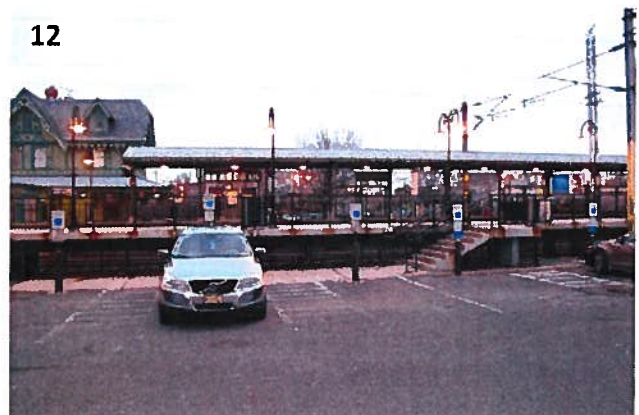
Lot 02 includes (5) ADA parking spaces with an accessible route to a ramp leading to the station platform. The ramp is $\pm 200'$ from the parking. (RedBank_180201_072434.JPG)

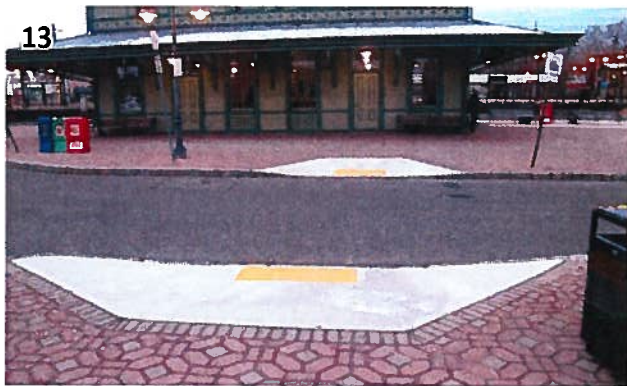
The east side of the station includes Lots 01, 08, and 03 with access roads and drive aisles throughout. Curb ramps were recently upgraded within the vicinity of the station. High visibility crosswalks will help with safety and circulation in these areas. (RedBank_180201_073348.JPG)

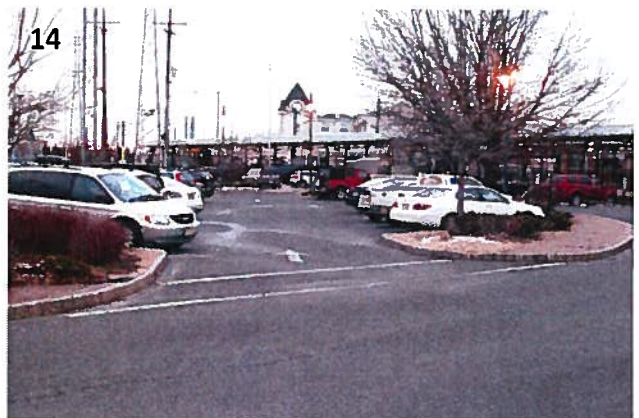
This crossing at a drive aisle in Lot 01 was not upgraded as shown in the previous photo. (RedBank_180201_073553.JPG)

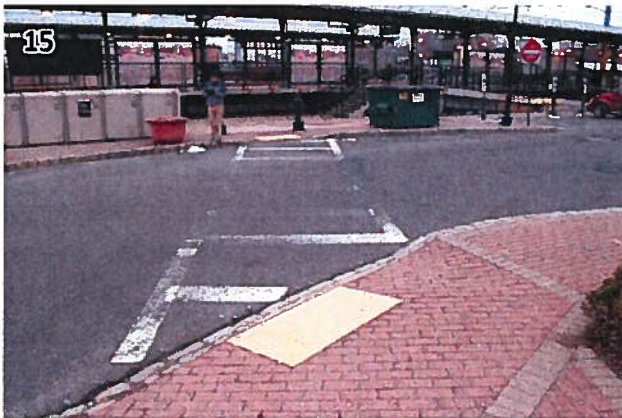
Cars were observed moving quickly through the station area. It may be advisable to post a parking lot speed limit (such as 9 MPH) and increase the visual presence of pedestrian crossings. (RedBank_180201_073921.JPG)

- Employ traffic calming strategies in Lots 01 and 03 to reduce vehicle travel speeds
- Create ADA compliant connection from Parking Lots 04 & 05 and the platform entrances
- Explore green infrastructure measures for stormwater infiltration in all parking lots

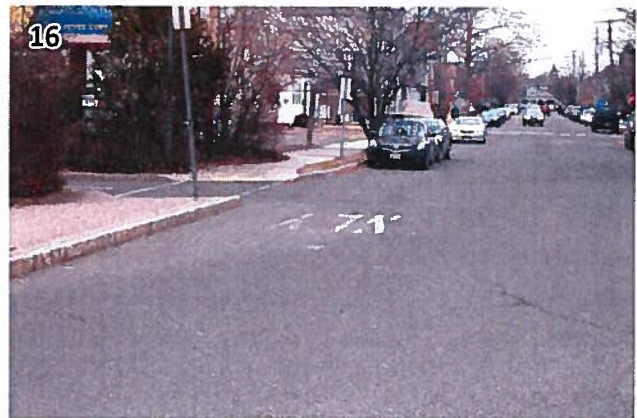
Markings and striping throughout the parking lots are due for replacement. (RedBank_180201_074611.JPG)

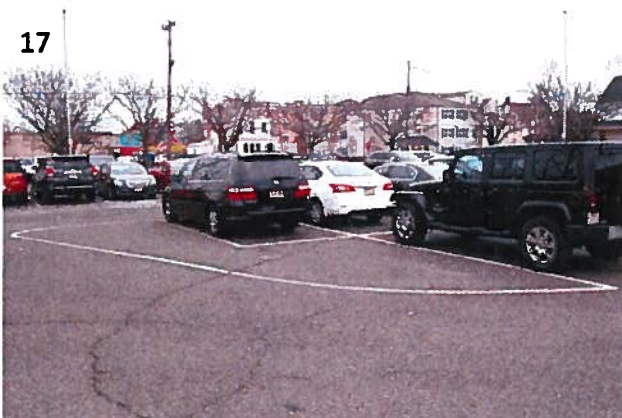
Lot 03 includes striped parking lot islands. These can be retrofitted as infiltration gardens through pavement removal, curbing, soil amendment, and planting. (RedBank_180201_074922.JPG)

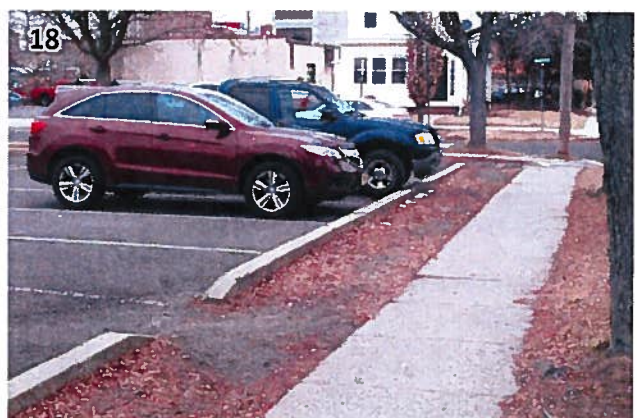
The eastern edge of Lot 03 could be retrofitted with a bioswale between the parking lot and sidewalk to aid in stormwater infiltration. (RedBank_180201_075201.JPG)

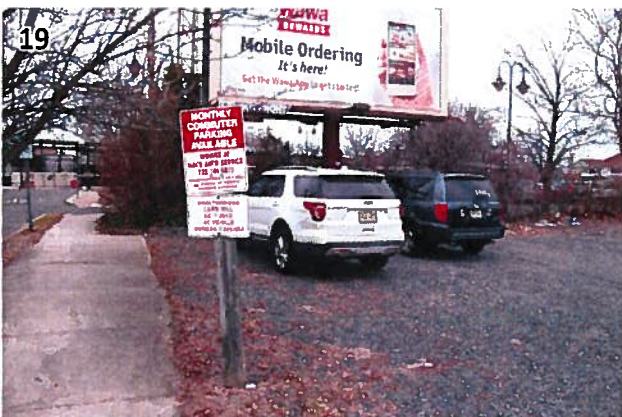
Lot 08 appears on NJ TRANSIT's parking lot inventory for Red Bank station, but signage at the site indicates it is managed by Mayo Auto Service. (RedBank_180201_075517.JPG)

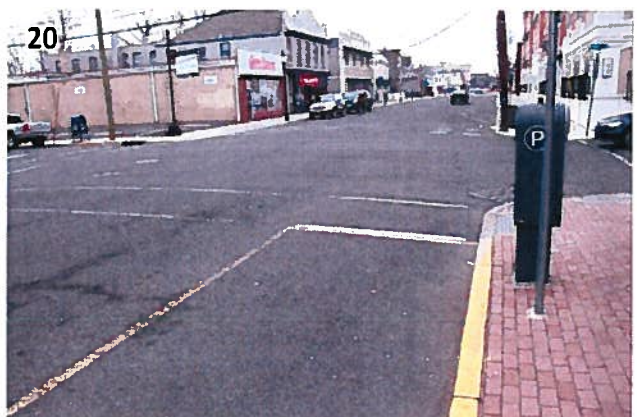
The intersection of West St and Monmouth St could be improved for pedestrian safety with high visibility crosswalks and curb extensions. (RedBank_180201_075840.JPG)

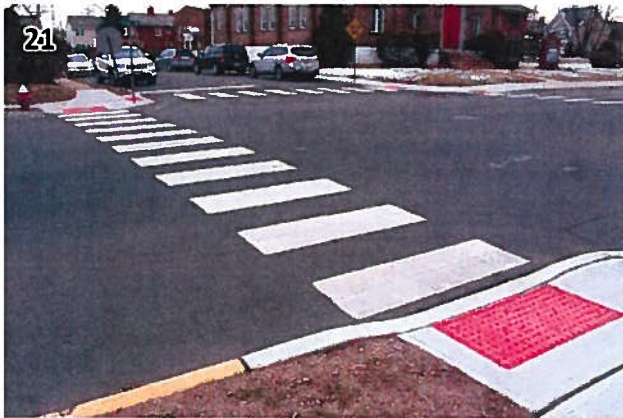
21 The intersection of Bridge Ave and Herbert St is an excellent example of ADA compliant curb ramps and high visibility crosswalks that could be replicated throughout the borough. (RedBank_180201_084125.JPG)

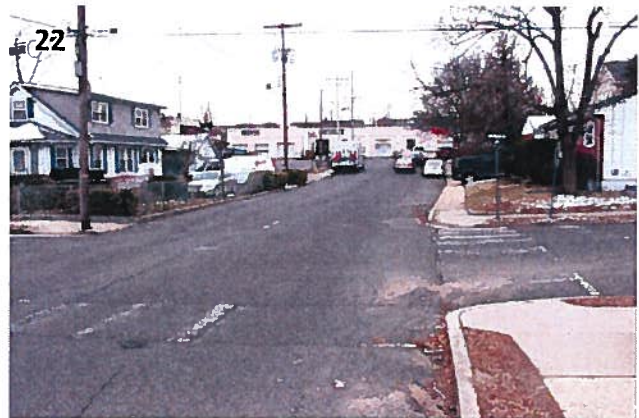
22 The intersection of Drummond Ave and S Bridge Ave is an example of an intersection due for curb ramp replacement and crosswalk re-stripping. (RedBank_180201_084825.JPG)

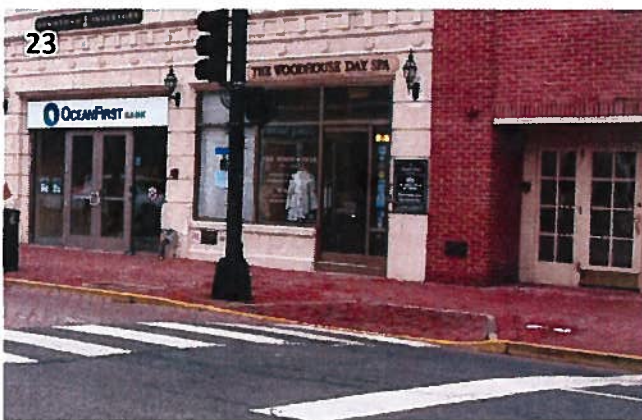
23 The northern half of Broad St is finished with brick paver sidewalks that are generally in good condition. Brick paver curb ramps should be retrofitted with detectable warning surface. (RedBank_180201_093350.JPG, RedBank_180201_093439.JPG)

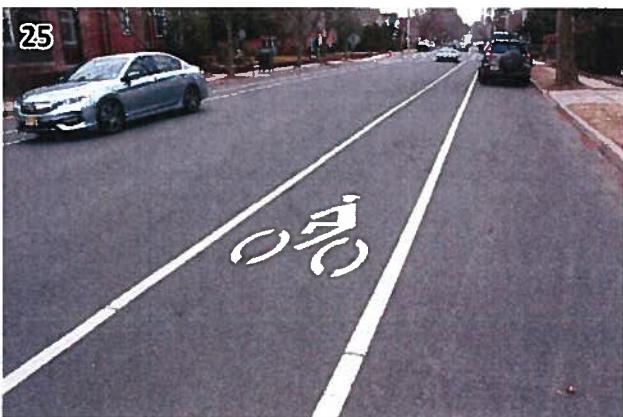
25 Bridge Ave has bike lanes between Chestnut St and Drs James Parker Blvd. It may be advisable to provide centerline striping on this road. (RedBank_180201_095919.JPG)

- Chestnut St: shared lane markings should be placed as frequent as every 100’ to provide greater visibility for the shared lane facility
 - Bridge Ave: bicycle lane lines should be re-striped with 6” bicycle lane lines to resist wear and increase longevity

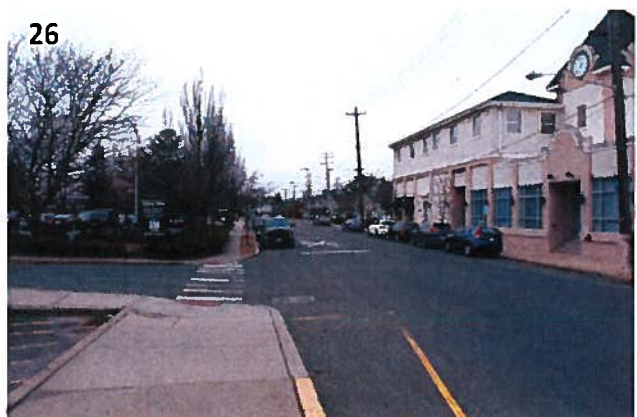
26 Chestnut St lacks a marked crossing for pedestrians between Lots 04 and 05 (to left) and the station (to right). (RedBank_180201_114230.JPG)

Provide a designated crossing for Lot 04 and 05 users across Chestnut St. Include high visibility crosswalks, curb ramps, concrete sidewalks with pedestrian priority driveway aprons, and Rectangular Rapid Flash Beacons.

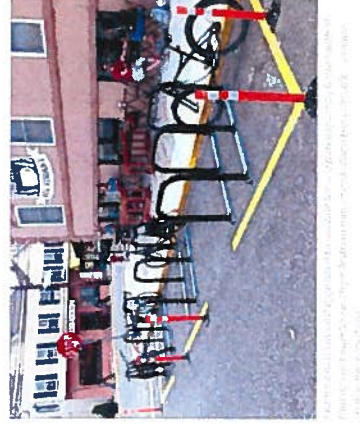
Red Bank Concept #6

SHREWSBURY AVE TYPICAL INTERSECTION TREATMENT

Provide Complete Streets improvements for pedestrians Shrewsbury Ave. Provide curb extensions and high visibility crosswalks at intersection crossings. Consider providing bicycle parking at cross streets.

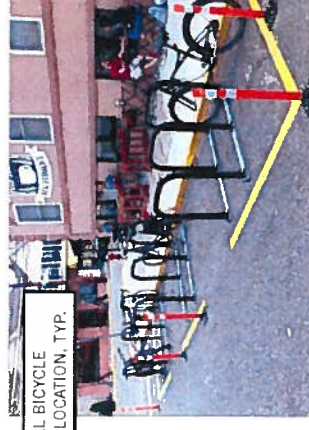
POTENTIAL BICYCLE PARKING LOCATION, TYP.

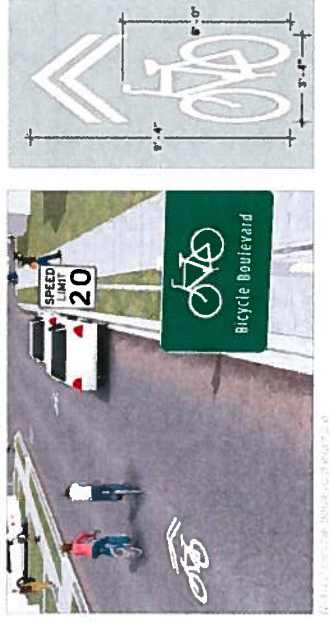
Red Bank Concept #7

BICYCLE BOULEVARDS

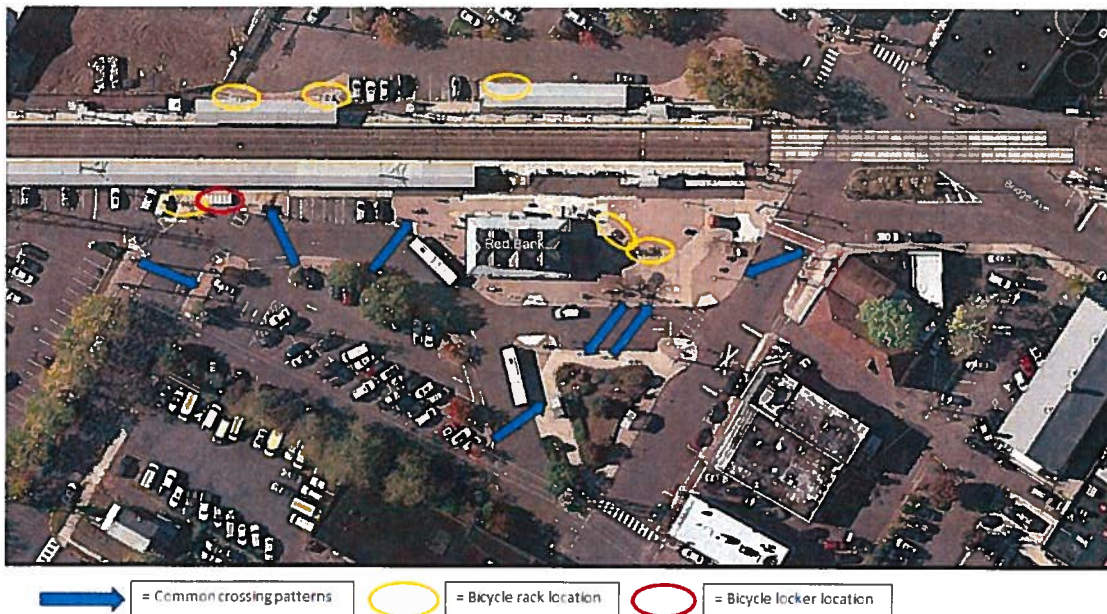
- Five (5) bicycle lockers are present at this train station. The design of the locker requires a lock and key and bicycles cannot be seen inside them. Cannot say for certain whether they were in use or not.
- Bus usage is very frequent at this location. Although safety for the entirety of the station is the goal, pedestrian safety around the bus drop-off/pick-up points should be put at a higher priority. Heaviest pedestrian use of the busses was between 8:45 AM and 9:00 AM.
- Existing crosswalks were used consistently and as intended throughout AM observation.
- Mapped irregular crossing patterns below were the most consistent throughout the morning.
