RED BANK TRAIN STATION REPORT

JUNE 2018

Bicycle and Pedestrian Access Study

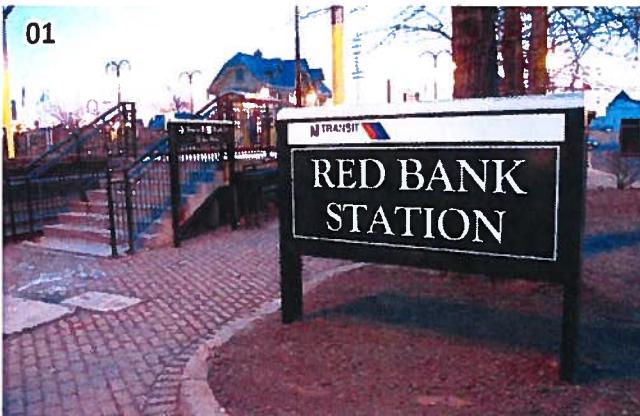
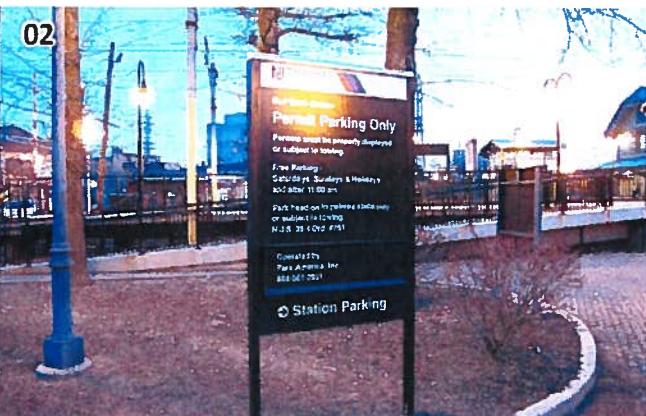
Red Bank Station has good quality signage that clearly identifies the station and how the parking lots are to be used.
(RedBank_180201_070506 JPG, RedBank_180201_070443 JPG)

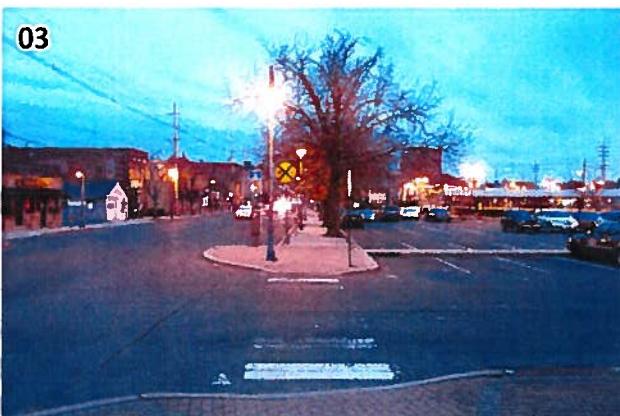
Lighting at the station and on adjacent sidewalks is bright and in good condition. (RedBank_180201_070313.JPG)

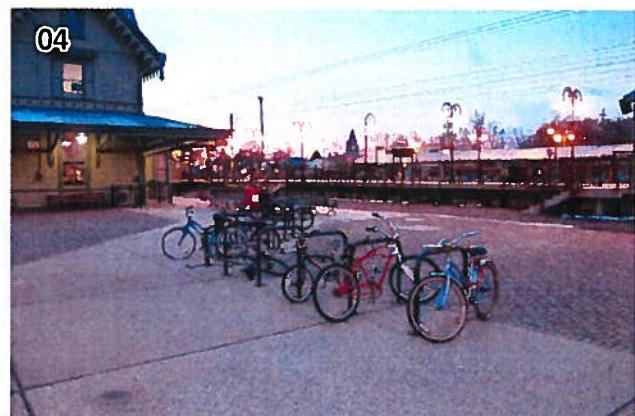
Parking for (20) bicycles is available on the north side of the station building with access to the New York-bound platform.
(RedBank_180201_070609.JPG)

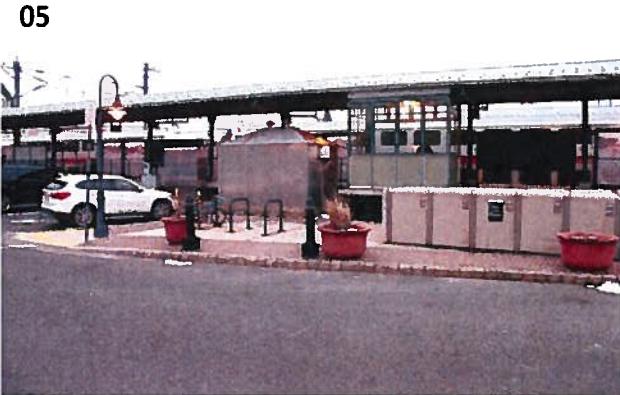
Additional parking for (16) bicycles is provided south of the station building on the NY-bound side (6 rack capacity + 10 bike box capacity) (RedBank_180201_074038.JPG)

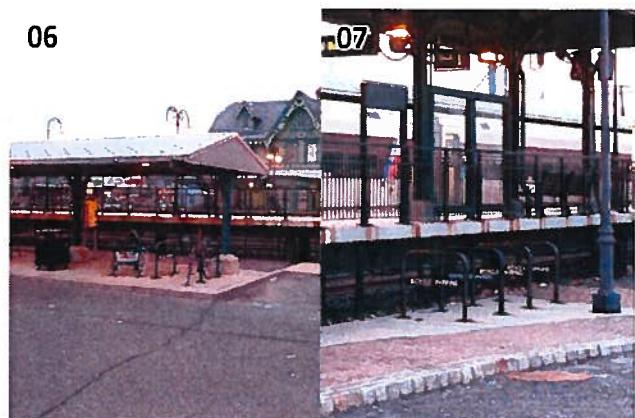
Parking for (22) bicycles is provided in (3) locations with access to the Bay Head-bound platform (RedBank_180201_072437.JPG, RedBank_180201_072303.JPG)

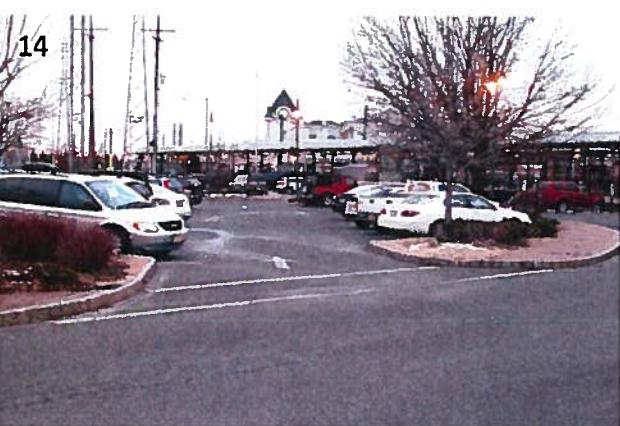
The east side of the station includes Lots 01, 08, and 03 with access roads and drive aisles throughout. Curb ramps were recently upgraded within the vicinity of the station. High visibility crosswalks will help with safety and circulation in these areas. (RedBank_180201_073348.JPG)

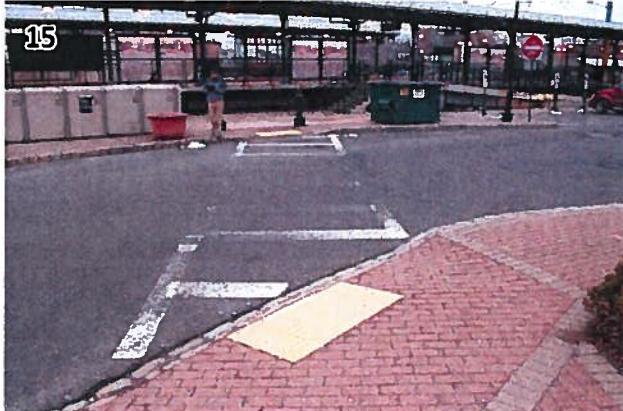
This crossing at a drive aisle in Lot 01 was not upgraded as shown in the previous photo (RedBank_180201_073553.JPG)

Cars were observed moving quickly through the station area. It may be advisable to post a parking lot speed limit (such as 9 MPH) and increase the visual presence of pedestrian crossings. (RedBank_180201_073921.JPG)

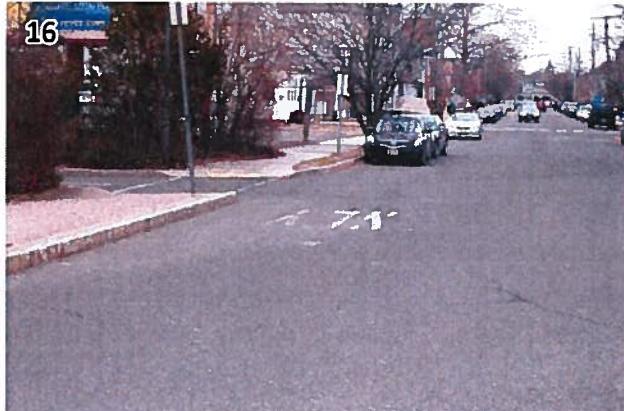
Markings and striping throughout the parking lots are due for replacement. (RedBank_180201_074611.JPG)

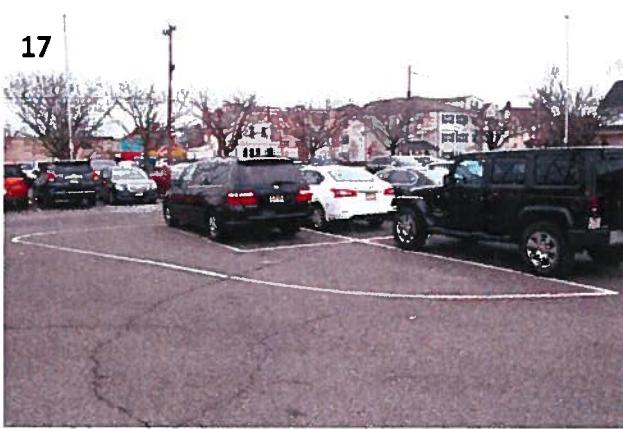
Lot 03 includes striped parking lot islands. These can be retrofitted as infiltration gardens through pavement removal, curbing, soil amendment, and planting. (RedBank_180201_074922.JPG)

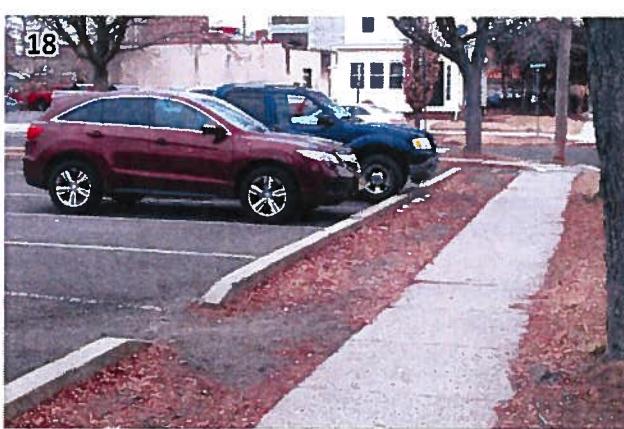
The eastern edge of Lot 03 could be retrofitted with a bioswale between the parking lot and sidewalk to aid in stormwater infiltration. (RedBank_180201_075201.JPG)

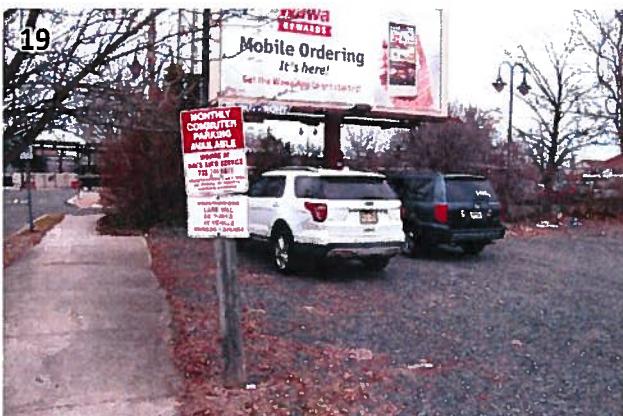
Lot 08 appears on NJ TRANSIT's parking lot inventory for Red Bank station, but signage at the site indicates it is managed by Mayo Auto Service (RedBank_180201_075517.JPG)

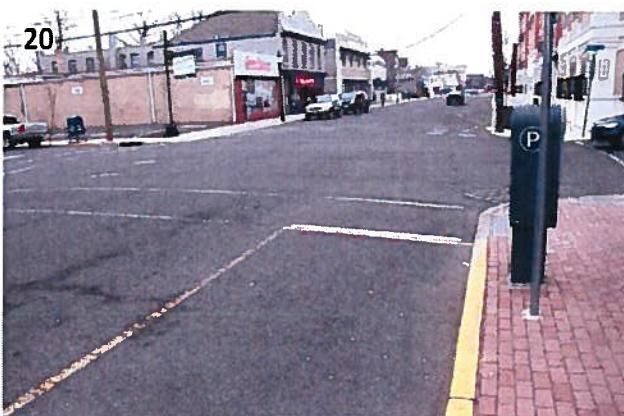
The intersection of West St and Monmouth St could be improved for pedestrian safety with high visibility crosswalks and curb extensions (RedBank_180201_075840.JPG)

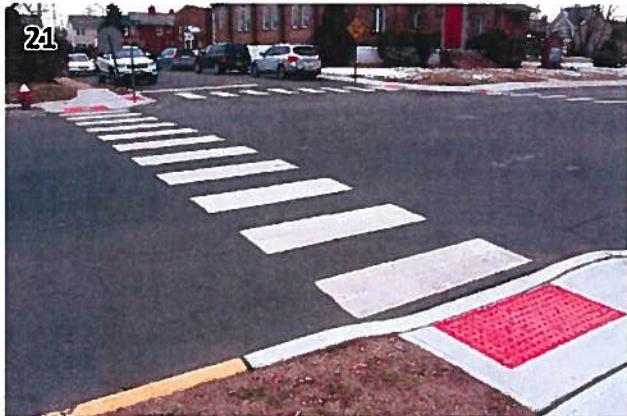
The intersection of Bridge Ave and Herbert St is an excellent example of ADA-compliant curb ramps and high visibility crosswalks that could be replicated throughout the borough. (RedBank_180201_084125.JPG)

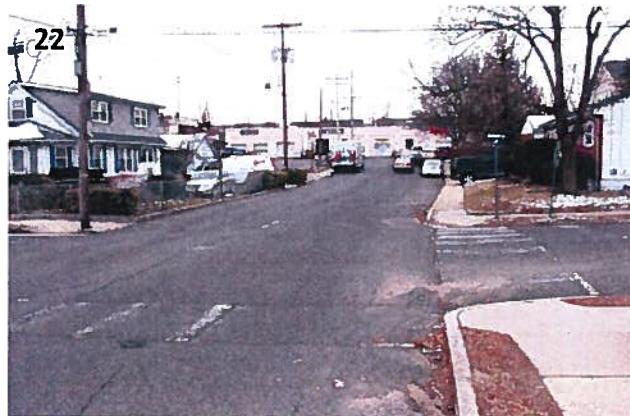
The intersection of Drummond Ave and S Bridge Ave is an example of an intersection due for curb ramp replacement and crosswalk re-striping. (RedBank_180201_084825.JPG)

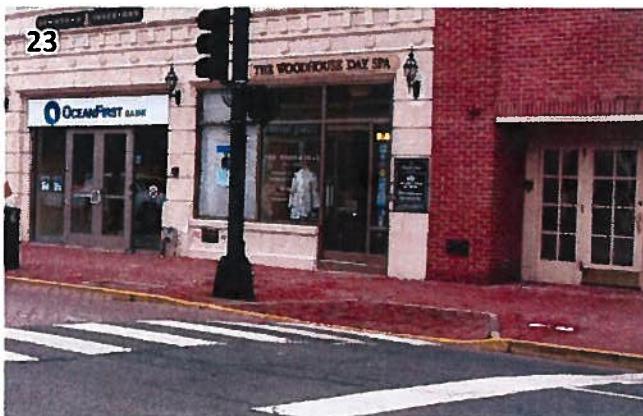
The northern half of Broad St is finished with brick paver sidewalks that are generally in good condition. Brick paver curb ramps should be retrofitted with detectable warning surface. (RedBank_180201_093350.JPG, RedBank_180201_093439.JPG)

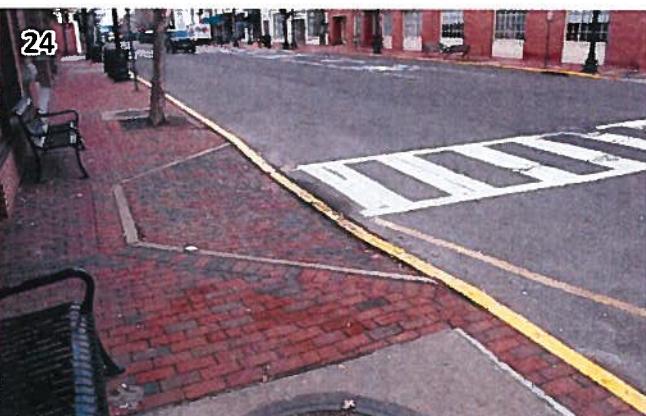
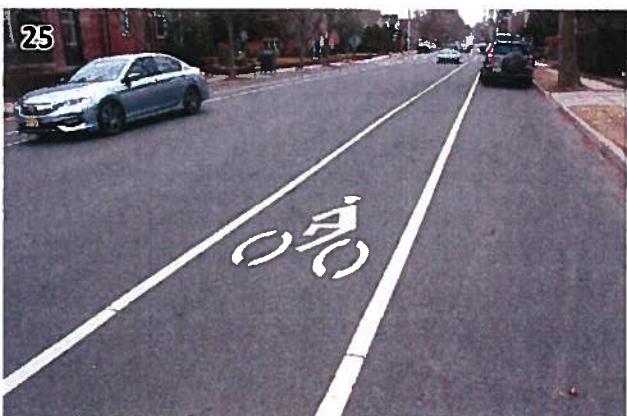
Bridge Ave has bike lanes between Chestnut St and Drs James Parker Blvd. It may be advisable to provide centerline striping on this road. (RedBank_180201_095919.JPG)

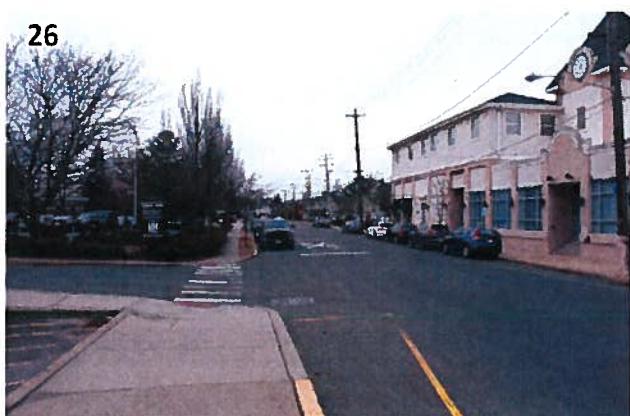
Chestnut St lacks a marked crossing for pedestrians between Lots 04 and 05 (to left) and the station (to right). (RedBank_180201_114230.JPG)
