**Re: Findings and Recommendations
Marion Street Community Garden
Block 15.01, Lot 27.03
37 Marion Street
Borough of Red Bank
Monmouth County, New Jersey**

**Soil Boring Location Plan
 Marion Street Commuinity Garden
 Block 15.01, Lot 27.03
 Borough of Red Bank
 Monmouth County, New Jersey**

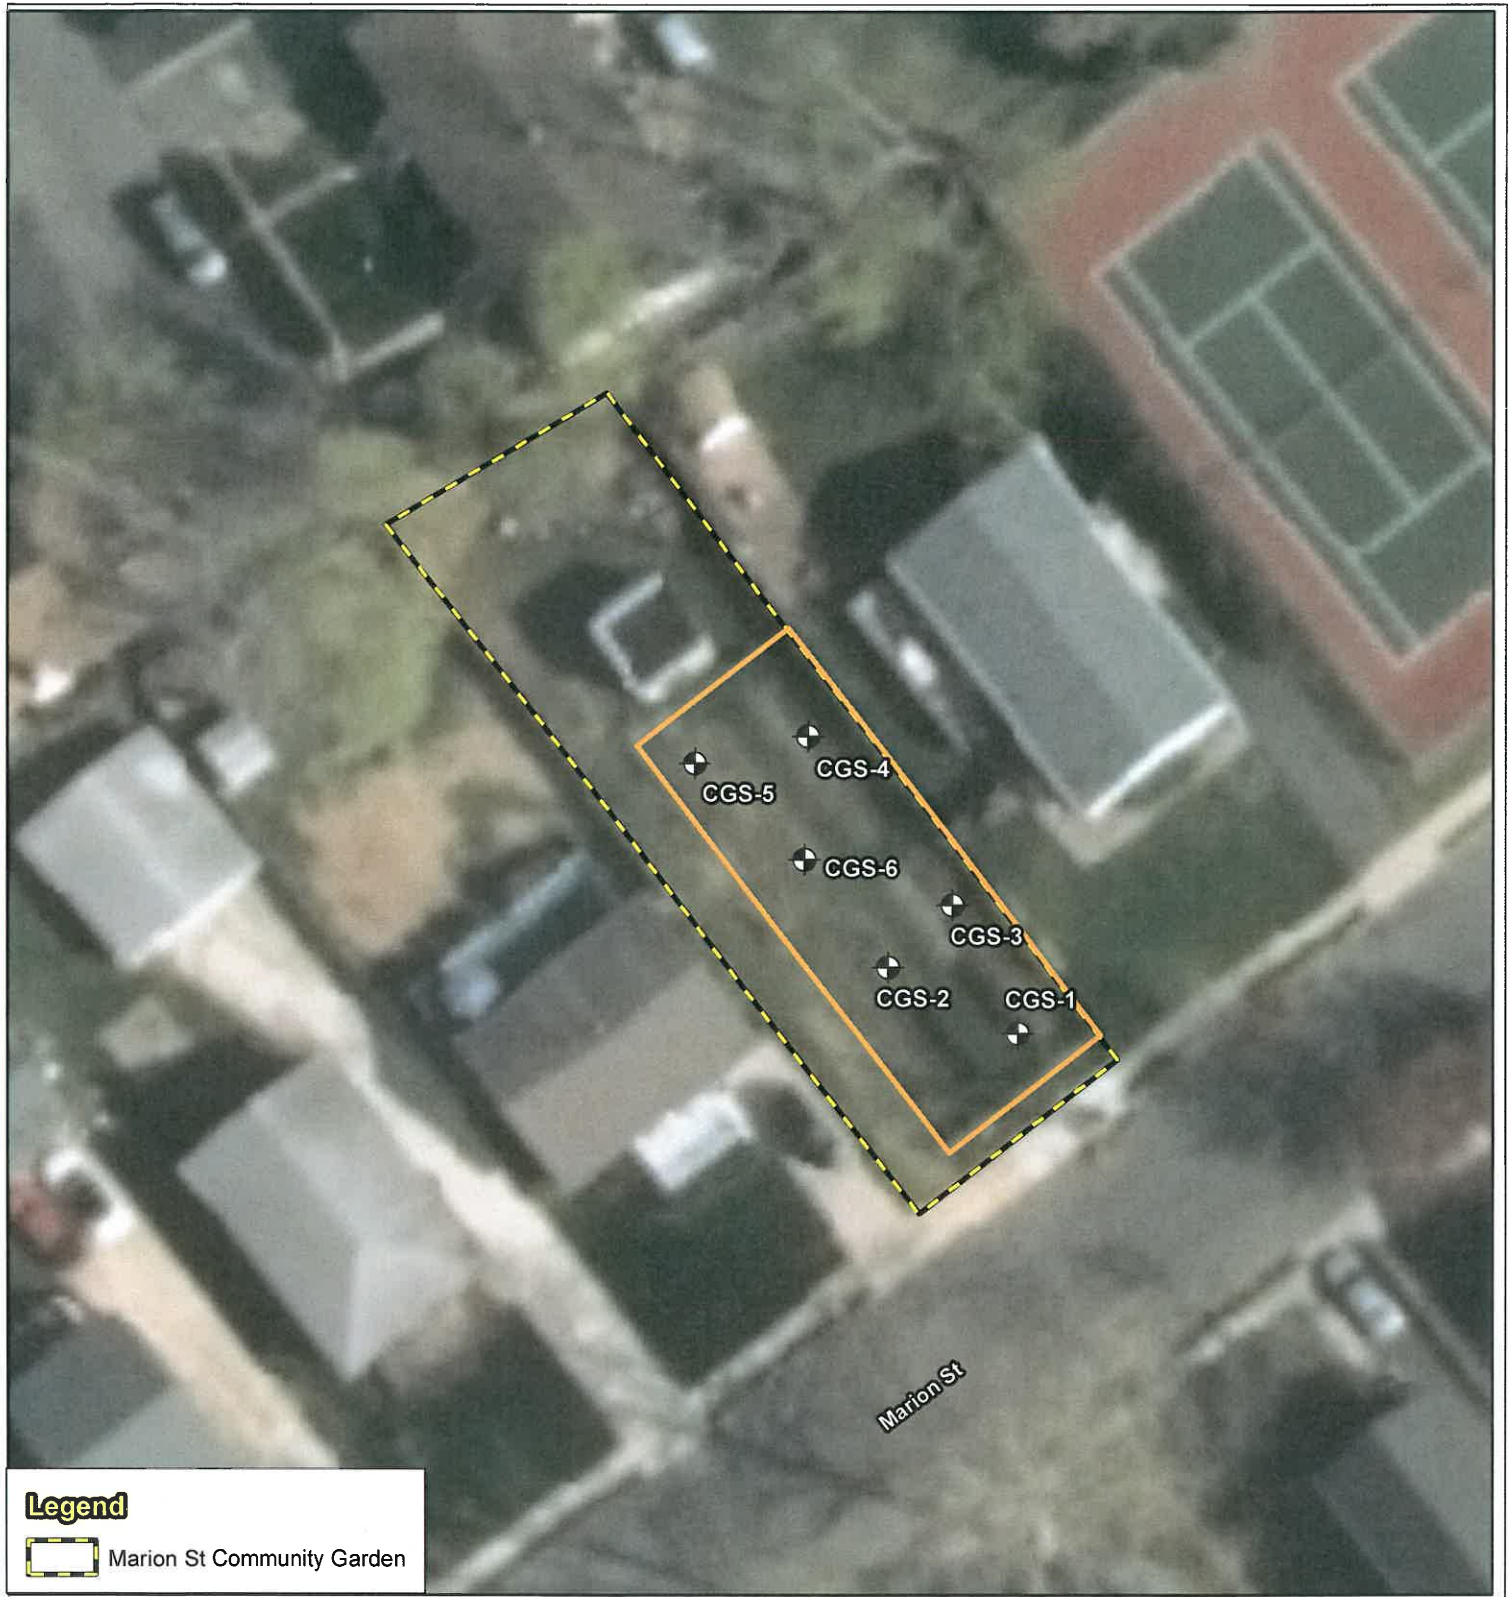
On August 16, 2019, CME advanced six (6) soil borings (CGS-1 through CGS-6) to depths of approximately three (3) feet below ground surface (bgs). Typical historic fill materials (cinders, ash, glass, and brick fragments) were observed in several borings at depths of approximately two (2) feet bgs, particularly in borings CGS-1 and CGS-3. Three (3) discrete soil samples were collected from depths of 0-0.5 ft, 1-1.5 ft, and 2-2.5 ft at each boring location, except at CGS-3 which encountered refusal at approximately two (2) ft bgs. In addition, CME personnel collected samples of the vegetables (e.g., kale, shard, tomatoes) growing within the garden beds to evaluate the potential for uptake of lead. A total of 17 soil samples, six (6) vegetation samples, and one (1) field blank sample were submitted for laboratory analysis for lead.
