Irving Place Historic District

Designation Report

Prepared by: Red Bank Historic Preservation Commission

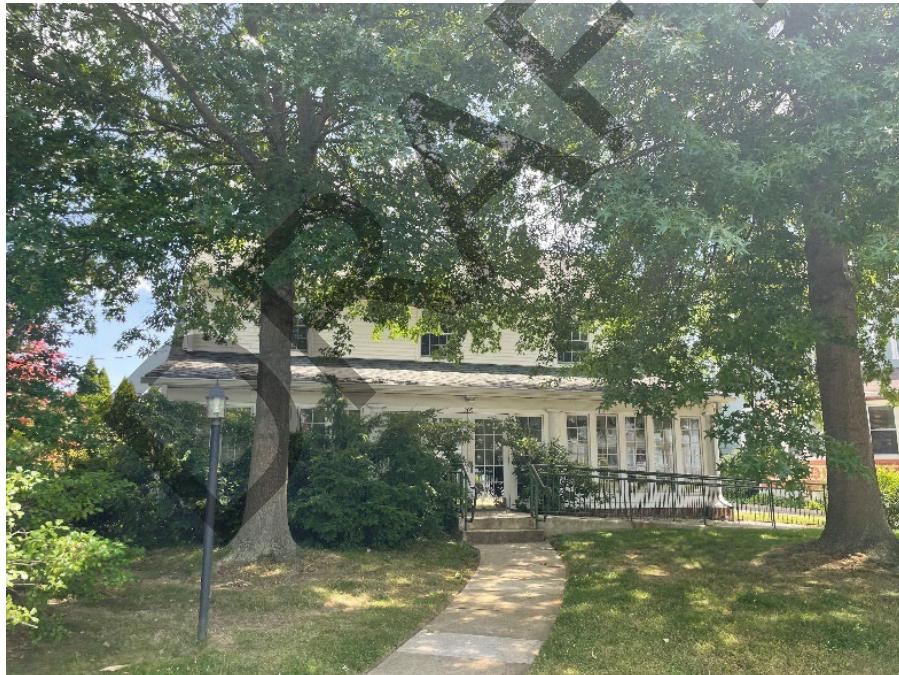
National Register	-	State Register	-
Present Use:	Residential	Historic Use:	-
Stories:	2 1/2	Bays:	
Architect:	-	Year Built:	1930
Architectural Style:	Dutch Colonial	Physical Condition:	Good
Exterior Finish:	Vinyl	Roof Finish:	Asphalt
Livable Area:	2664	Acreage:	.258
Foundation:	Concrete Block

Single-family dwelling with cross-gable roof with vinyl siding. The roof is asphalt shingles. There is an extended, enclosed, full-width porch with columns. The porch extends to the side of the building. Windows throughout the houses are double hung 8/8 in the front and 6/6 and 4/4 on the sides and rear.

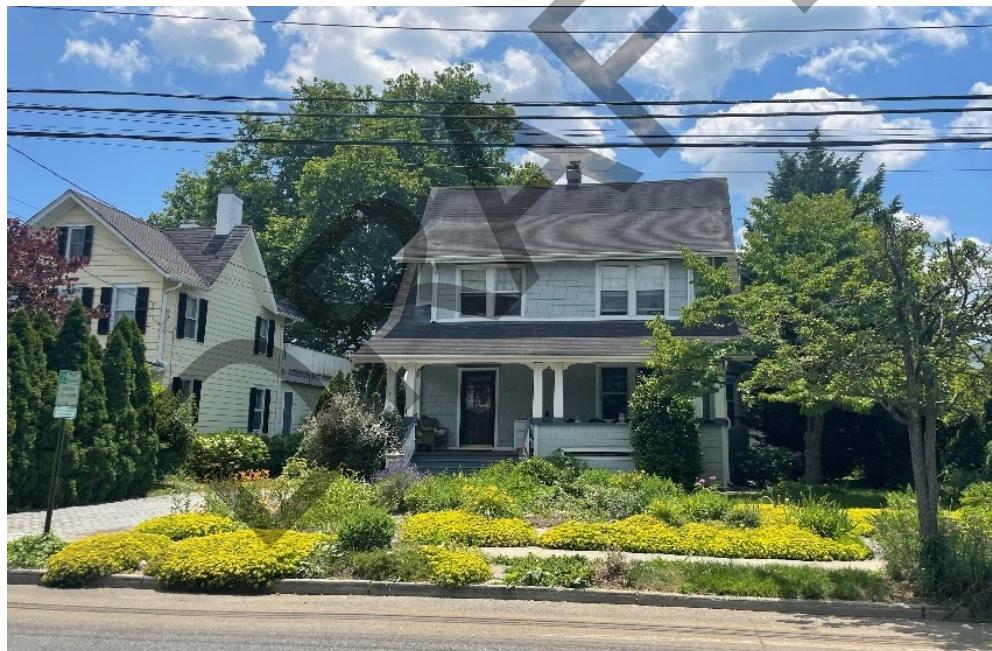
National Register	-	State Register	-
Present Use:	Residential	Historic Use:	-
Stories:	2 1/2	Bays:	
Architect:	-	Year Built:	1925
Architectural Style:	Dutch Colonial	Physical Condition:	Good
Exterior Finish:	Wood Shingles	Roof Finish:	Asphalt
Livable Area:	1648	Acreage:	.073
Foundation:	Concrete Block

Single-family dwelling with a gable roof. Stagger wood shingle shake siding. The roof is asphalt shingles—a full-extended open porch with solid railing and slender bracket posts. Center chimney. Windows throughout the houses are double-hung 6/1 in the front.

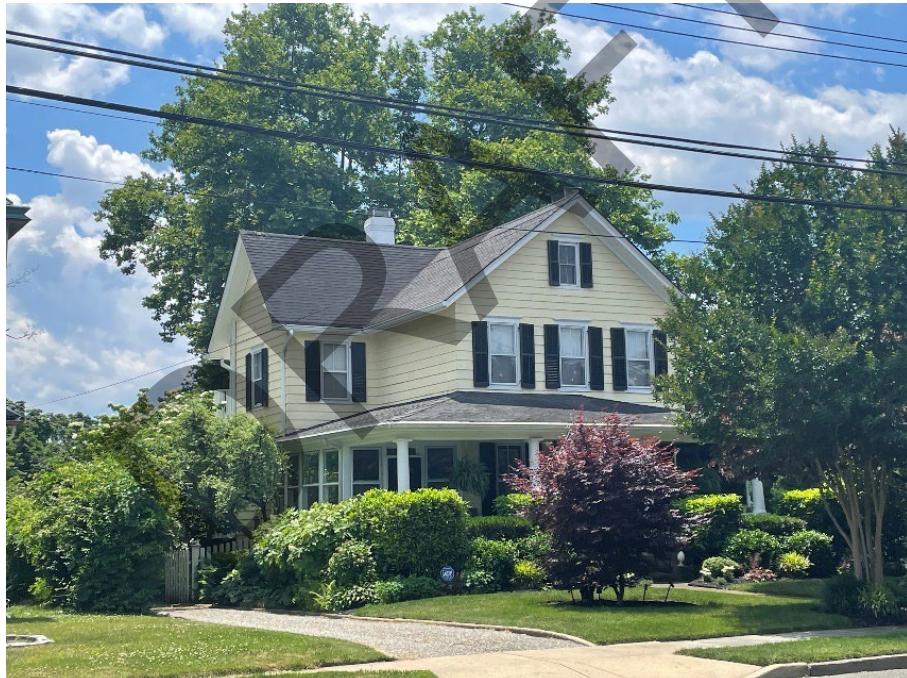
National Register	-	State Register	-
Present Use:	Residential	Historic Use:	-
Stories:	2 1/2	Bays:	
Architect:	-	Year Built:	1910
Architectural Style:	Colonial	Physical Condition:	Good
Exterior Finish:	Wood Panels	Roof Finish:	Asphalt
Livable Area:	2218	Acreage:	.196
Foundation:	Brick

Single-family dwelling with a cross-gabled roof. The roof material is asphalt shingles. Wood panel siding. Full extended open porch with columns and solid railing. The porch extends to the side of the building. Windows throughout the houses are double hung 2/2. Wood shutters are on the windows.

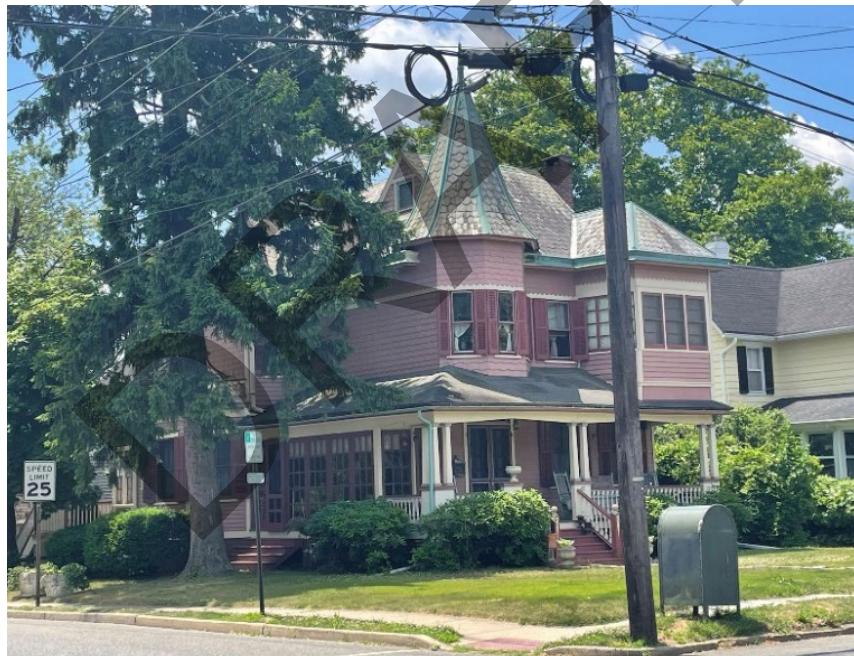
National Register	-	State Register	-
Present Use:	Residential	Historic Use:	-
Stories:	2 1/2	Bays:	
Architect:	-	Year Built:	1901
Architectural Style:	Queen Anne-Shingle	Physical Condition:	Good
Exterior Finish:	Wood Shingles	Roof Finish:	Asphalt
Livable Area:	1992	Acreage:	.189
Foundation:	Brick

Single-family dwelling with a pitched roof. Mixed pattern-shaped wood shingles and panel siding. Hexagon-shaped asphalt shingles. The second floor has a projecting bay in the front. On the side of the house is a projecting bay with a balcony. Wrap the porch with square columns and slender-turned spindles railing. Variety of window styles. Some windows feature shutters that appear to be operational. A brick chimney is located at the rear of the house. A barn-style two-car garage is at the rear of the property.

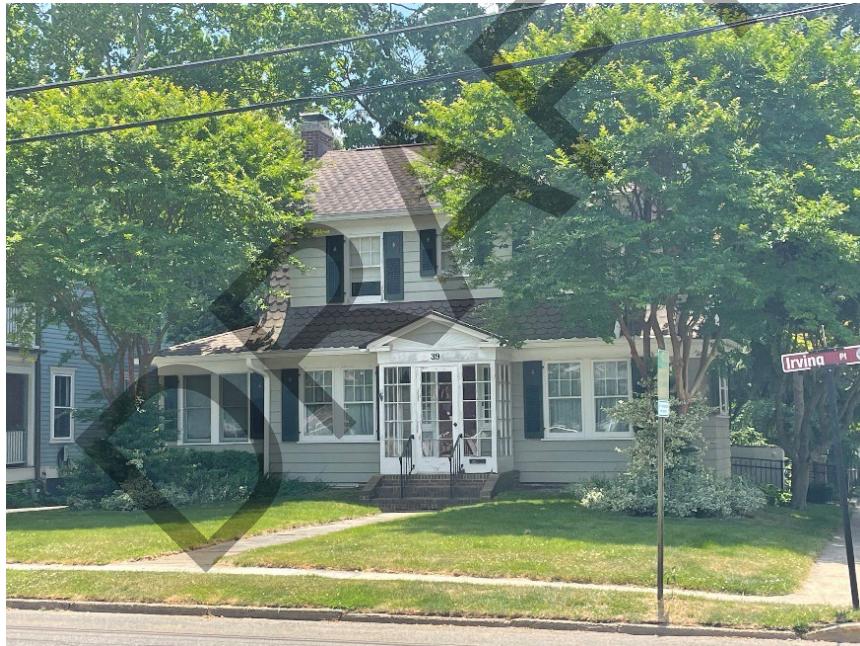
National Register	-	State Register	-
Present Use:	Residential	Historic Use:	-
Stories:	2 1/2	Bays:	
Architect:	-	Year Built:	1923
Architectural Style:	Dutch Colonial	Physical Condition:	Good
Exterior Finish:	Wood Panel	Roof Finish:	Asphalt
Livable Area:	1482	Acreage:	.230
Foundation:	Brick

Single-family dwelling with a gambrel roof and hexagon-shaped asphalt shingles. The entrance has an enclosed portico. Windows 6/1 double-hung with wood shutters. There is a small semi-round window on the 1/2 story side of the house. A brick chimney is located at the side of the house. A barn-style single-car garage is at the rear of the property.

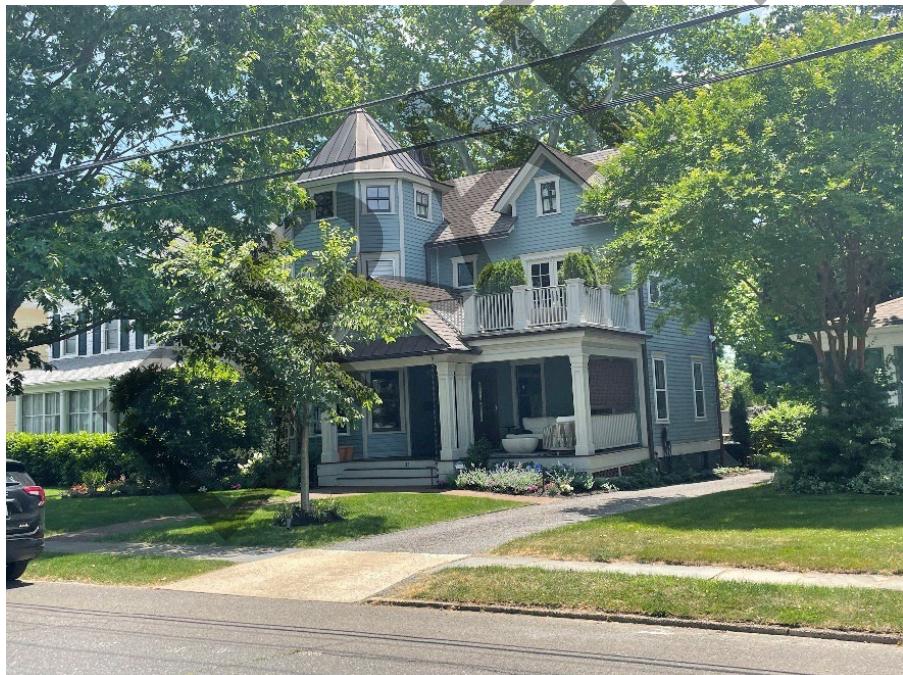
National Register	-	State Register	-
Present Use:	Residential	Historic Use:	-
Stories:	2 ½	Bays:	
Architect:	-	Year Built:	1901
Architectural Style:	Queen Anne-Shingle	Physical Condition:	Good
Exterior Finish:	Wood	Roof Finish:	Asphalt & Metal
Livable Area:	2913	Acreage:	.252
Foundation:	Brick

Single-family dwelling with a cross-gabled roof. On the side of the house are cascading hip roofs—an extended wrap open porch with round columns and a railing with slender turned spindles. The siding is clad with wood scales on the second, patterned wood on the half stories, and panels on the first floor—double-hung windows: 1/1 on the first and second floors and small 2/1 on the half story. A brick chimney is located at the side of the house.

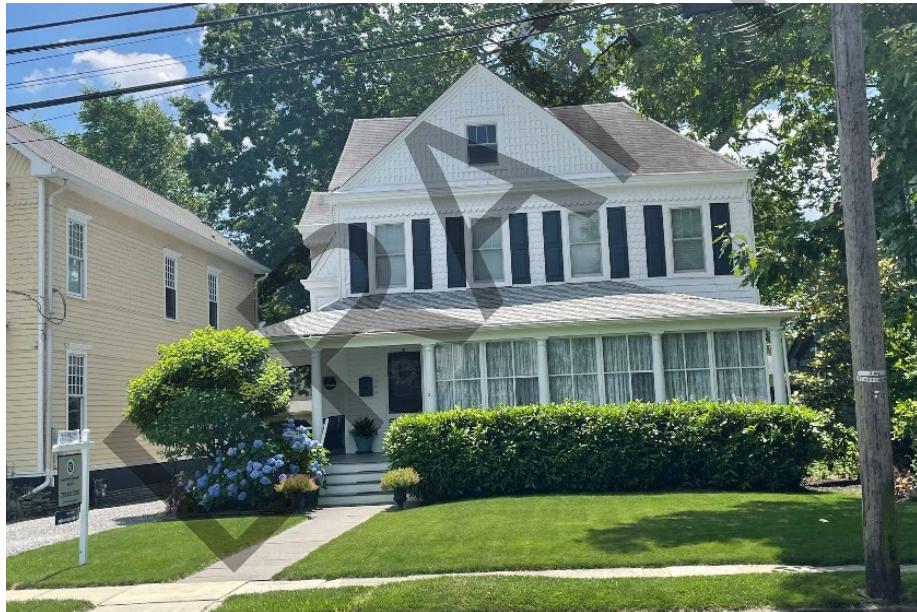
National Register	-	State Register	-
Present Use:	Residential	Historic Use:	-
Stories:	2 1/2	Bays:	
Architect:	-	Year Built:	1901
Architectural Style:	Queen Anne	Physical Condition:	Good
Exterior Finish:	Wood	Roof Finish:	Asphalt
Livable Area:	2846	Acreage:	.306
Foundation:	Brick

Single-family dwelling with a cross-gabled roof. On the side of the house are cascading hip roofs—an extended wrap open porch with round columns and a railing with slender turned spindles. The siding is clad with wood scales on the second, patterned wood on the half stories, and panels on the first floor—double-hung windows: 1/1 on the first and second floors and small 2/1 on the half story. A brick chimney is located at the side of the house.

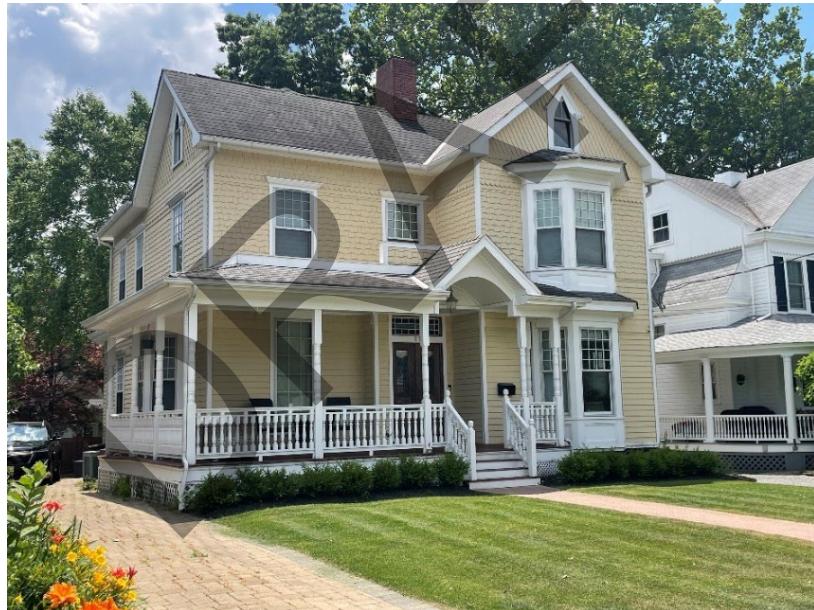
National Register	-	State Register	-
Present Use:	Residential	Historic Use:	-
Stories:	2 1/2	Bays:	2
Architect:	-	Year Built:	1910
Architectural Style:	Queen Anne-Shingle	Physical Condition:	Good
Exterior Finish:	Wood	Roof Finish:	Asphalt
Livable Area:	3342	Acreage:	.247
Foundation:	Brick

Single-family dwelling with a crossed gable roof with staggered and diamond-shaped wood shingles on the second and half stories and panels on the first floor. Extended warped open porch with decorative bracket posts and matching railing. Projecting bay windows on the first and second floors of the front. Double-hang windows: 12/1 on the first and second floors and a small 2/1 on the half story. Stain glass transom above the front door. A brick chimney is in the center of the house.

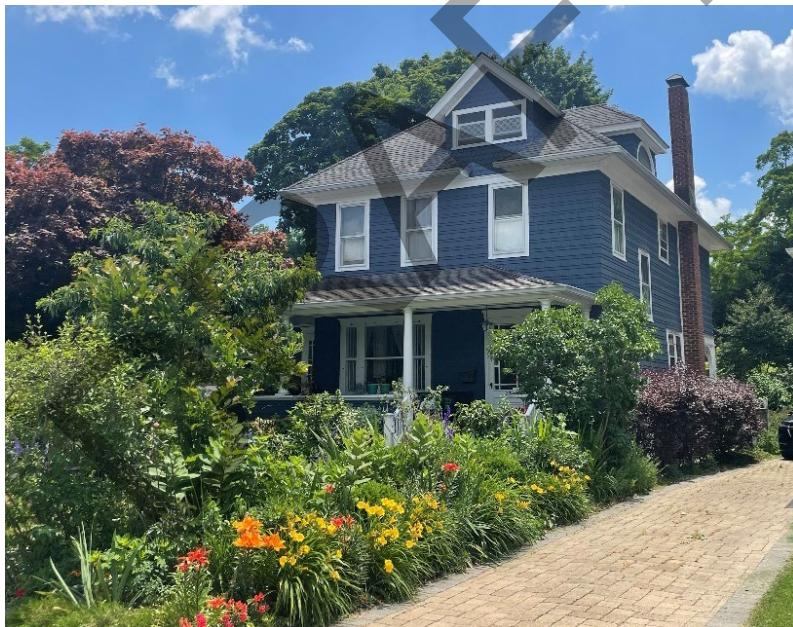
National Register	-	State Register	-
Present Use:	Residential	Historic Use:	-
Stories:	2 1/2	Bays:	-
Architect:	-	Year Built:	1901
Architectural Style:	American Foursquare	Physical Condition:	Good
Exterior Finish:	Wood	Roof Finish:	Asphalt
Livable Area:	1860	Acreage:	.184
Foundation:	Brick

Single-family dwelling with a hipped roof. Wood panel siding. Open porch with circular columns. Full-extended open porch with a solid railing and round columns. Picture window recessed within the porch—double-hung windows 1/1. A brick chimney is located at the side of the house. Three gable dormers on the front and side of the house.

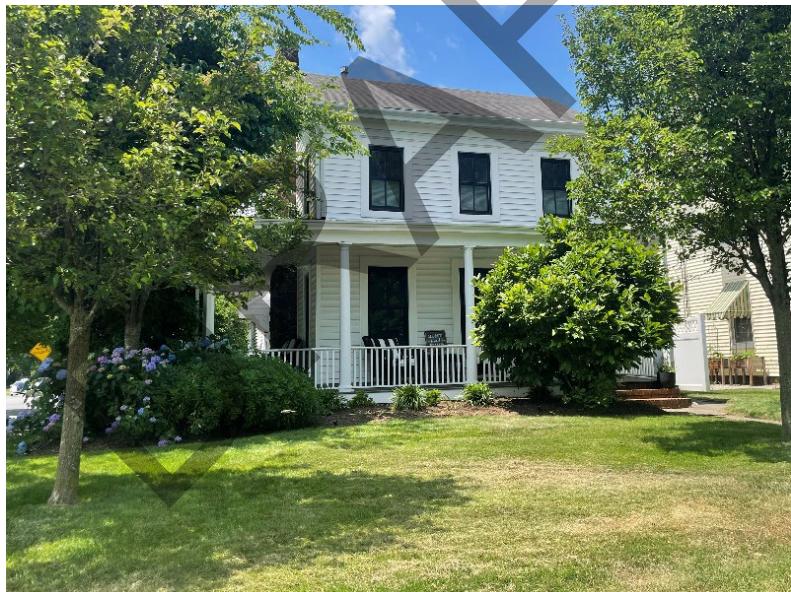
National Register	-	State Register	-
Present Use:	Residential	Historic Use:	-
Stories:	2 1/2	Bays:	-
Architect:	-	Year Built:	1901
Architectural Style:	Colonial	Physical Condition:	Good
Exterior Finish:	Vinyl	Roof Finish:	Asphalt
Livable Area:	2750	Acreage:	.213
Foundation:	Concrete Block

Single-family dwelling with gable roof. An open, warped porch with round columns and railings with square balusters. A stone chimney is on the side of the structure—double-hung windows 2/2. A stained-glass window is on the side of the structure.

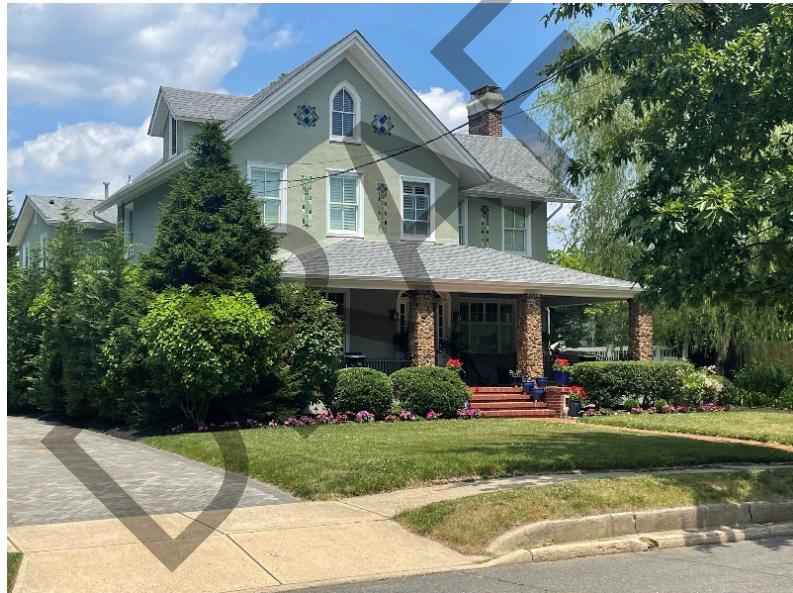
National Register	-	State Register	-
Present Use:	Residential	Historic Use:	-
Stories:	2 1/2	Bays:	-
Architect:	-	Year Built:	1907
Architectural Style:	Craftsman	Physical Condition:	Good
Exterior Finish:	Stucco	Roof Finish:	Asphalt
Livable Area:	3062	Acreage:	.267
Foundation:	Concrete Block

Single-family dwelling with a cross-gable roof. Open extended porch with stone columns. There is a brick chimney on the side of the structure—double-hung windows 2/2. A stained glass window is on the side of the structure. Decorative glass tilework on the front façade. Two picture windows on the first floor. One gabled dormer on the side of the second floor. There is a brick chimney on the side of the structure.

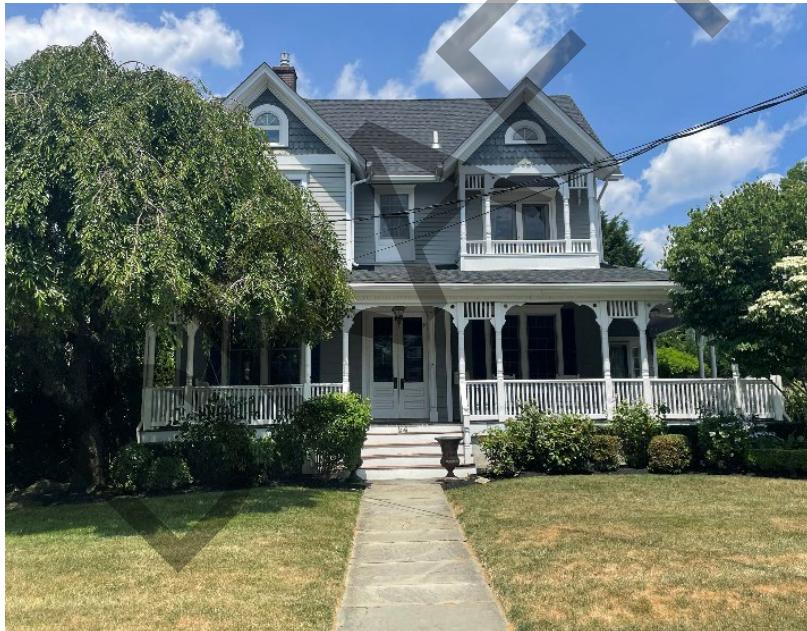
National Register	-	State Register	-
Present Use:	Residential	Historic Use:	-
Stories:	2 ½	Bays:	-
Architect:	-	Year Built:	1907
Architectural Style:	Queen Anne-Stick	Physical Condition:	Good
Exterior Finish:	Vinyl	Roof Finish:	Asphalt
Livable Area:	3104	Acreage:	.267
Foundation:	Brick

Single-family dwelling with gabled roof. There is an extended open wrap porch with decorative brackets and posts. There is a brick chimney on the side of the structure—double-hung windows 2/2. A stained-glass window is on the side of the structure. Crisscross lattice under the porch. Decorative glass tilework on the front façade. Dentils along the cornice of the porch and two balconies.

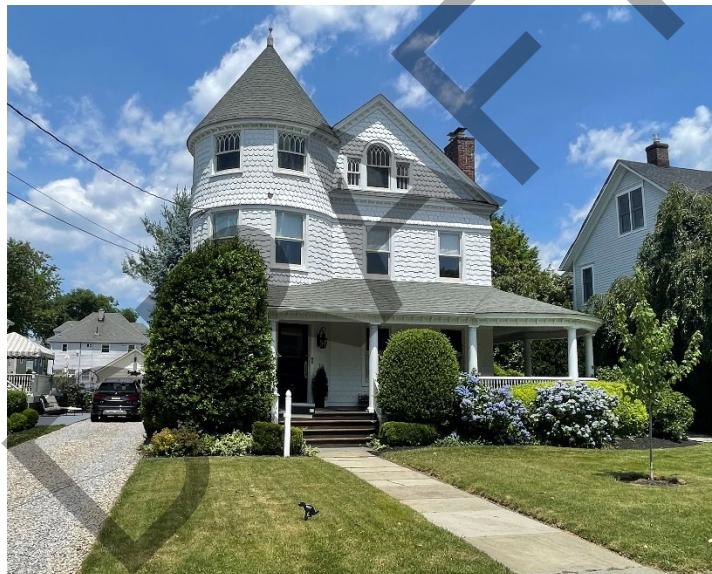
National Register	-	State Register	-
Present Use:	Residential	Historic Use:	-
Stories:	3	Bays:	-
Architect:	-	Year Built:	1890
Architectural Style:	Shingle	Physical Condition:	Good
Exterior Finish:	Wood	Roof Finish:	Asphalt
Livable Area:	2474	Acreage:	.267
Foundation:	Concrete Block

Single-family dwelling with a gable roof and circular tower. An open, extended wrap porch with circular columns. There is a brick chimney on the side of the structure. Modillion cornices. Variation of wood shingles around the structure. Double-hang cottage-style windows on the third story. Balcony on the side of the second story.

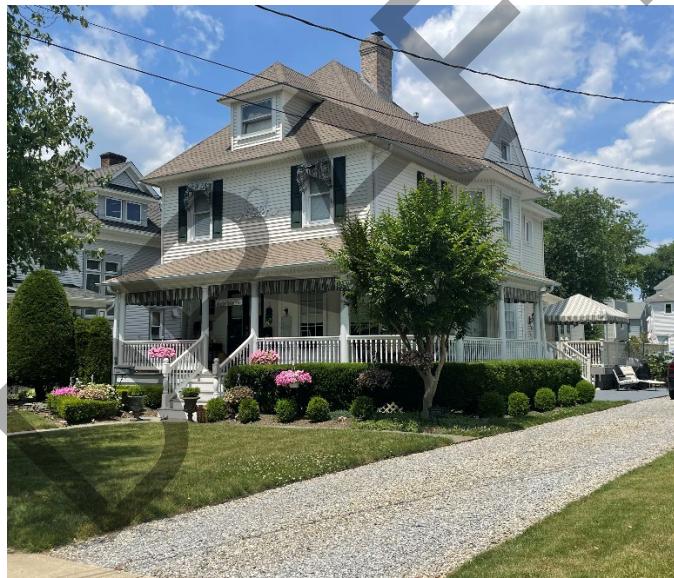
National Register	-	State Register	-
Present Use:	Residential	Historic Use:	-
Stories:	2 1/2	Bays:	2
Architect:	-	Year Built:	1907
Architectural Style:	American Foursquare	Physical Condition:	Good
Exterior Finish:	Aluminum/Vinyl	Roof Finish:	Asphalt
Livable Area:	2528	Acreage:	.267
Foundation:	Brick

Single-family dwelling with a hipped roof and three dormers, two gabled and one hipped. An open, extended wrap porch with circular columns and railing with slender turned spindles. There is a brick chimney in the center of the structure. Dentil cornices. Windows 1/1 double-hung with shutters on the second floor. Single-panel multiple-light windows on the first floor. Floral ornament on the second floor.

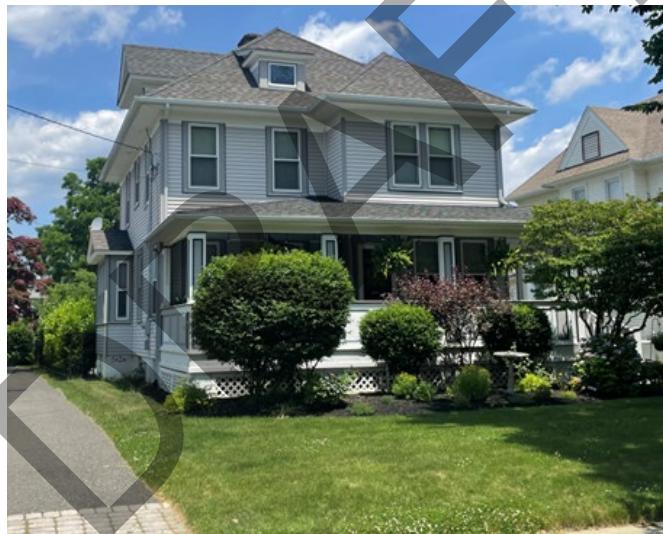
National Register	-	State Register	-
Present Use:	Residential	Historic Use:	-
Stories:	2 ½	Bays:	
Architect:	-	Year Built:	1907
Architectural Style:	American Foursquare	Physical Condition:	Good
Exterior Finish:	Vinyl	Roof Finish:	Asphalt
Livable Area:	2012	Acreage:	.234
Foundation:	Brick

Single-family dwelling with a hipped roof and three dormers, two gabled and one hipped. An open, extended wrap porch with square columns and solid railing. There is a brick chimney in the center of the structure. There is a projecting bay window on the side of the building. Windows 1/1 double-hung. Crisscross lattice under the porch.

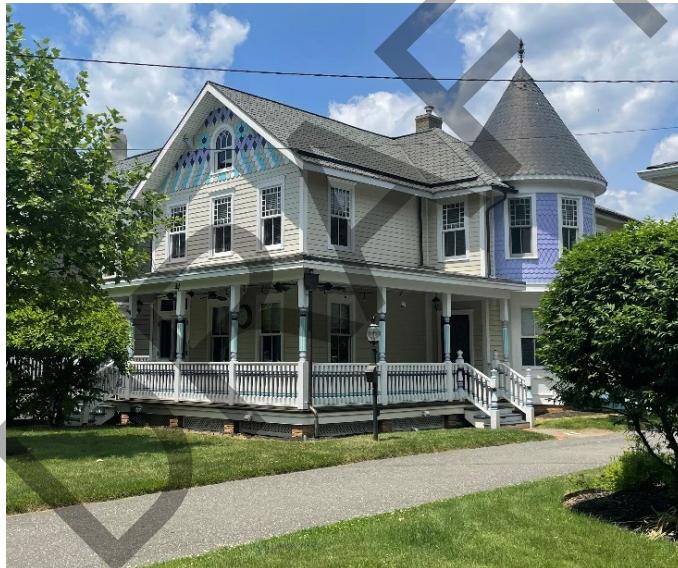
National Register	-	State Register	-
Present Use:	Residential	Historic Use:	-
Stories:	2 ½	Bays:	-
Architect:	-	Year Built:	1901
Architectural Style:	Queen Anne	Physical Condition:	Good
Exterior Finish:	Wood	Roof Finish:	Asphalt & Slate
Livable Area:	1972	Acreage:	.230
Foundation:	Brick

Single-family dwelling with a cross-gable roof and a tower on the side of the structure. A finial is on top of the building—double-hung windows with large panes of glass bounded by smaller panes. Open, extended wrap porch with decorative posts and railing with slender turned spindles. The front gable has decorative woodwork—a brick chimney in the center of the structure. The principal roof has hexagon-shaped asphalt shingles, and the tower roof has hexagon-shaped slate.

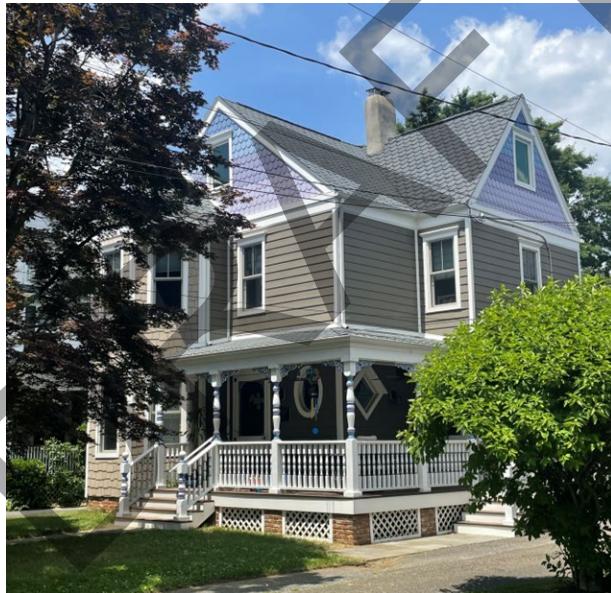
National Register	-	State Register	-
Present Use:	Residential	Historic Use:	-
Stories:	2 1/2	Bays:	-
Architect:	-	Year Built:	1907
Architectural Style:	Queen Anne	Physical Condition:	Good
Exterior Finish:	Wood	Roof Finish:	Asphalt
Livable Area:	2273	Acreage:	.230
Foundation:	Brick

Single-family dwelling with a cross-gable roof. Double-hung windows 2/1. The front first-floor windows are of different shapes and sizes, including an extended open partial porch with decorative posts and railing with slender turned spindles. Front and side gables have detailed woodwork—a stucco chimney in the center of the structure. The principal roof has hexagon-shaped asphalt shingles.

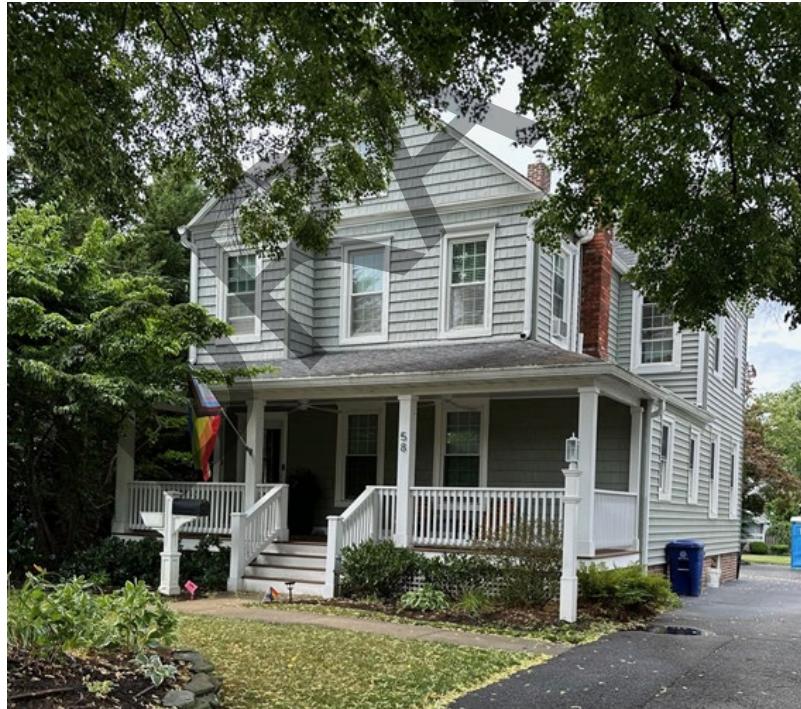
National Register	-	State Register	-
Present Use:	Residential	Historic Use:	-
Stories:	2 1/2	Bays:	-
Architect:	-	Year Built:	1907
Architectural Style:	American Foursquare	Physical Condition:	Good
Exterior Finish:	Wood	Roof Finish:	Asphalt
Livable Area:	2029	Acreage:	.225
Foundation:	Brick

Single-family dwelling with a cross-gable roof. Double-hung window 6/6. An open extended full porch with rectangular shaped columns and railing with rectangular spindles—a brick chimney on the side of the structure.

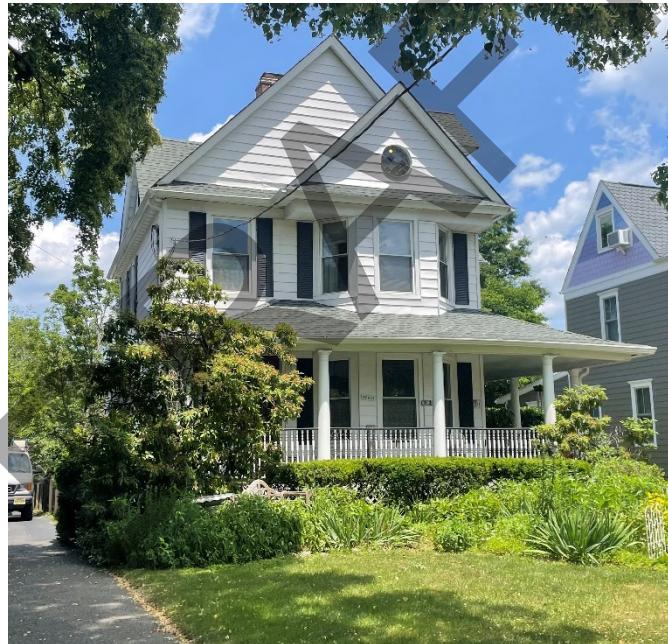
National Register	-	State Register	-
Present Use:	Residential	Historic Use:	-
Stories:	2 1/2	Bays:	-
Architect:	-	Year Built:	1920
Architectural Style:	Colonial Revival	Physical Condition:	Good
Exterior Finish:	Wood	Roof Finish:	Asphalt
Livable Area:	2114	Acreage:	.220
Foundation:	Brick

Single-family dwelling with a cross-gable roof. Double-hung window 1/1. There is an extended open wrap porch with circular columns and railing with slender turned spindles. There is a brick chimney in the center of the structure. Shutters on the windows. Oval window on the front gable.

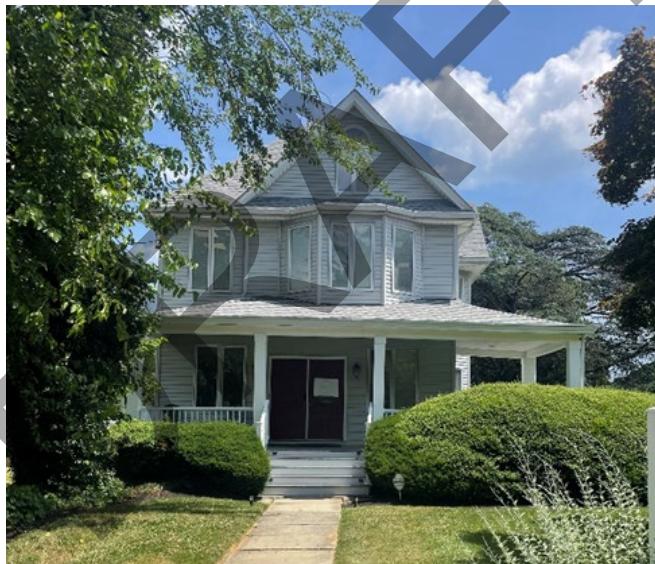
National Register	-	State Register	-
Present Use:	Commercial	Historic Use:	Residential
Stories:	2 1/2	Bays:	1
Architect:	-	Year Built:	1901
Architectural Style:	American Foursquare	Physical Condition:	Good
Exterior Finish:	Vinyl	Roof Finish:	Asphalt
Livable Area:	2650	Acreage:	.298
Foundation:	Brick

Professional office building with a cross-gable roof. Casement windows. An open, extended wrapped porch with rectangular-shaped columns and railing with rectangular spindles. Two brick chimneys are in the center of the structure.
