**Impervious Cover Assessment
for
Red Bank Borough, Monmouth County, New Jersey**

*Prepared for Red Bank Borough by the
Rutgers Cooperative Extension Water Resources Program*

December 1, 2017

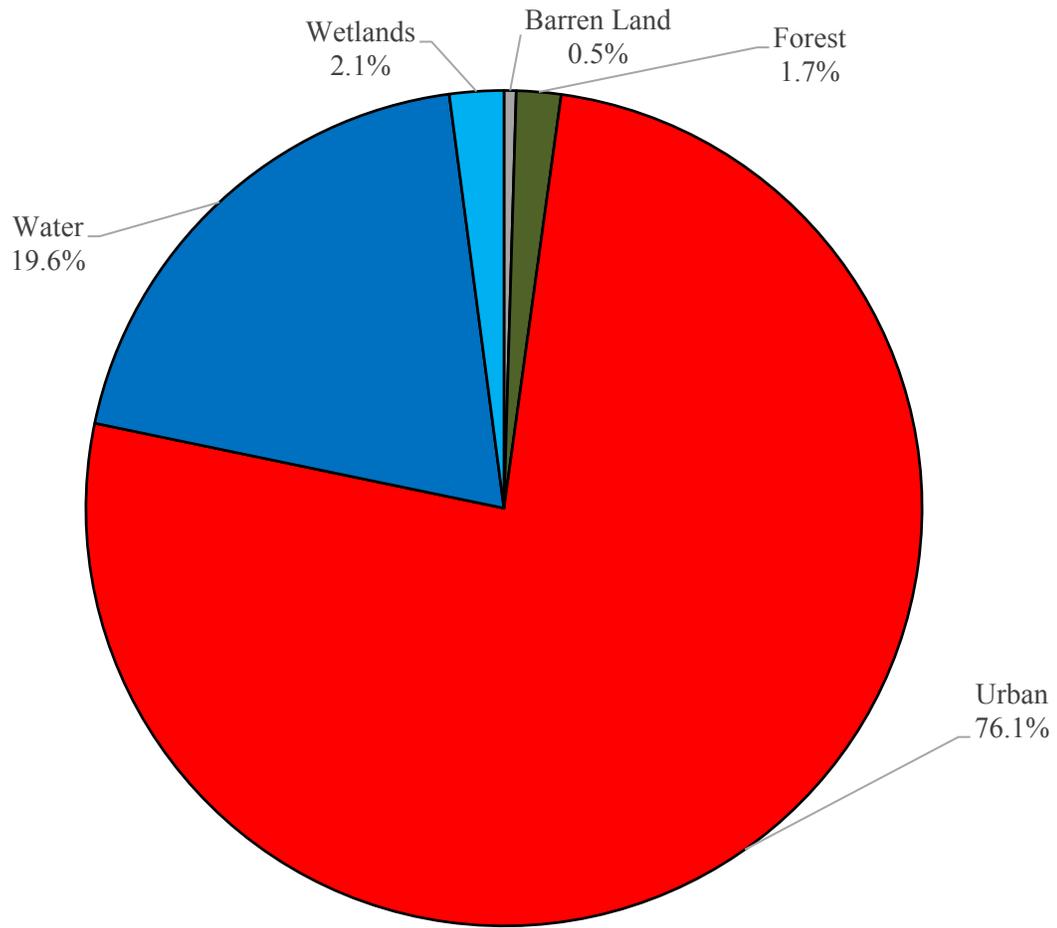
Figure 3: Pie chart illustrating the land use in Red Bank Borough

Located in Monmouth County in central New Jersey, Red Bank Borough covers approximately 2.2 square miles. Figures 3 and 4 illustrate that Red Bank Borough is dominated by urban land uses. A total of 76.1% of the municipality's land use is classified as urban. Of the urban land in Red Bank Borough, high density residential is the dominant land use (Figure 5).

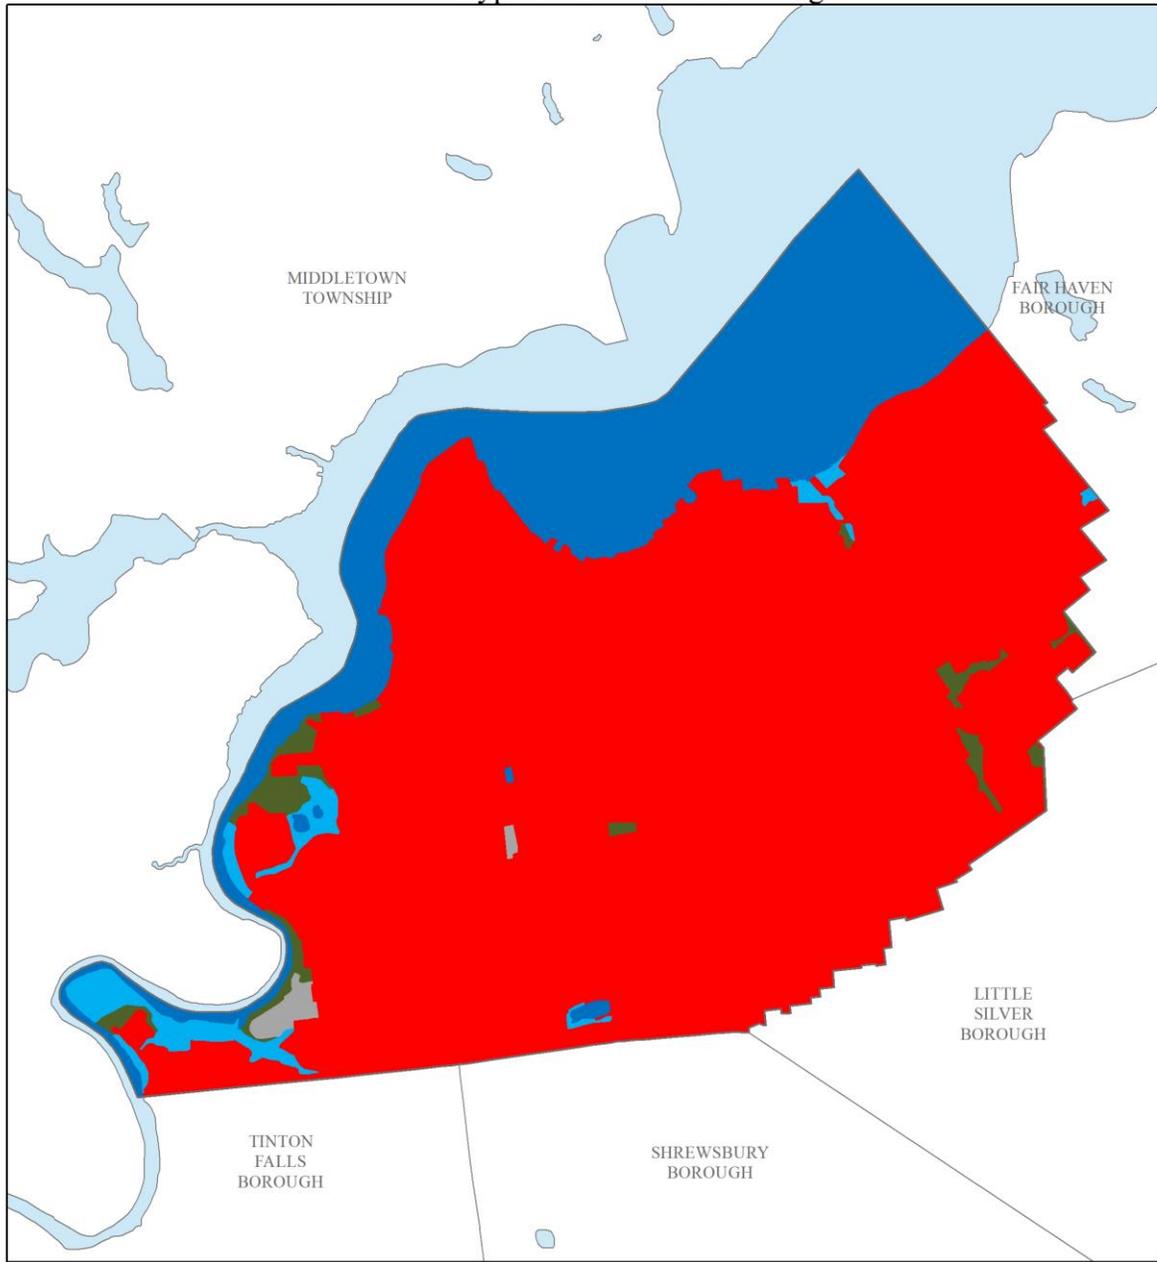
Figure 4: Map illustrating the land use in Red Bank Borough

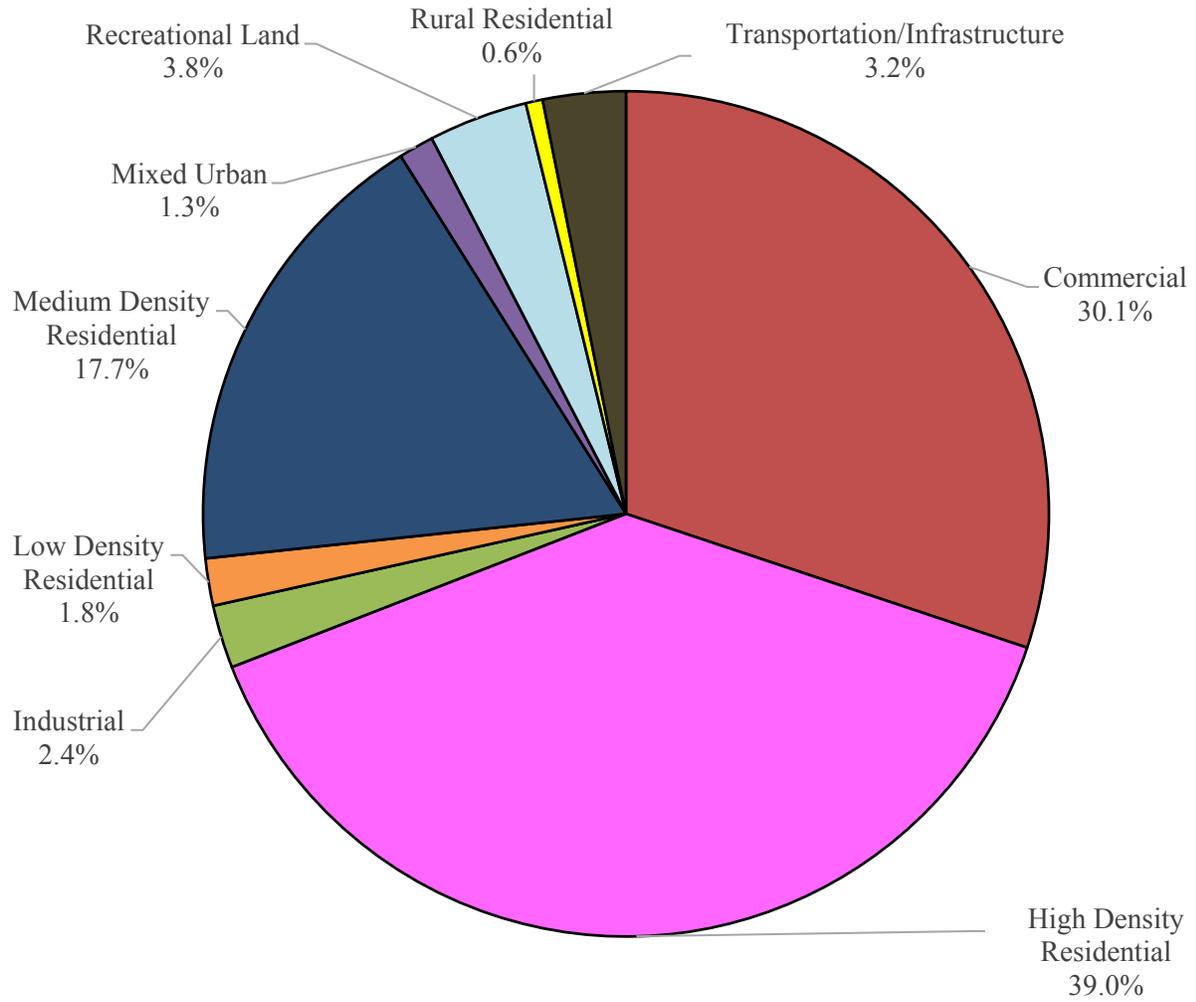
Figure 5: Pie chart illustrating the various types of urban land use in Red Bank Borough

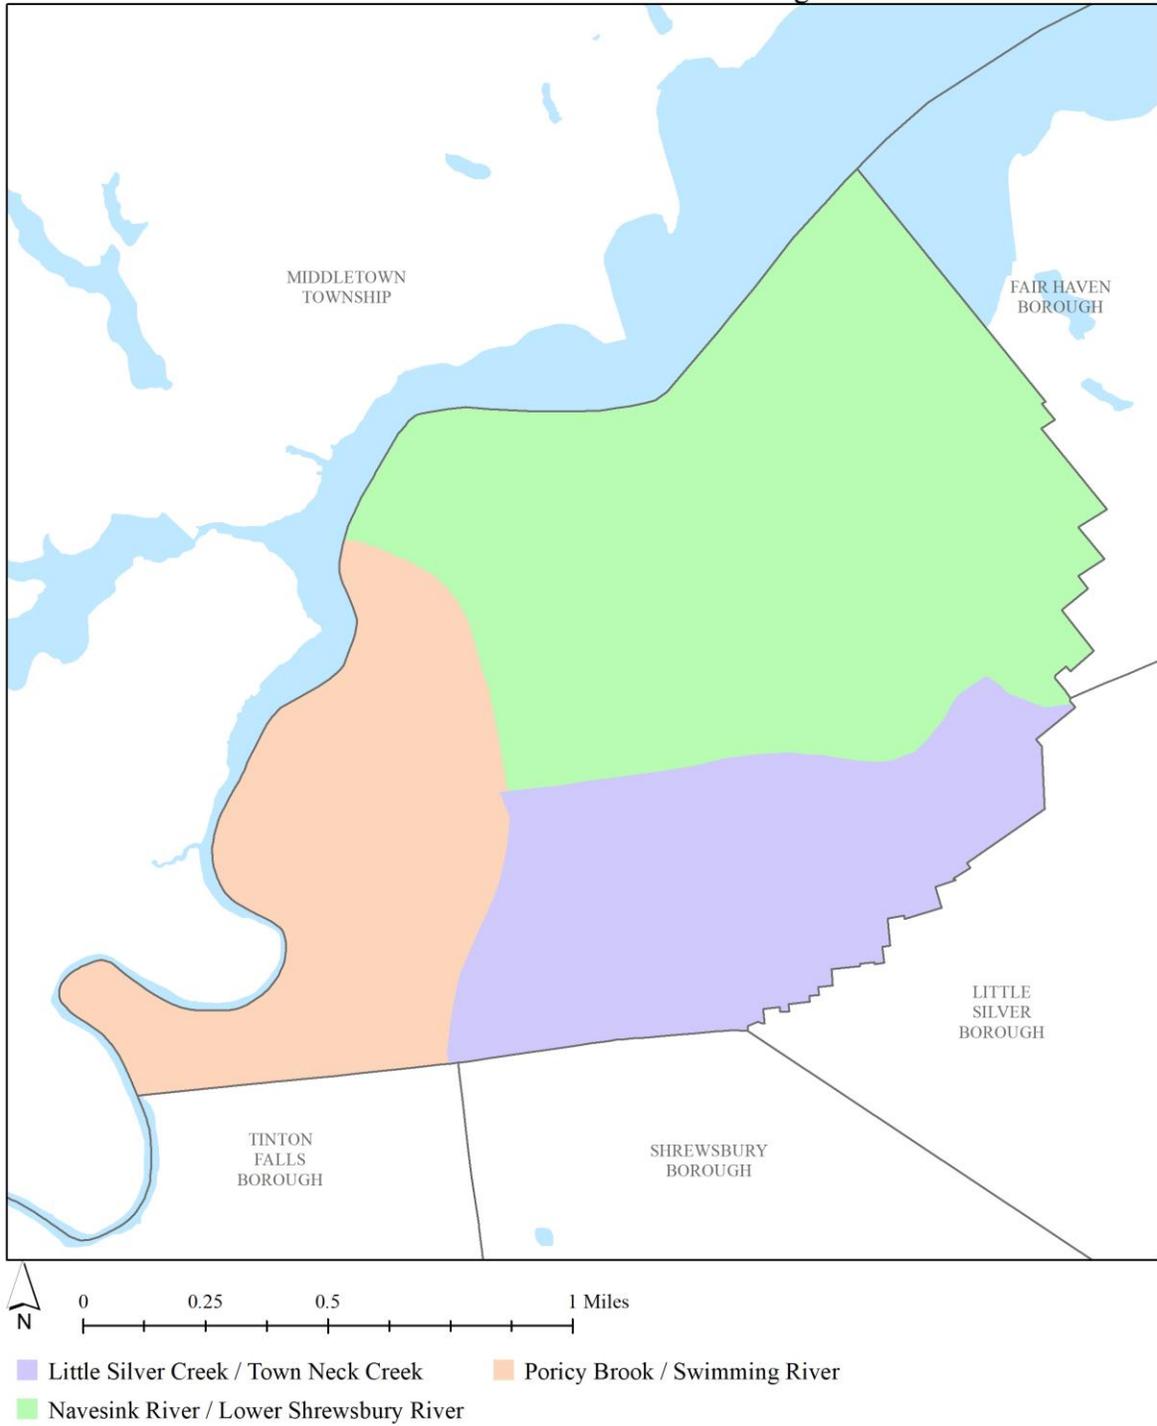
Figure 6: Map of the subwatersheds in Red Bank Borough

Water resources are typically managed on a watershed/subwatershed basis; therefore an impervious cover analysis was performed for each subwatershed within Red Bank Borough (Table 1 and Figure 6). On a subwatershed basis, impervious cover ranges from 43.9% in the Poricy Brook subwatershed to 57.8% in the Navesink River subwatershed. Evaluating impervious cover on a subwatershed basis allows the municipality to focus impervious cover reduction or disconnection efforts in the subwatersheds where frequent flooding occurs.

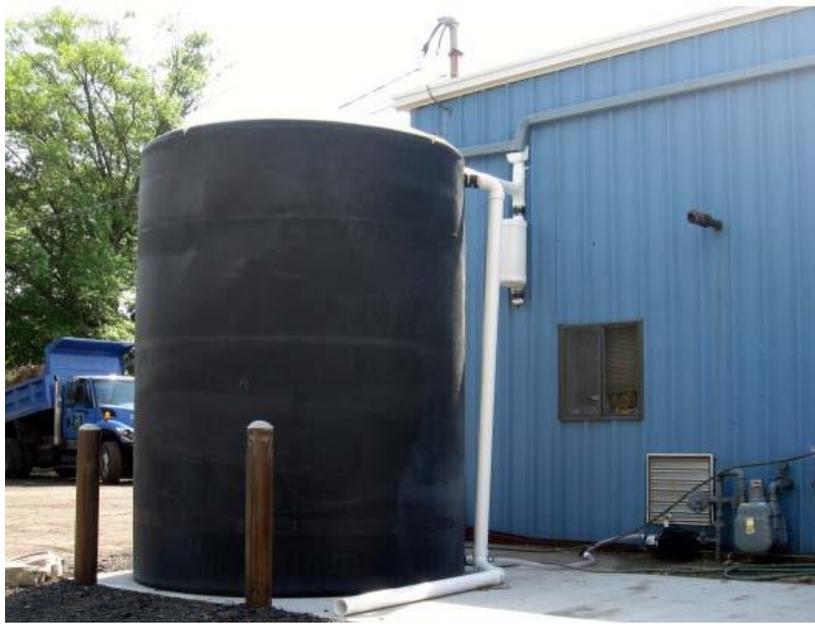
Figure 8b: A 5,000 gallon cistern used to disconnect the rooftop of the Department of Public Works in Clark Township to harvest rainwater for nonprofit car wash events

- Rainwater Harvesting: Rainwater harvesting includes the use of rain barrels and cisterns (Figures 8a and 8b). These can be placed below downspouts to collect rooftop runoff. The collected water has a variety of uses including watering plants and washing cars. This practice also helps cut down on the use of potable water for nondrinking purposes. It is important to divert the overflow from the rainwater harvesting system to a pervious area.

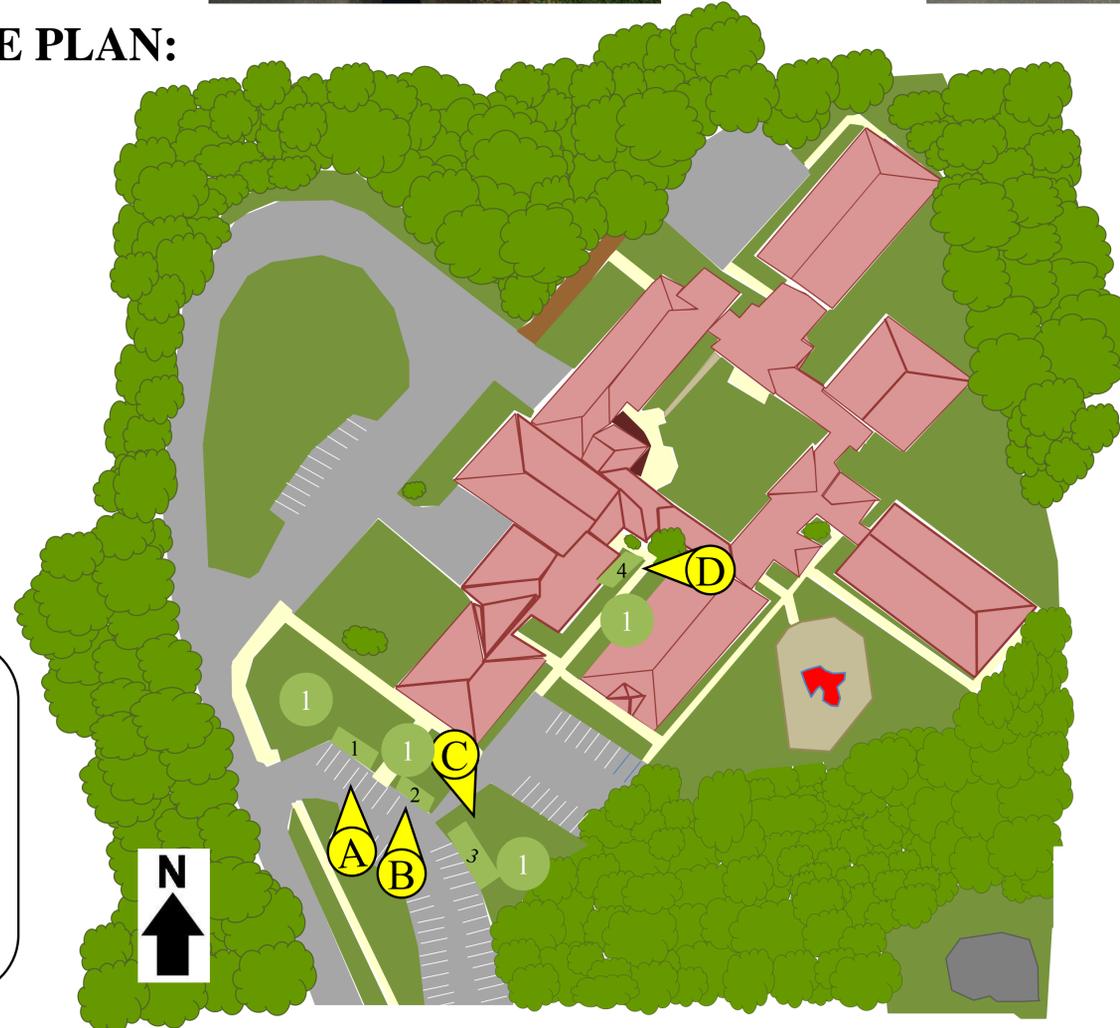
SITE PLAN:

1 BIORETENTION SYSTEM: Rain gardens could be installed at the Red Bank Primary School to reduce sediment and nutrient loading to the adjacent Navesink River and increase groundwater recharge. Four opportunities were identified where rain gardens could be installed on the school's property.

<p>Proposed Solution(s): Three areas were identified adjacent to the parking lot closest to the Navesink River where rain gardens could be installed to capture, treat, and infiltrate parking lot runoff. A rain garden could be installed in the courtyard with the native plant garden to capture roof runoff from two downspouts.</p>	
<p>Anticipated Benefits: Since the bioretention systems would be designed to capture, treat, and infiltrate the entire 2-year design storm (3.4 inches of rain over 24 hours), these systems are estimated to achieve a 95% pollutant load reduction for TN, TP, and TSS. A bioretention system would also provide ancillary benefits, such as enhanced wildlife and aesthetic appeal to the local residents of Red Bank Borough.</p> <p>Rutgers Cooperative Extension could additionally present the <i>Stormwater Management in Your Schoolyard</i> program to students and include them in bioretention system planting efforts to enhance the program. This may also be used as a demonstration project for Red Bank Borough's Public Works staff to launch educational programming.</p>

Rain garden #1 would need to be approximately 500 square feet. At \$5 per square foot, the estimated cost is \$2,500. Rain garden #2 would need to be approximately 500 square feet. At \$5 per square foot, the estimated cost is \$2,500. Rain garden #3 would need to be approximately 600 square feet. At \$5 per square foot, the estimated cost is \$3,000. Rain garden #4 would need to be approximately 280 square feet. At \$5 per square foot, the estimated cost is \$1,400.

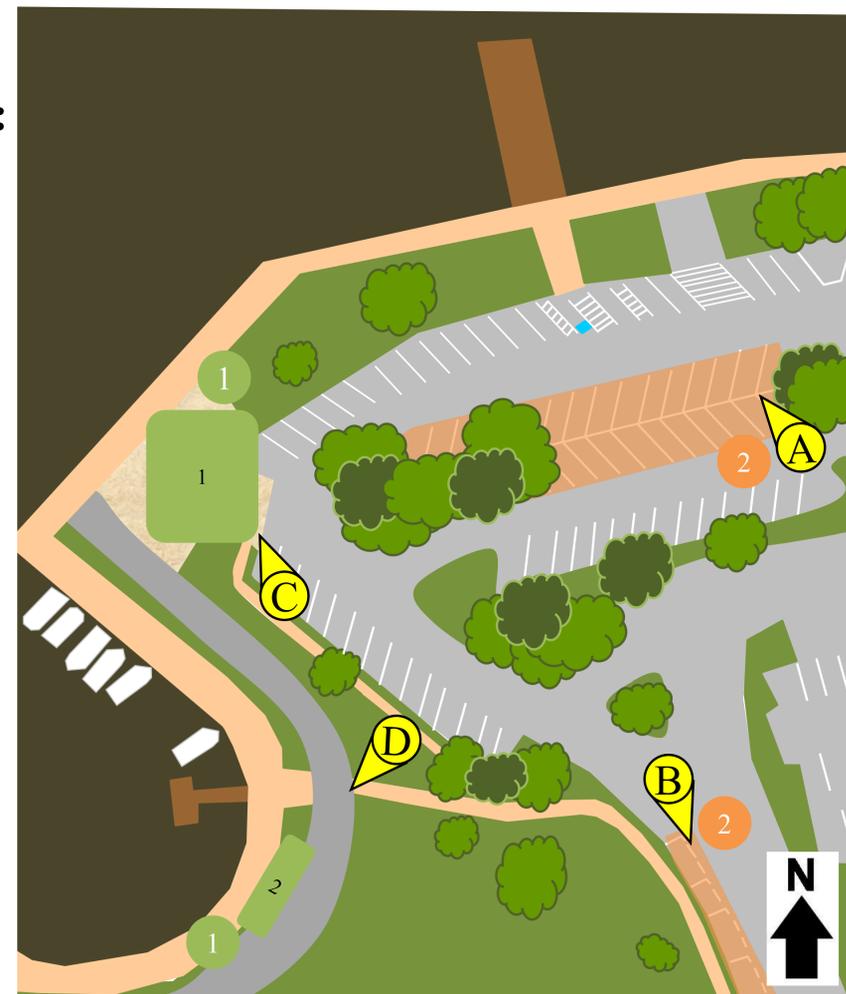
SITE PLAN:

- 1 BIORETENTION SYSTEM:** Rain gardens could be installed at Marine Park to reduce sediment and nutrient loading to the Navesink River. Two opportunities were identified where rain gardens could be installed as demonstration projects for the community to see and be inspired to do at home.
- 2 POROUS PAVEMENT:** Porous pavement promotes groundwater recharge and filters stormwater. The parking spots could be replaced with porous pavement.

<p>Proposed Solution(s): To reduce the amount of stormwater draining to the catch basins and remediate the area of pooling water, porous pavement can be used to replace public parking spaces. Demonstration rain gardens could be installed to capture, treat, and infiltrate runoff in the areas where erosion was identified within the turfgrass of the park.</p>	
<p>Anticipated Benefits: Since the bioretention systems would be designed to capture, treat, and infiltrate the entire 2-year design storm (3.4 inches of rain over 24 hours), these systems are estimated to achieve a 95% pollutant load reduction for TN, TP, and TSS. A bioretention system would also provide ancillary benefits, such as enhanced wildlife and aesthetic appeal to the local residents of Red Bank Borough.</p> <p>Porous pavement allows stormwater to infiltrate through to soil layers which will promote groundwater recharge as well as intercept and filter stormwater runoff. The porous pavement system will achieve the same level of pollutant load reduction for TN, TP, and TSS as the bioretention system.</p>

The porous asphalt section #1 would cover approximately 2,000 square feet and have a 2-foot stone reservoir under the surface. At \$25 per square foot, the estimated cost of the porous asphalt system would be \$50,000. The porous asphalt section #2 would cover 1,150 square feet and have a 2-foot stone reservoir under the surface. At \$25 per square foot, the estimated cost of the porous asphalt system would be \$28,750.

Rain garden #1 would need to be approximately 1,000 square feet. At \$5 per square foot, the estimated cost is \$5,000. Rain garden #2 would need to be approximately 450 square feet. At \$5 per square foot, the estimated cost is \$2,250.

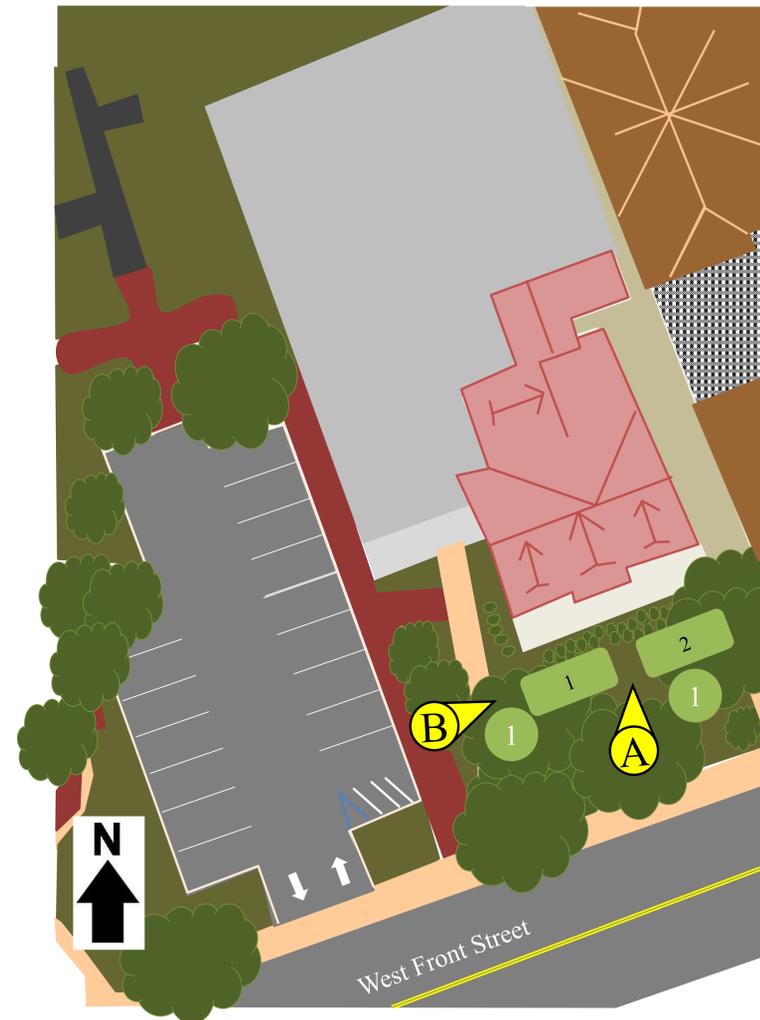
SITE PLAN:

1 BIORETENTION SYSTEM: Rain gardens can be used to reduce sediment and nutrient loading to the Navesink River and increase groundwater recharge. Two rain gardens can be installed in front of the library to capture, treat, and infiltrate runoff from the downspouts in front of the building.

<p>Location: 84 West Front Street Red Bank, NJ 07701</p>	<p>Municipality: Red Bank Borough</p>
<p>Green Infrastructure Description: bioretention system (rain garden)</p>	<p>Subwatershed: Navesink River</p>
<p>Mitigation Opportunities: recharge potential: yes stormwater peak reduction potential: yes total suspended solids removal potential: yes</p>	<p>Targeted Pollutants: total nitrogen (TN), total phosphorus (TP), and total suspended solids (TSS) in surface runoff</p>
<p>Stormwater Captured and Treated Per Year: bioretention system # 1: 15,633 gal. bioretention system # 2: 15,633 gal.</p>	
<p>Existing Conditions and Issues: The parking lot appeared to be in satisfactory condition. External downspouts are present around the perimeter of the library. During the site assessment it was noted that the landscaping beds in front of the library consisted of native plants.</p>	
<p>Proposed Solution(s): Two areas were identified in front of the library where rain gardens could be installed to capture, treat, and infiltrate roof runoff by expanding the existing native plant beds.</p>

Rain garden #1 would need to be approximately 150 square feet. At \$5 per square foot, the estimated cost is \$750 for the rain garden. Rain garden #2 would need to be approximately 150 square feet. At \$5 per square foot, the estimated cost is \$750 for the rain garden.
