**Impervious Cover Reduction Action Plan  
for  
Red Bank Borough, Monmouth County, New Jersey**

*Prepared for Red Bank Borough by the  
Rutgers Cooperative Extension Water Resources Program*

December 13, 2017

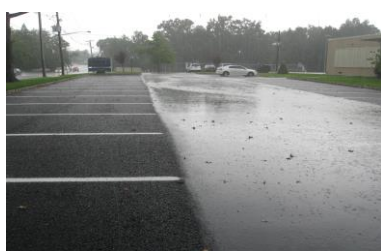
### ***Pervious pavements***

There are several types of permeable pavement systems including porous asphalt, pervious concrete, permeable pavers, and grass pavers. These surfaces are hard and support vehicle traffic but also allow water to infiltrate through the surface. They have an underlying stone layer to store stormwater runoff and allow it to slowly seep into the ground.

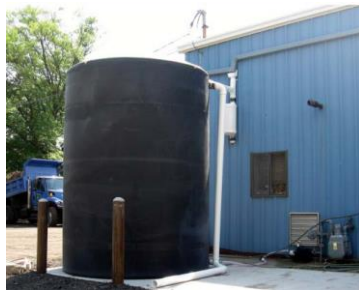
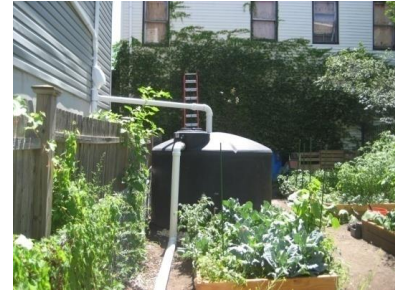
### ***Rainwater harvesting systems (cistern or rain barrel)***

These systems capture rainwater, mainly from rooftops, in cisterns or rain barrels. The water can then be used for watering gardens, washing vehicles, or for other non-potable uses.

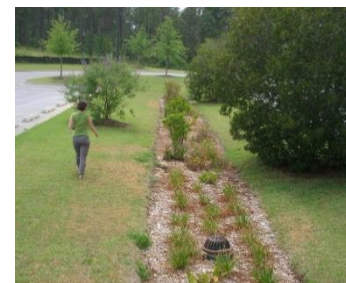
### ***Bioswale***

Bioswales are landscape features that convey stormwater from one location to another while removing pollutants and providing water an opportunity to infiltrate.

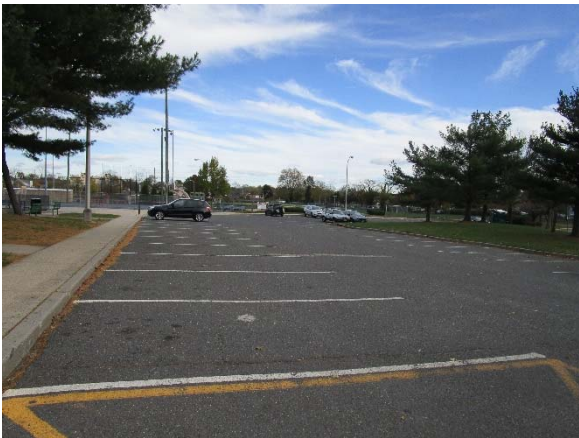
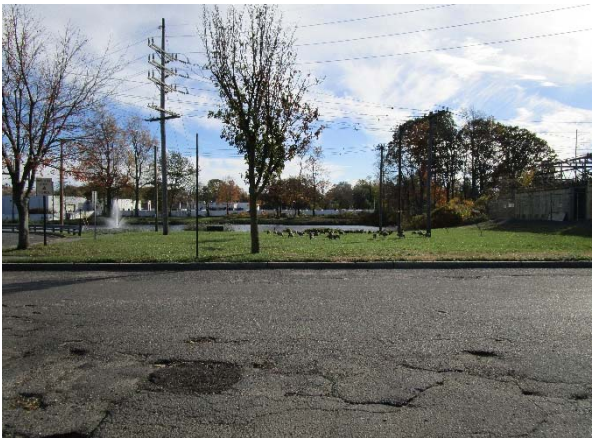
# Count Basie Park

Parking spots to the west of the park can be replaced with porous asphalt to capture and infiltrate stormwater. Installing a rain garden along the street can capture, treat, and infiltrate road runoff. A preliminary soil assessment suggests that the soils have suitable drainage characteristics for green infrastructure.

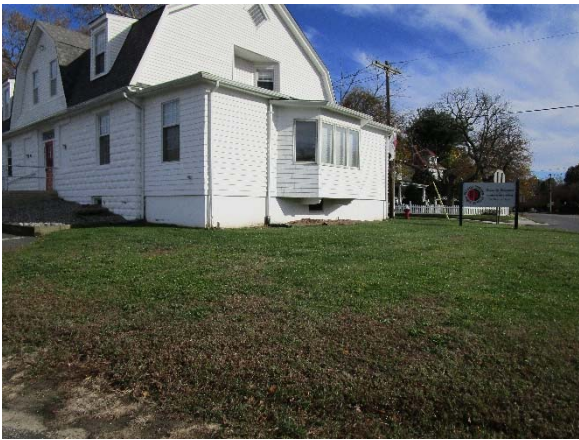
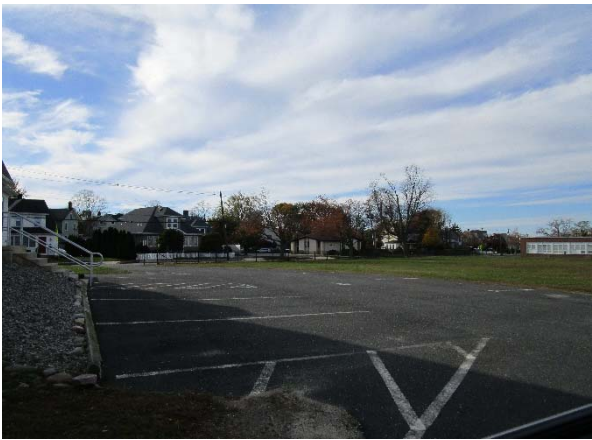
Parking spots to the north of the building can be replaced with porous asphalt to capture and infiltrate stormwater. Installing a rain garden adjacent to the building can capture, treat, and infiltrate roof runoff. A preliminary soil assessment suggests that the soils have suitable drainage characteristics for green infrastructure.

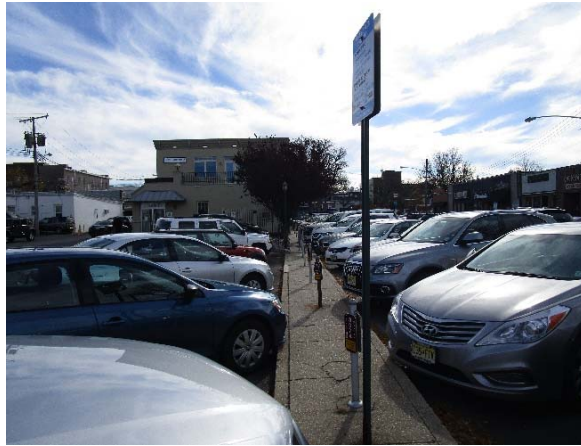
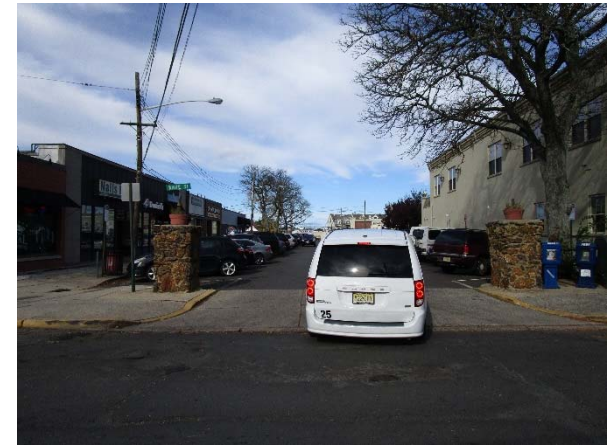
Parking spots along the street can be replaced with porous asphalt to capture and infiltrate stormwater. A preliminary soil assessment suggests that more soil testing would be required before determining the soil's suitability for green infrastructure.

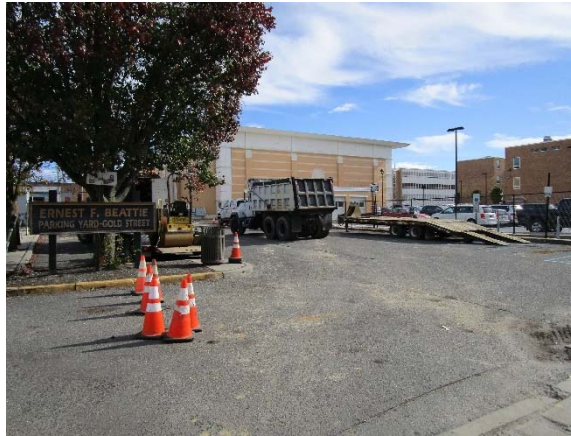
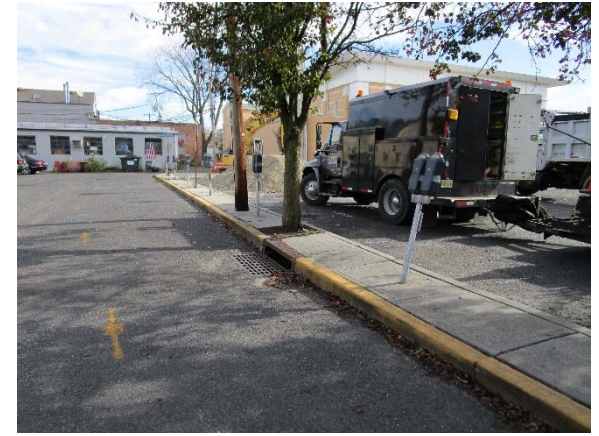
Parking spots along the street can be replaced with porous asphalt to capture and infiltrate stormwater. A preliminary soil assessment suggests that more soil testing would be required before determining the soil's suitability for green infrastructure.

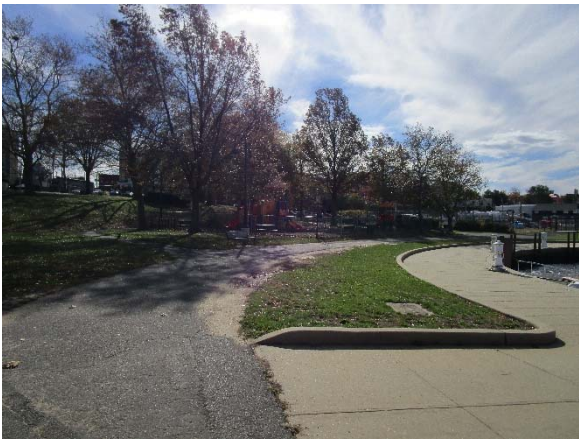
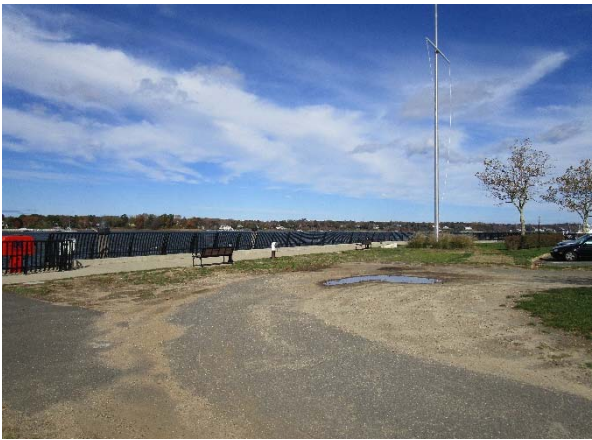
Parking spots to the north end can be replaced with porous asphalt to capture and infiltrate stormwater. Installing rain gardens in the eroded areas around the park can capture, treat, and infiltrate runoff from the parking lot and walkways. A preliminary soil assessment suggests that the soils have suitable drainage characteristics for green infrastructure.

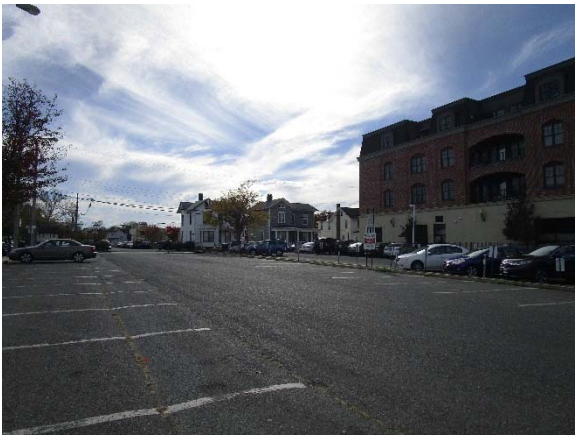
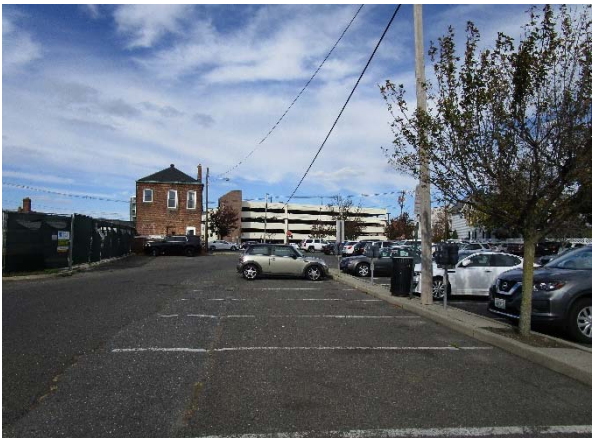
Parking spots can be replaced with porous asphalt to capture and infiltrate stormwater. A preliminary soil assessment suggests that the soils have suitable drainage characteristics for green infrastructure.

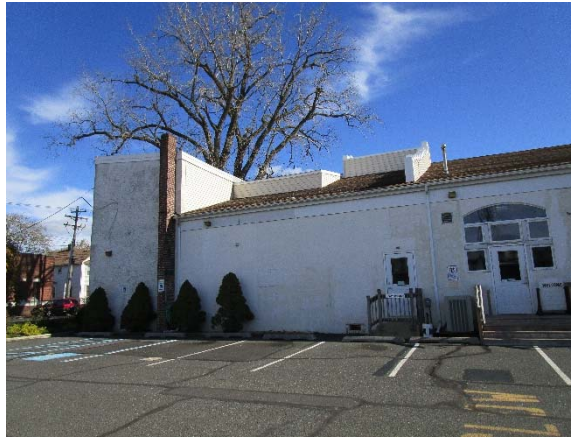
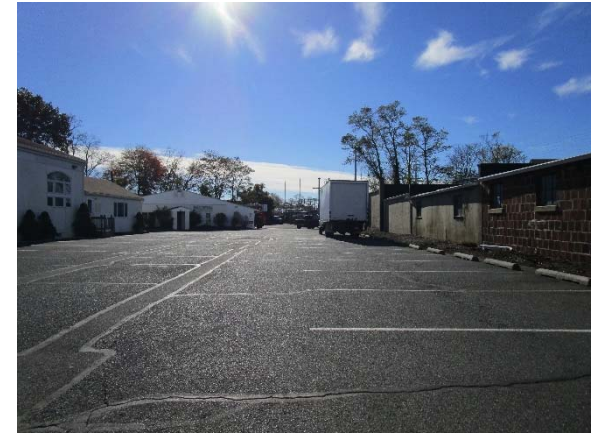
Parking spots can be replaced with porous asphalt to capture and infiltrate stormwater from the parking lot and rooftop by directing downspouts into it. A preliminary soil assessment suggests that the soils have suitable drainage characteristics for green infrastructure.

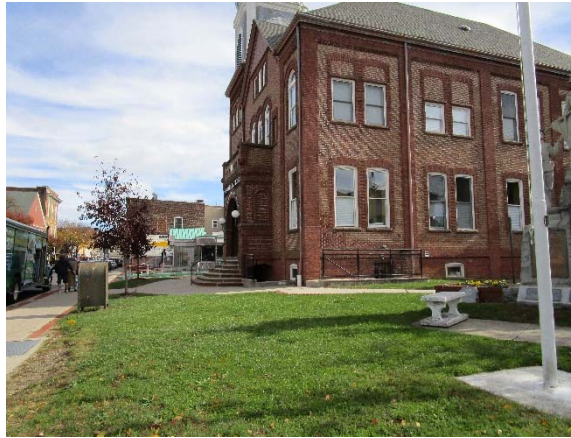
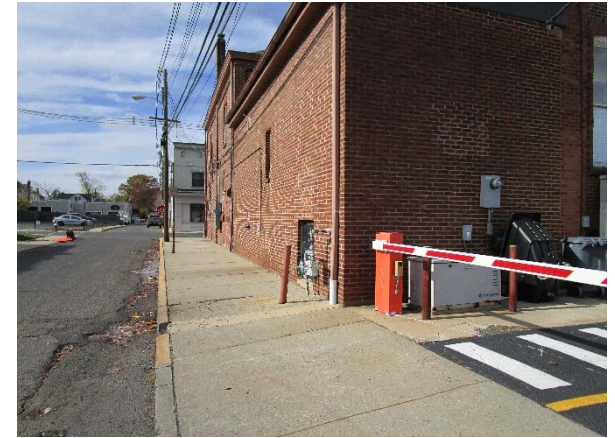
Installing a rain garden adjacent to the building can capture, treat, and infiltrate roof runoff. A stormwater planter can be constructed to the south of the building by directing the downspout that is already routed under the sidewalk into the planter. A preliminary soil assessment suggests that more soil testing would be required before determining the soil's suitability for green infrastructure.

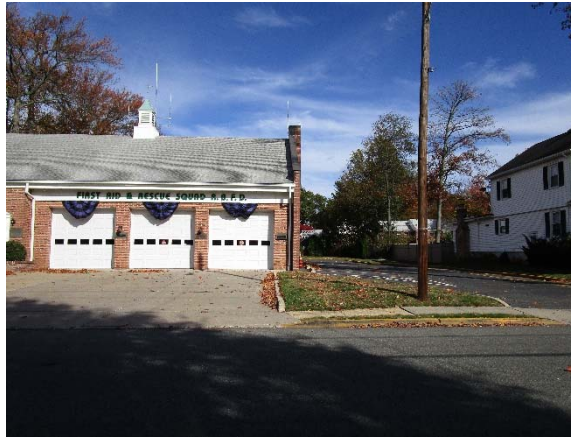
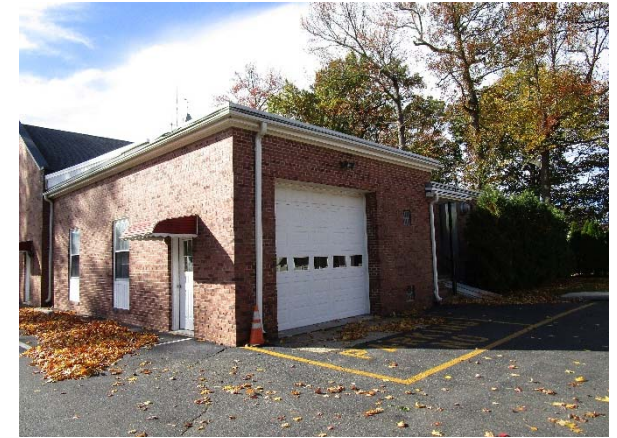
Roof runoff can be harvested by installing a cistern at the northeast corner of the building. The water can then be used for watering gardens, washing vehicles, or for other non-potable uses. Installing a rain garden in front of the building can capture, treat, and infiltrate roof runoff. A preliminary soil assessment suggests that the soils have suitable drainage characteristics for green infrastructure.

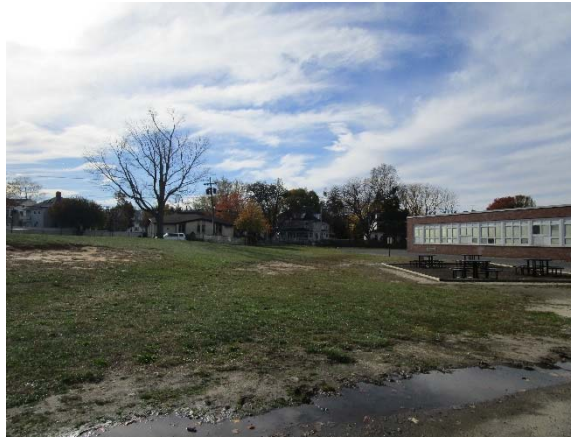
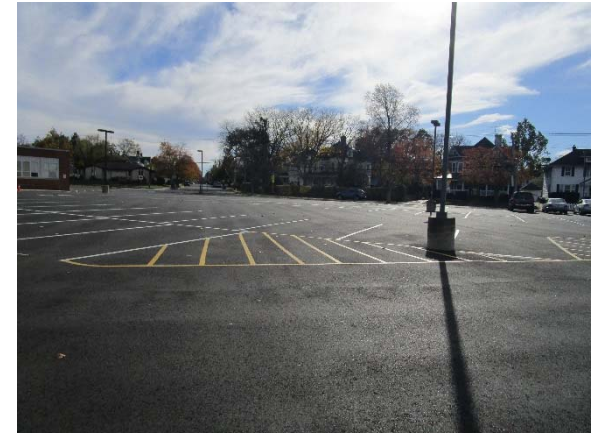
Installing two rain gardens near the outdoor seating area can capture, treat, and infiltrate runoff from the surrounding pavement. A portion of the parking spaces can be repaved with porous asphalt to capture a large volume of runoff from the parking lot. A preliminary soil assessment suggests that the soils have suitable drainage characteristics for green infrastructure.

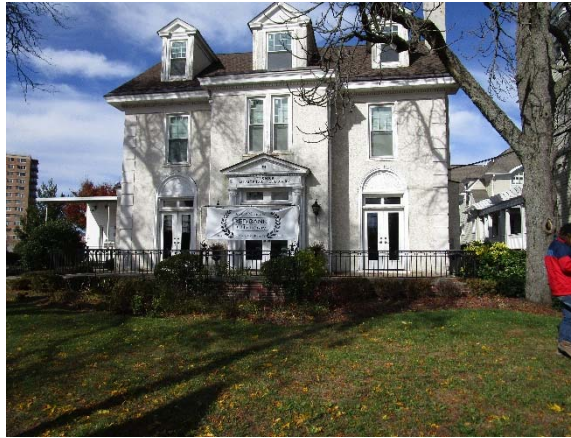
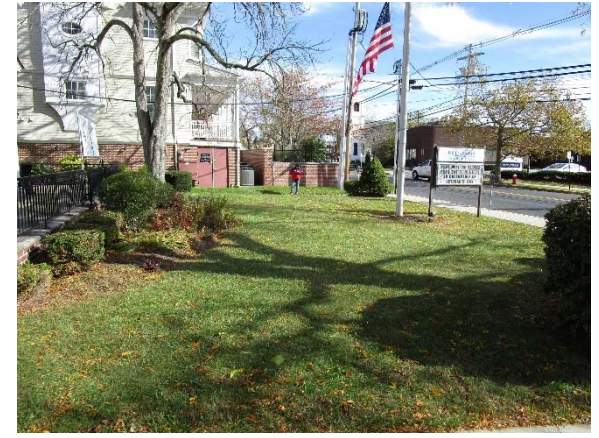
Installing a rain garden at the front of the building can capture, treat, and infiltrate roof runoff. A preliminary soil assessment suggests that the soils have suitable drainage characteristics for green infrastructure.

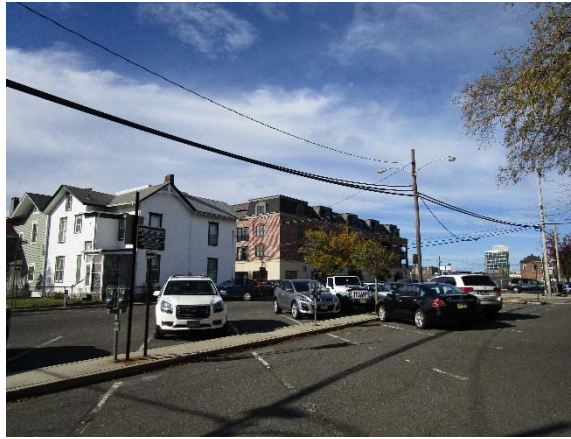
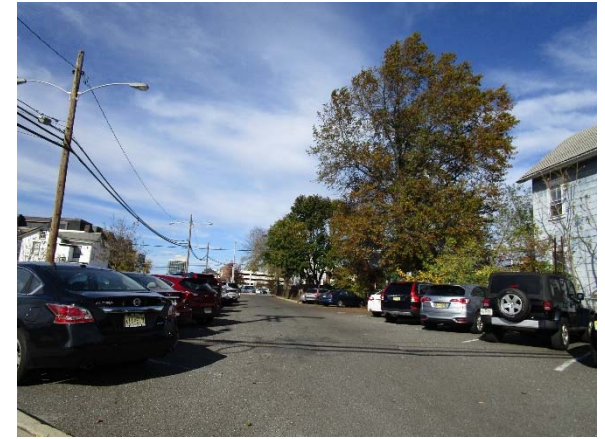
Parking spaces can be replaced with porous asphalt to capture and infiltrate stormwater. A preliminary soil assessment suggests that the soils have suitable drainage characteristics for green infrastructure.

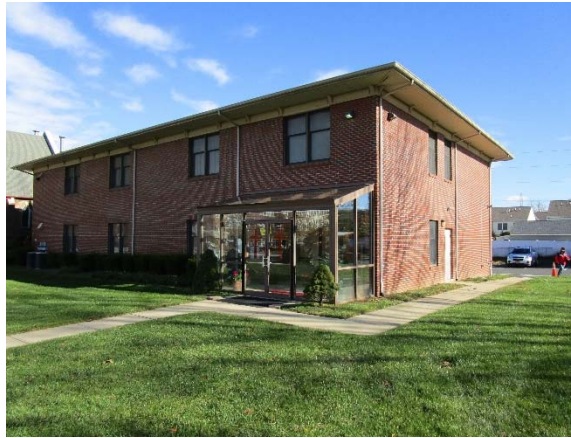
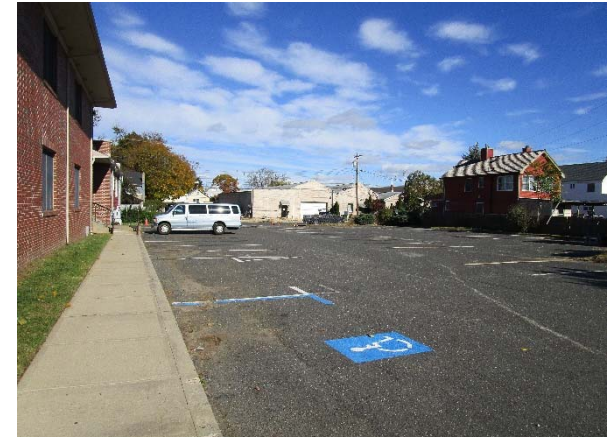
Parking spots to the east of the building can be replaced with porous asphalt to capture and infiltrate stormwater from downspouts already discharging to them. Installing rain gardens adjacent to the building can capture, treat, and infiltrate roof runoff. A preliminary soil assessment suggests that the soils have suitable drainage characteristics for green infrastructure.

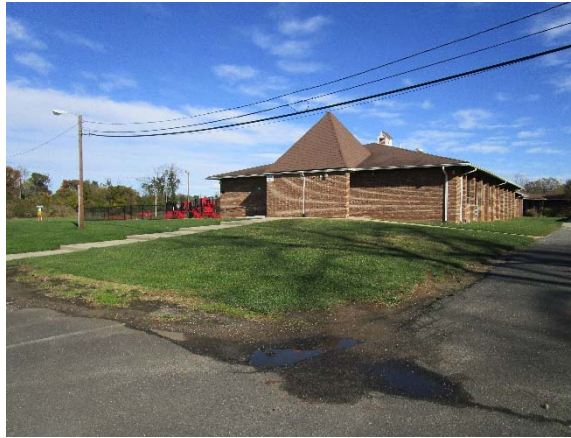
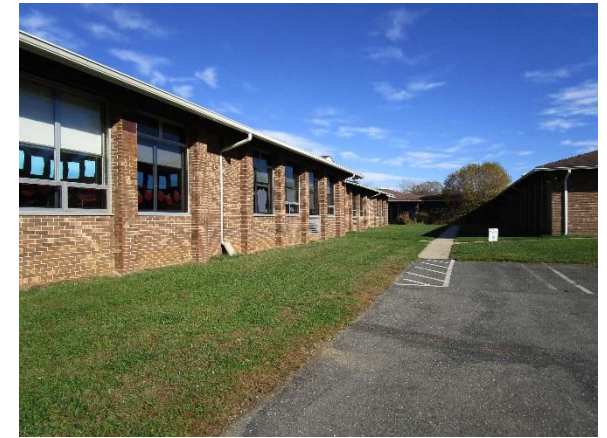
Installing rain gardens adjacent to the building and by the parking lot can capture, treat, and infiltrate roof runoff. A rain garden near the parking lot can help remediate some of the erosion occurring and capture runoff from the parking lot. A preliminary soil assessment suggests that the soils have suitable drainage characteristics for green infrastructure.

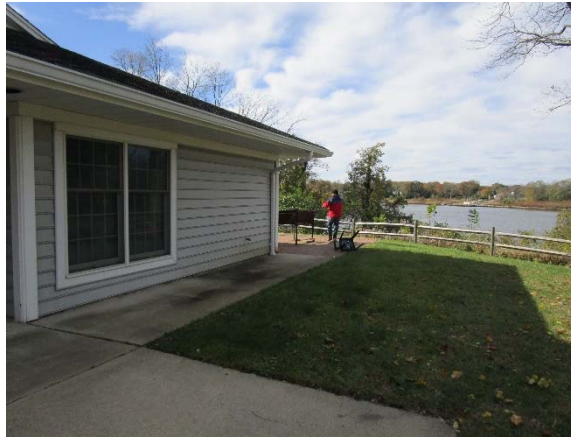
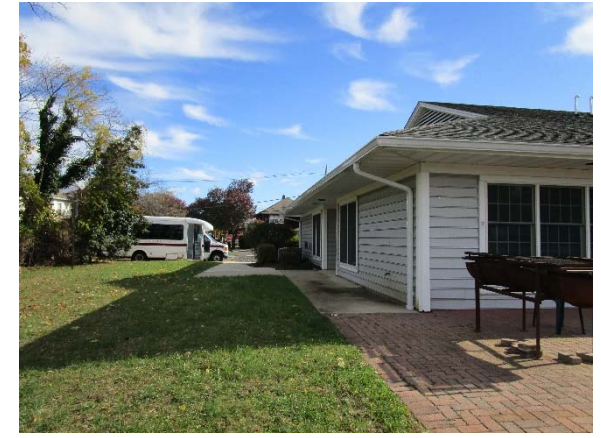
Installing a rain garden adjacent to the building can capture, treat, and infiltrate roof runoff. A preliminary soil assessment suggests that the soils have suitable drainage characteristics for green infrastructure.

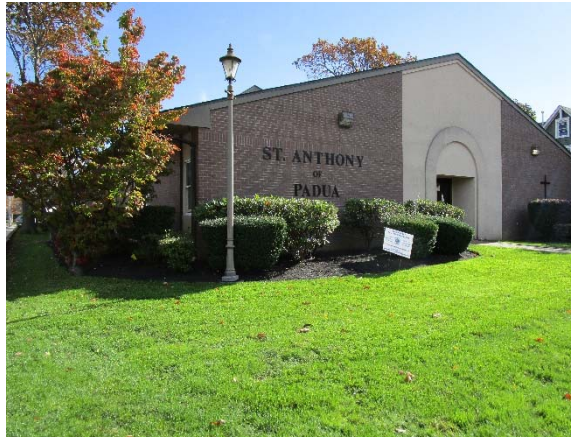
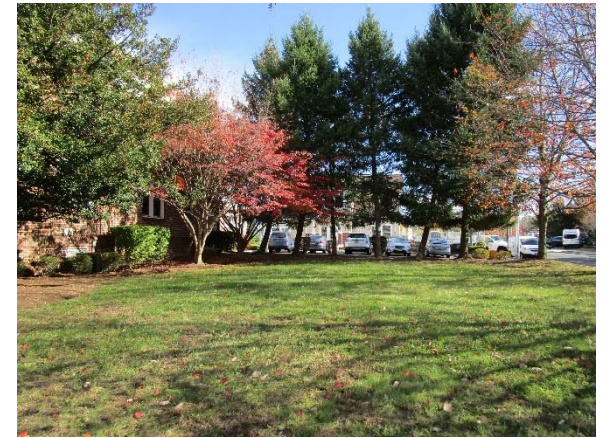
Roof runoff can be harvested by installing a cistern at the back of the building near the existing community garden raised beds. The water can then be used for watering the garden. Installing a rain garden adjacent to each of the building can capture, treat, and infiltrate roof runoff. A preliminary soil assessment suggests that the soils have suitable drainage characteristics for green infrastructure.
